# Project Background and Description for Lake St. Martin Outlet Channel

May 9, 2019

**Workshop 1: EIS Status**

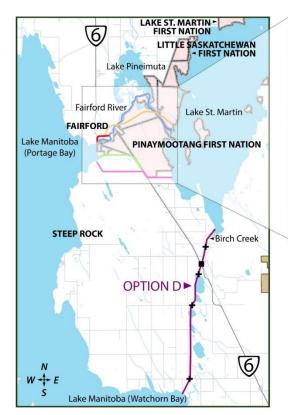
### Lake Manitoba Outlet (Stage 1 Study)

- 6 alignment options considered
- Range in flows from 0 to 15,000 cfs
- Options C & D
   preferred based on
   cost and
   environmental
   rankings

- Combined Control Structure and PTH Bridge
- Municipal Road & Control Structure
- Municipal Road Bridge

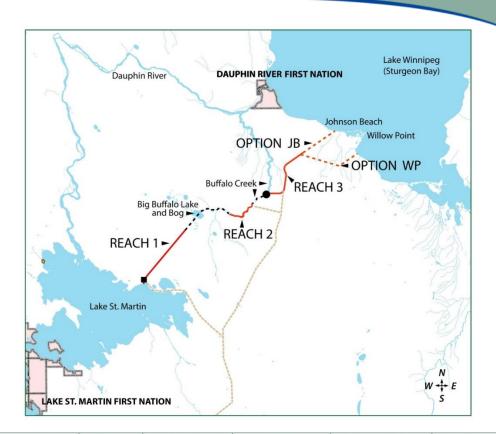
### Lake St. Martin Outlet (Stage 1 Study)

- 2 alignment options considered for LSM
  - Both through Big Buffalo Lake wetland/bog
- Range in flows from (4000 to 19 000 cfs)
- Both options ranked similarly – WP option tentatively preferred for socio-economic reasons

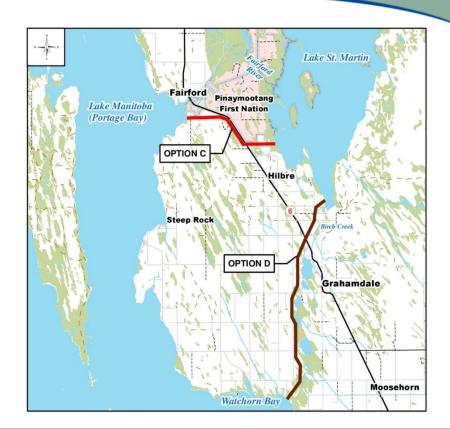
### Lake Manitoba Outlet (Stage 2 Study)

- Refinement of alignments
- Key issue:
  - Risks associated with potential groundwater impacts on Route C

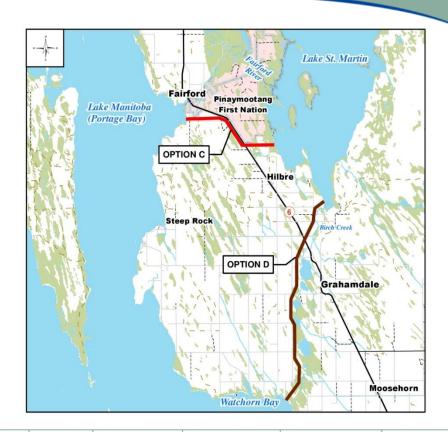
### **Preliminary Engineering for LMB Options C&D**

- Scope of work included:
  - Drilling and monitoring program
  - Groundwater study
  - Surface water study
  - Geotechnical investigations and analyses
  - Risk Assessment

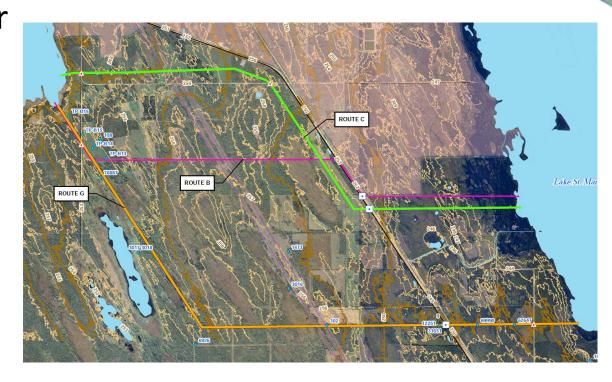
- Based stakeholder input, additional Option "G" considered
- Concluded to have similar concerns to Option C

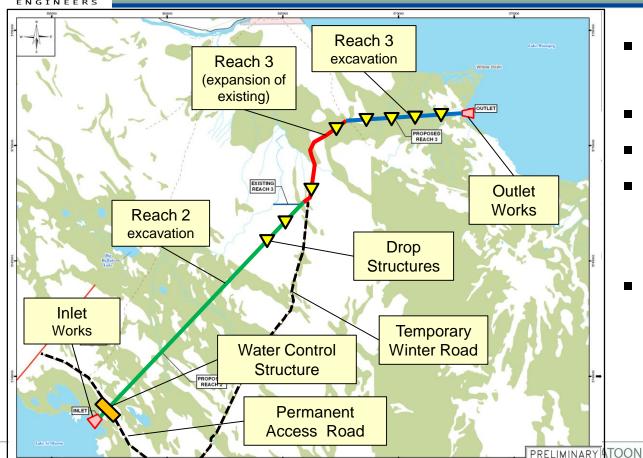
### Lake St. Martin Outlet Channel Description

- Design continues to evolve
- Alignment is fixed
- Profile being updated
- Number, location & type of drop structures under review
- WCS location may change

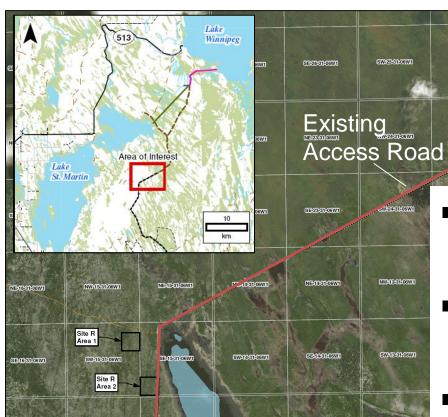
### **Rock Availability Assessment**

Studying quality/quantity of rock available for riprap

Alternate sites under consideration

Various testing ongoing

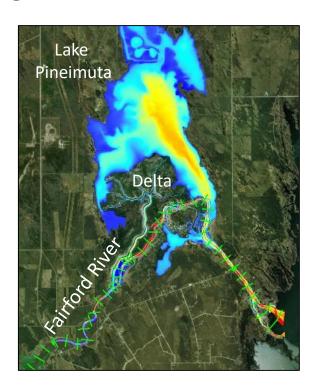
### Fairford River and Dauphin River Flow System

- Phased surveys to support modelling and assessments
  - fluvial geomorphology
  - water retention times
  - river ice processes
