RE: Emergency Reduction of Lake Manitoba and Lake St. Martin Water Levels
Dauphin River Bathymetric Survey Investigation - FINAL

1.0 INTRODUCTION

EMERGENCY REDUCTION OF
LAKE MANITOBA AND
LAKE ST. MARTIN WATER LEVELS
LOWER DAUPHIN RIVER BATHYMETRY
OVERVIEW

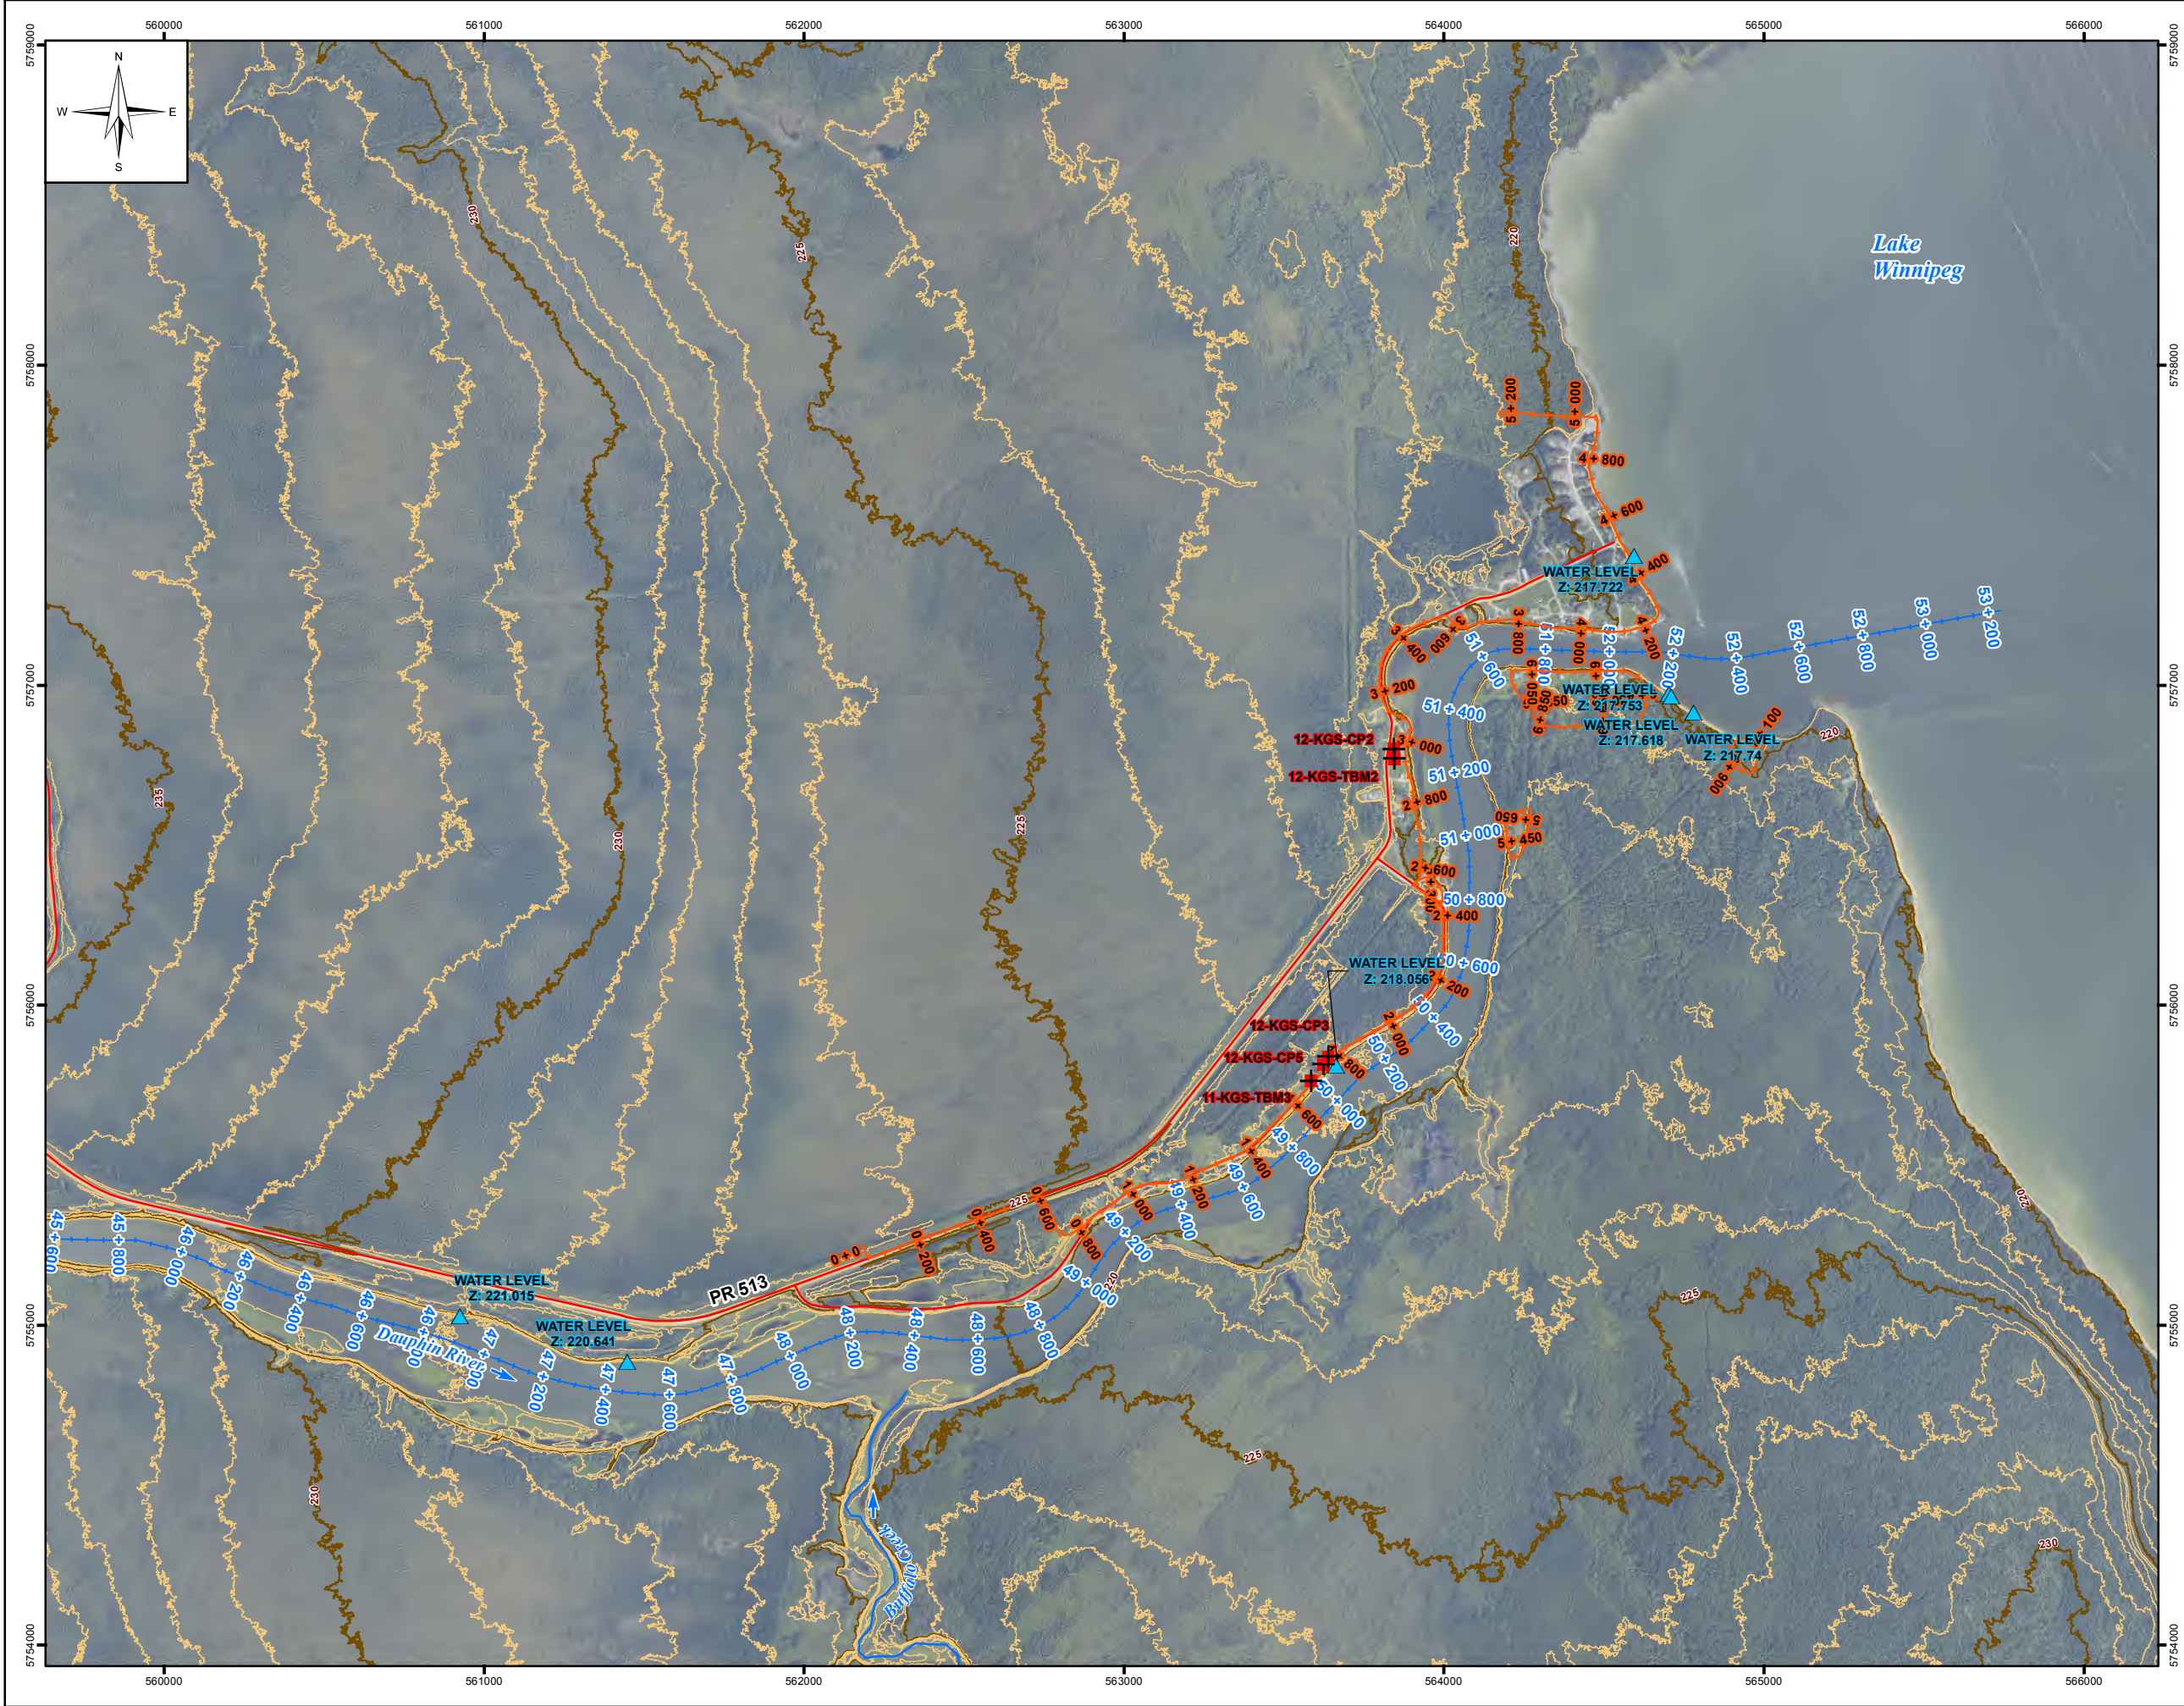
The 2012 survey program was undertaken along the Dauphin River from upstream of Buffalo Creek at station 42+200 to the mouth of the river at Lake Winnipeg. The water surface elevation of Lake Winnipeg at the mouth of the Dauphin River at the time of the bathymetric survey was 714.2 ft. (217.7 metres). The LSMEOC was in operation during the 2012 survey program (LSMEOC was operated from November 2011 to November 2012). The focus of the survey was to capture the river bottom to develop river bottom contours, profile and river cross-sections where possible. The same boat operator that was hired in 2011 provided services for the 2012 survey program. Figure 1 shows the limits of the field investigation completed by KGS Group.

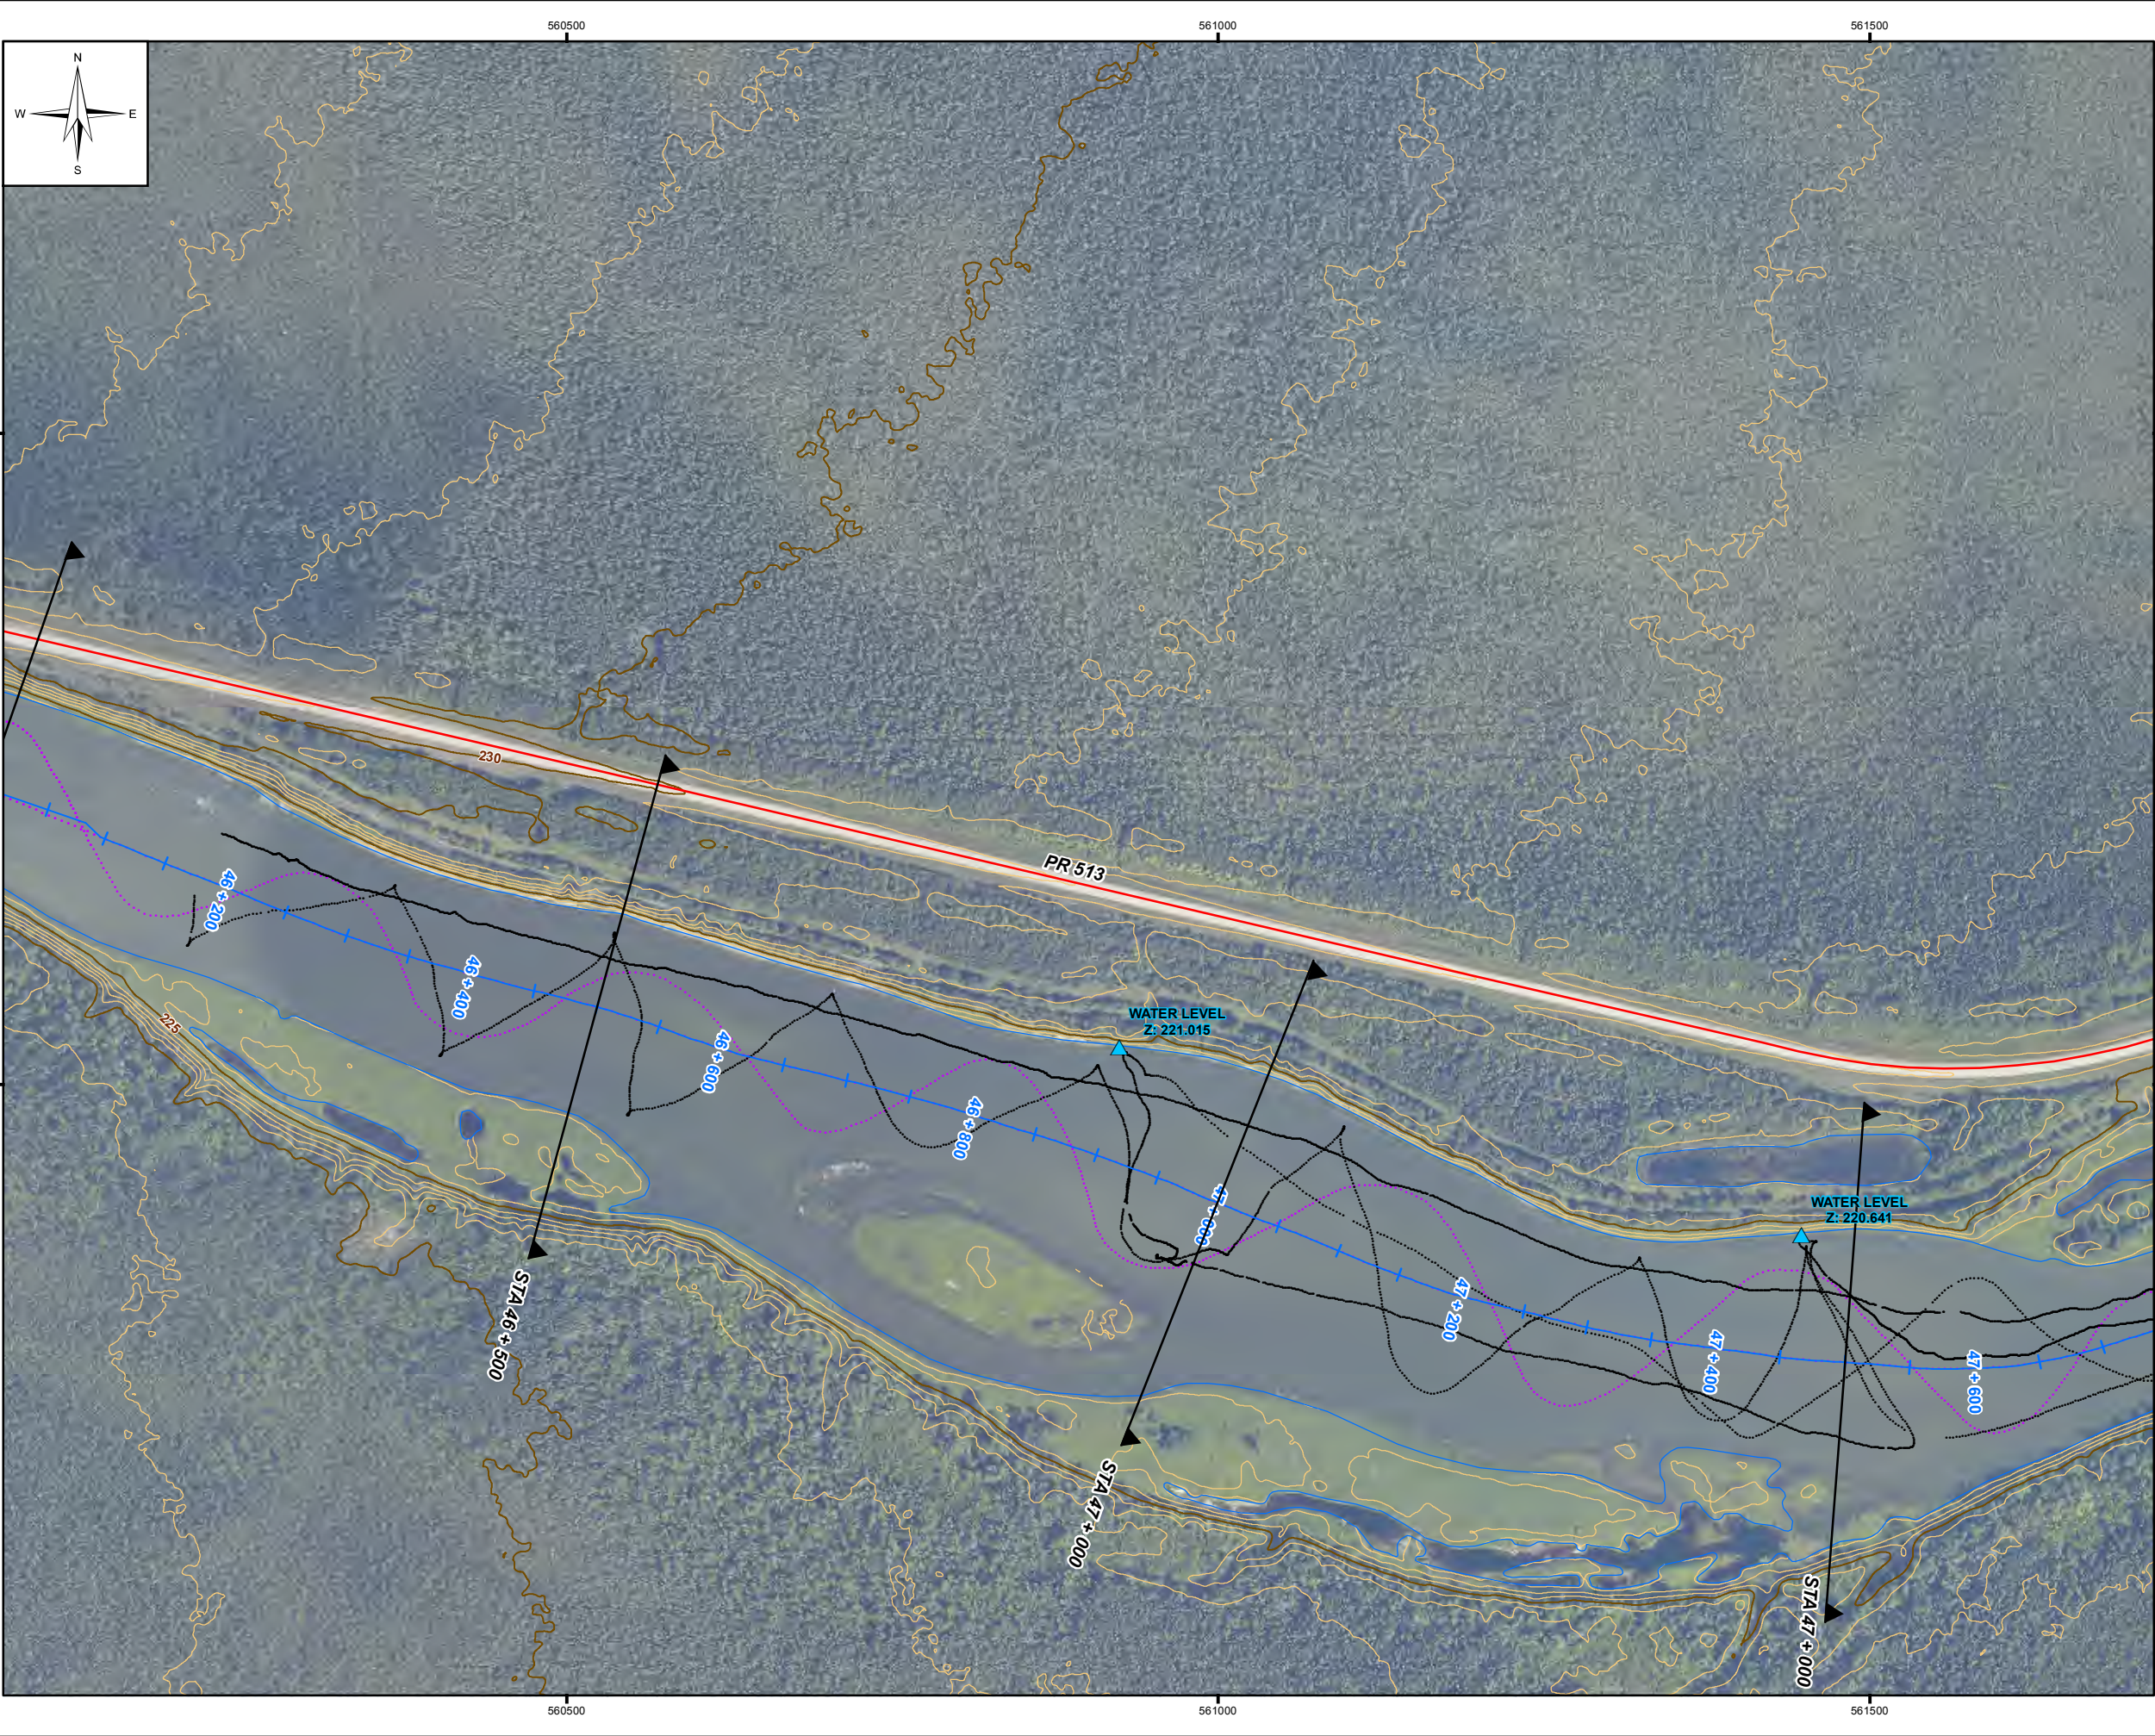
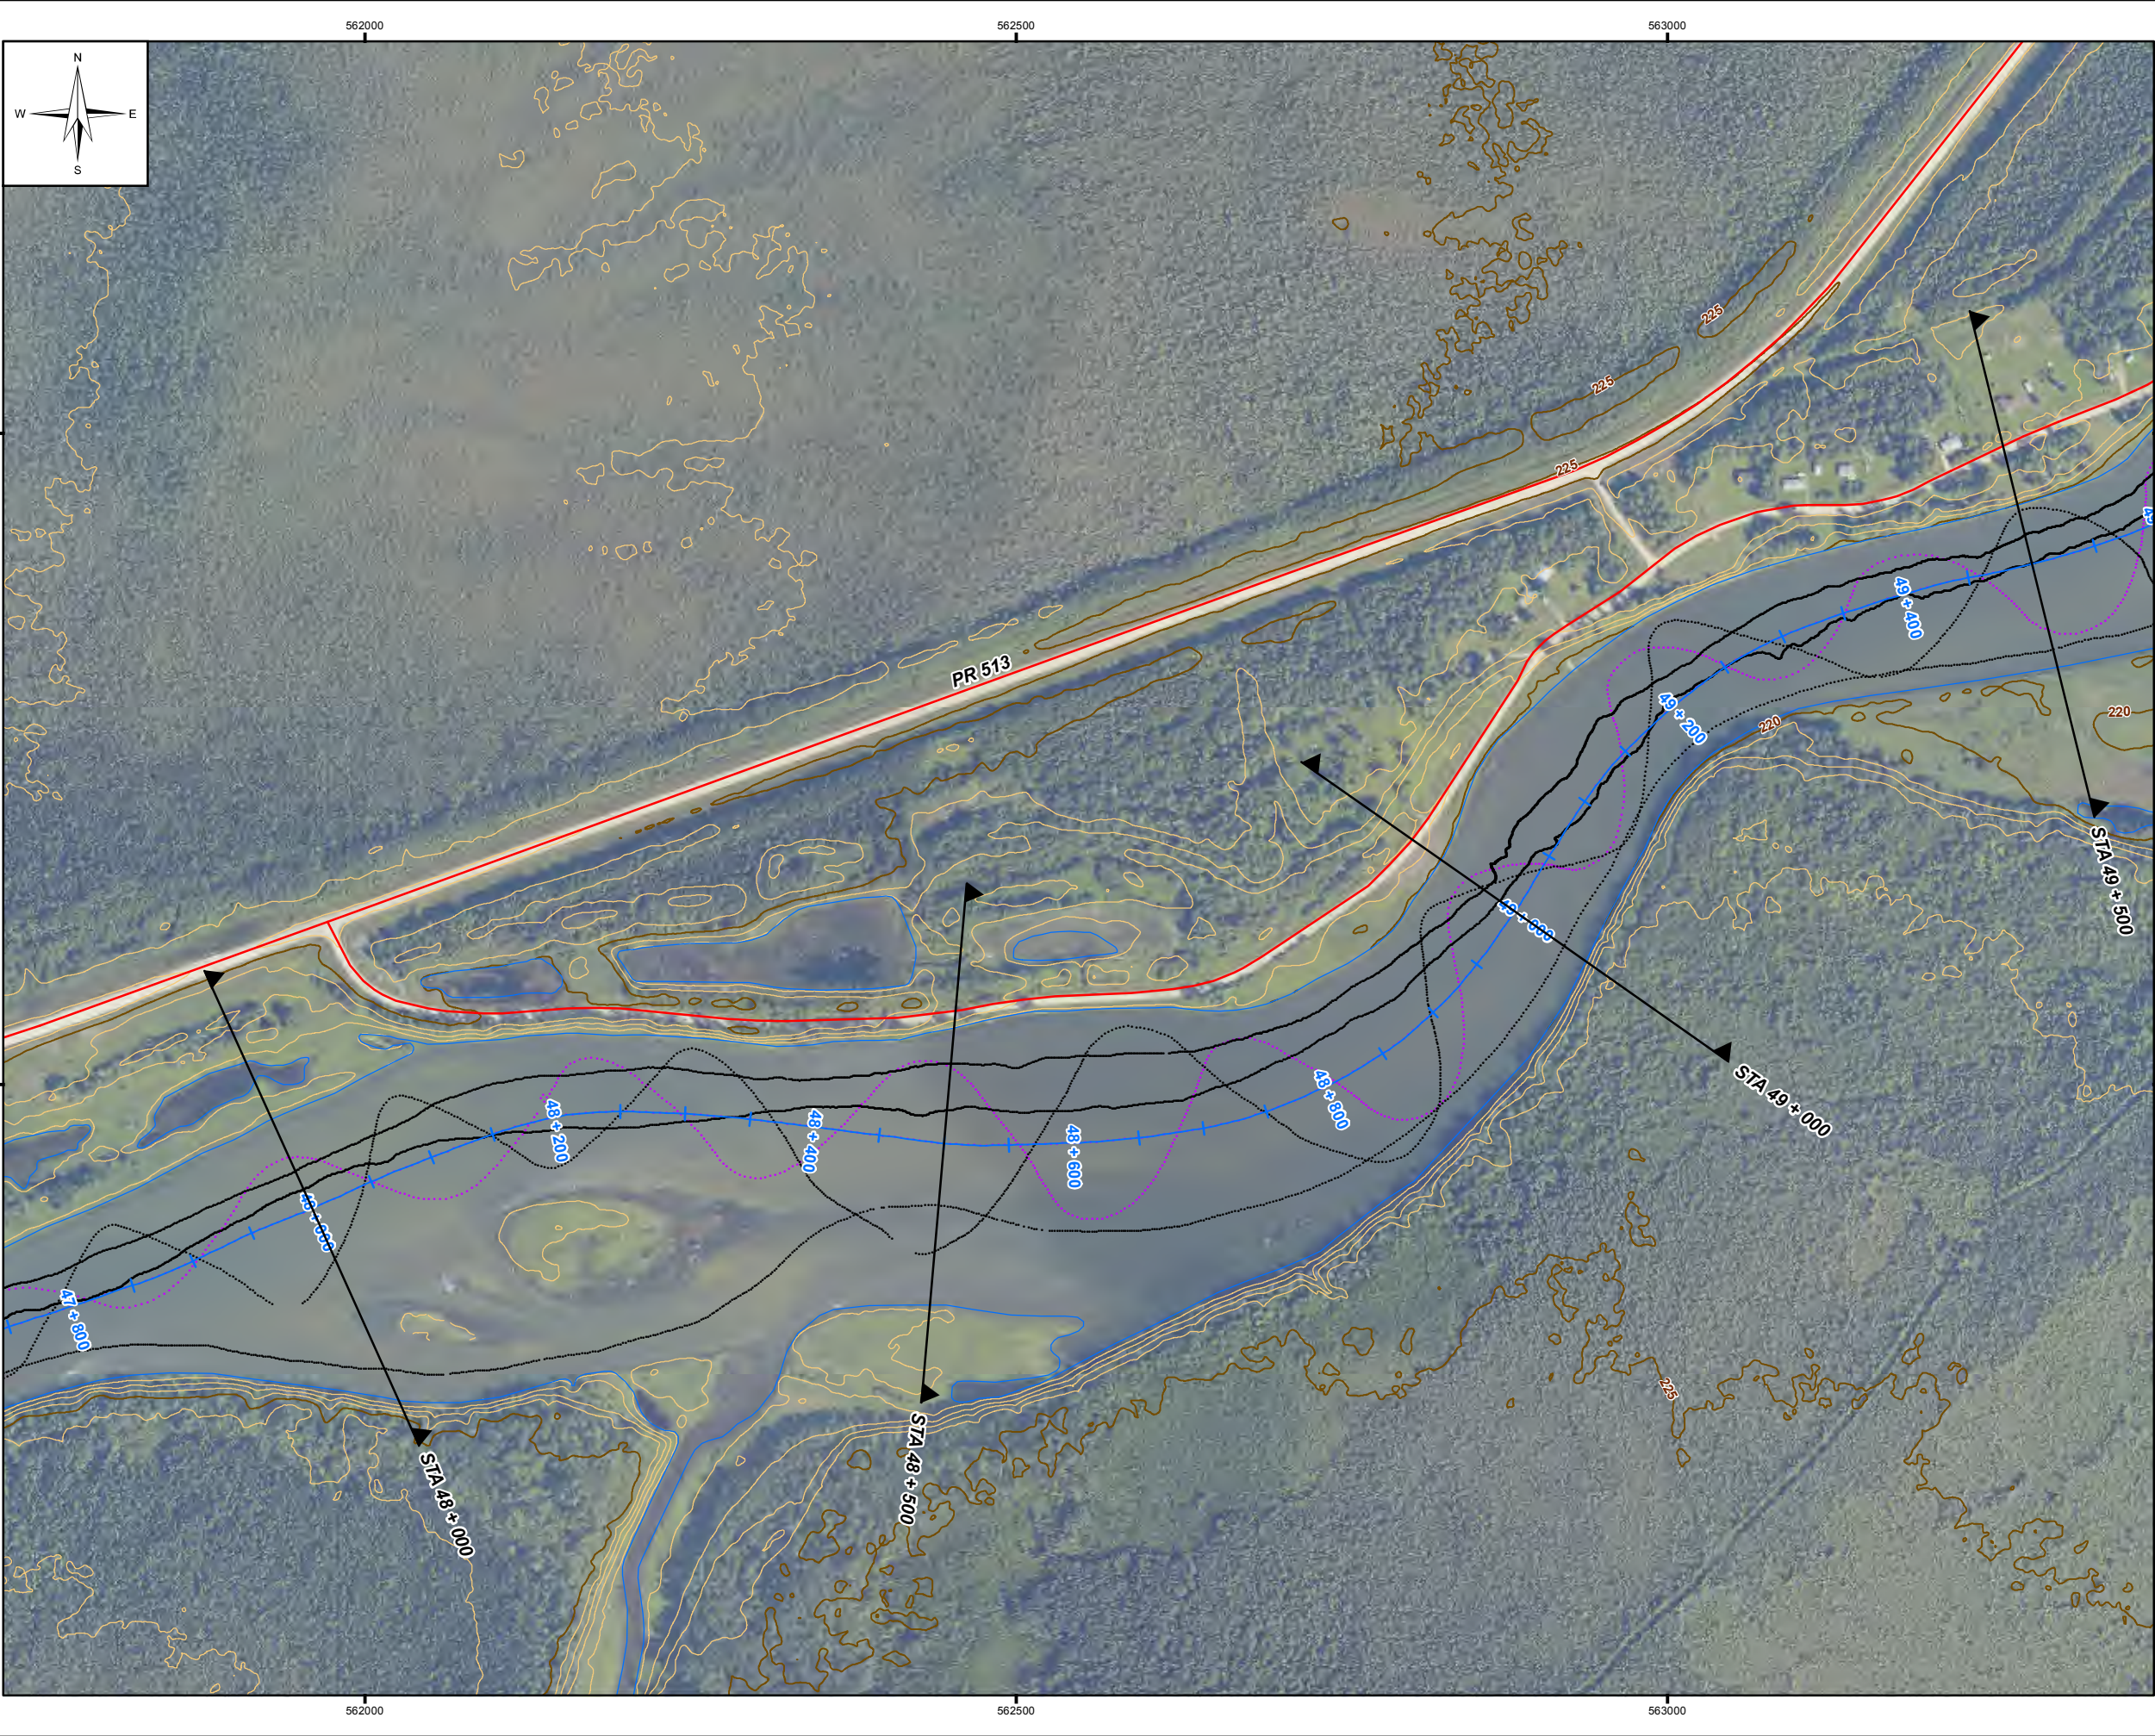
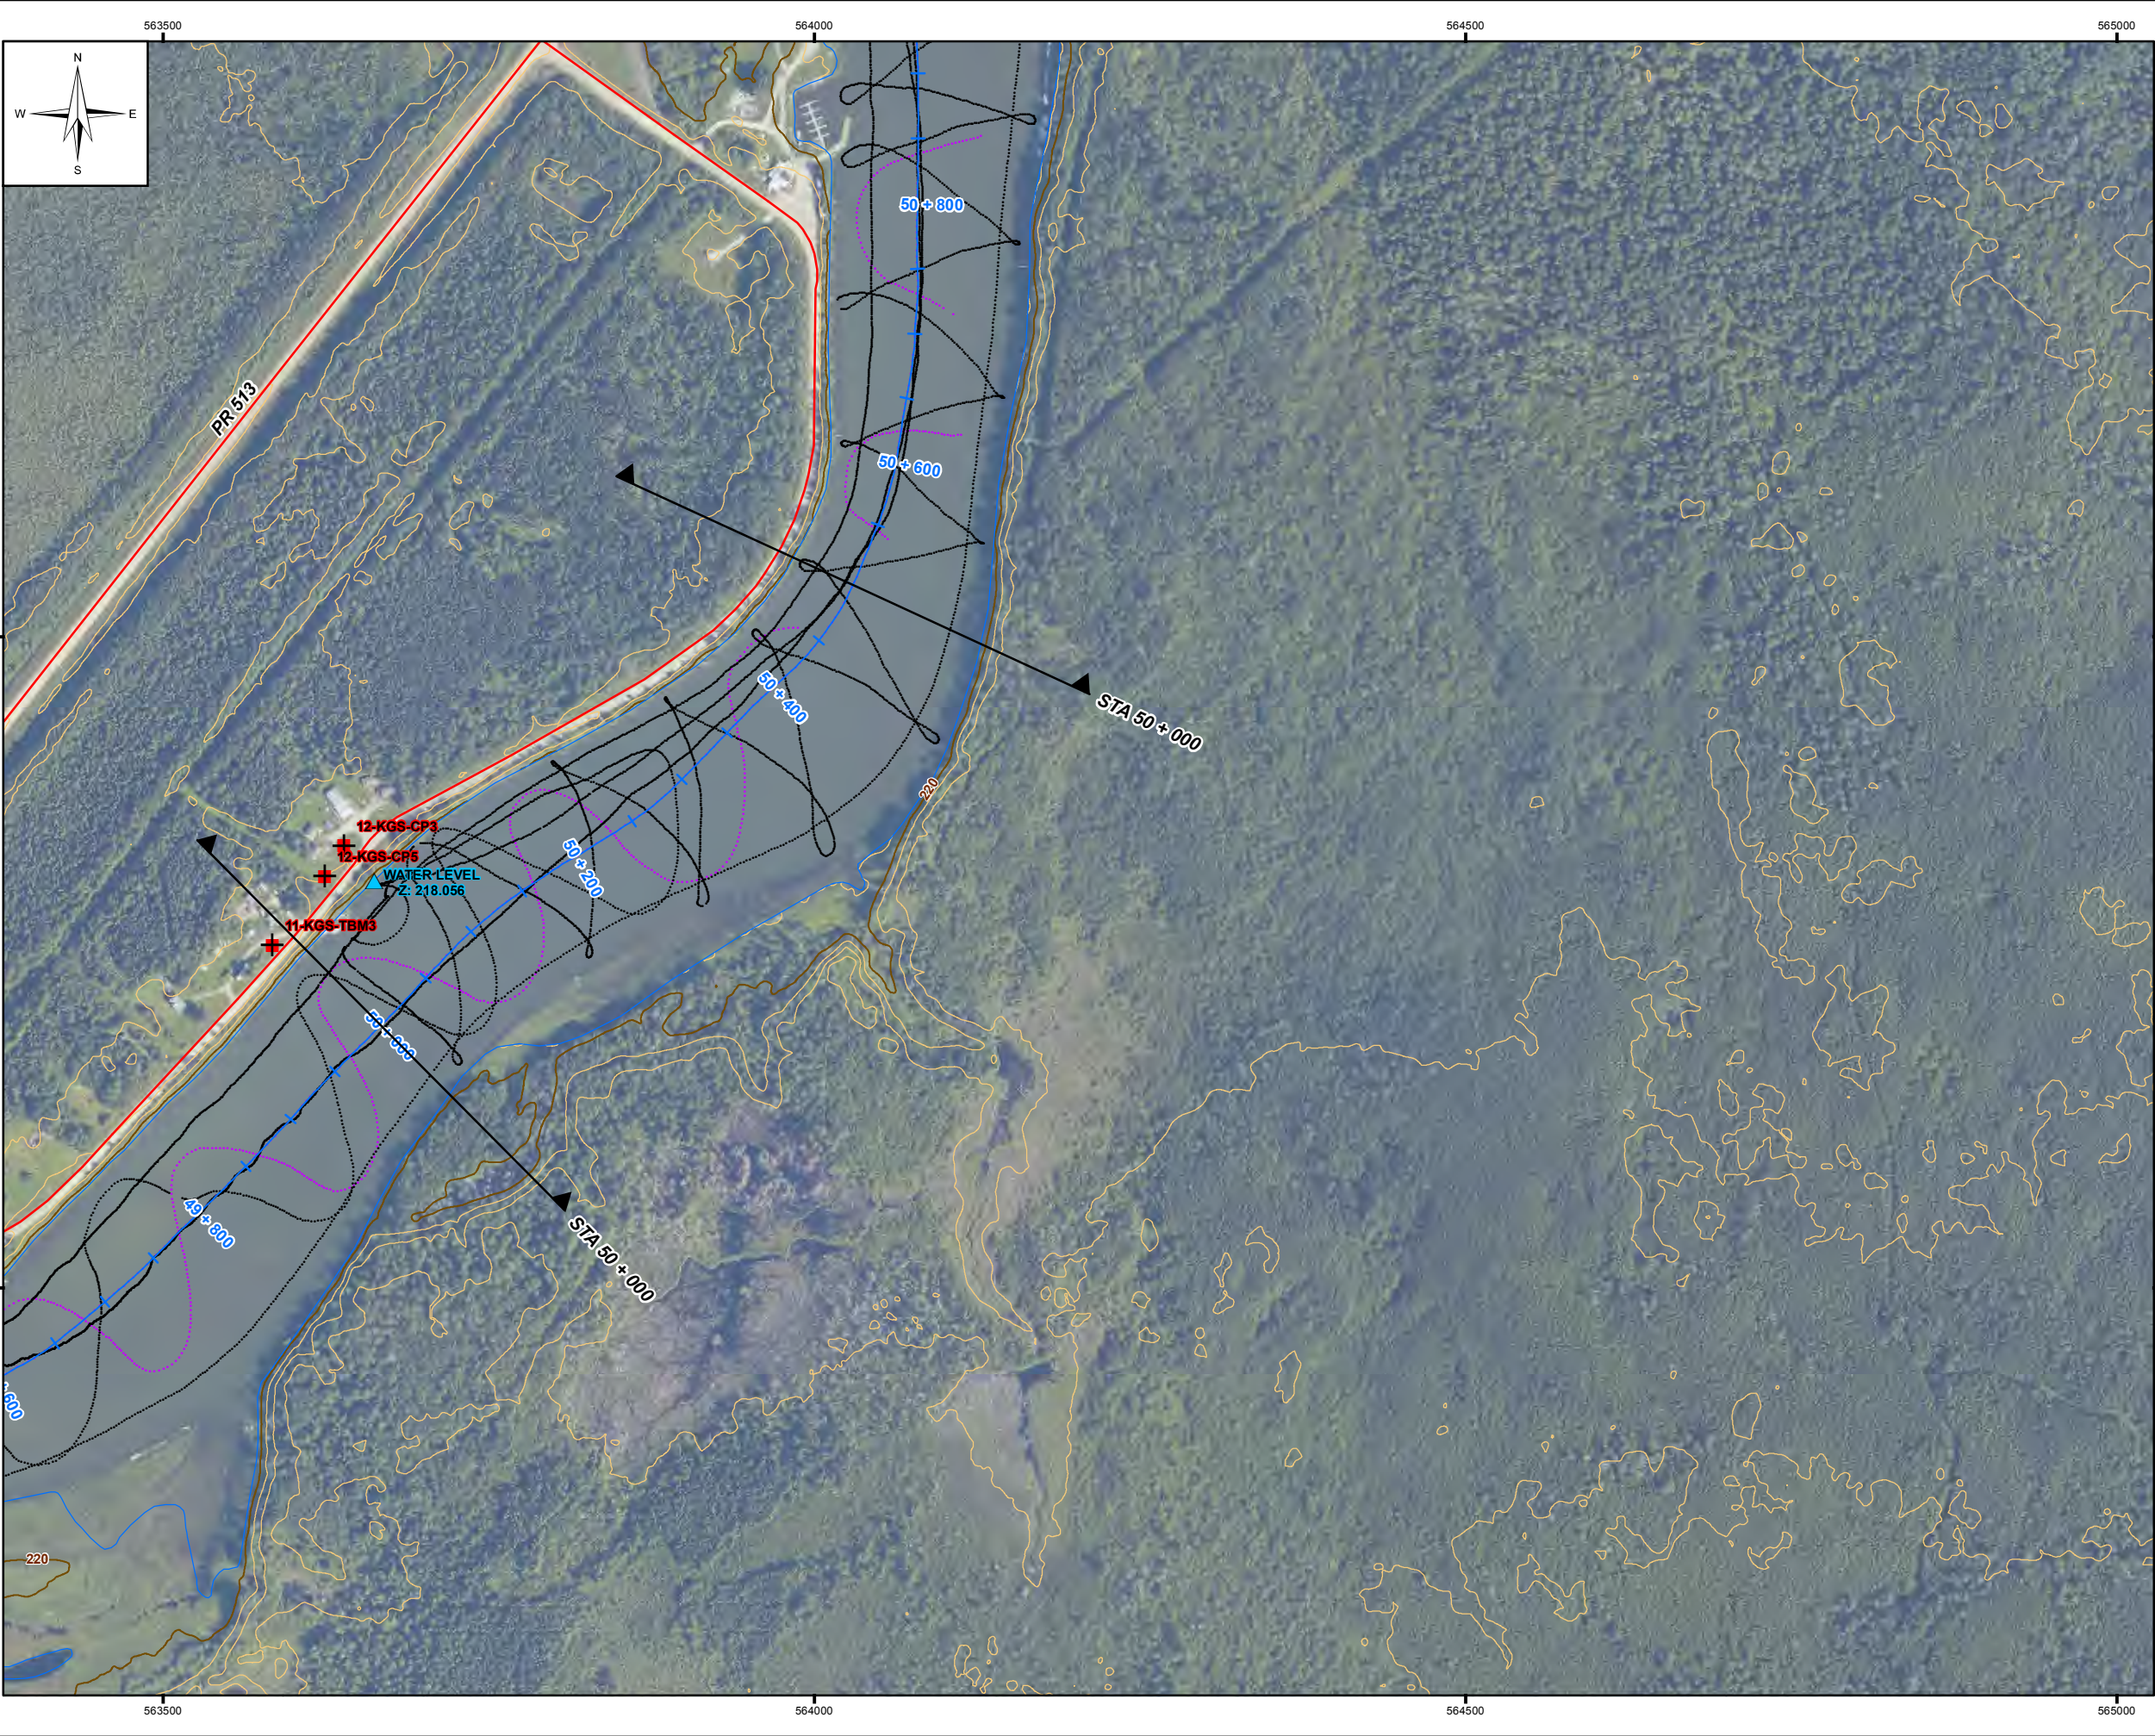
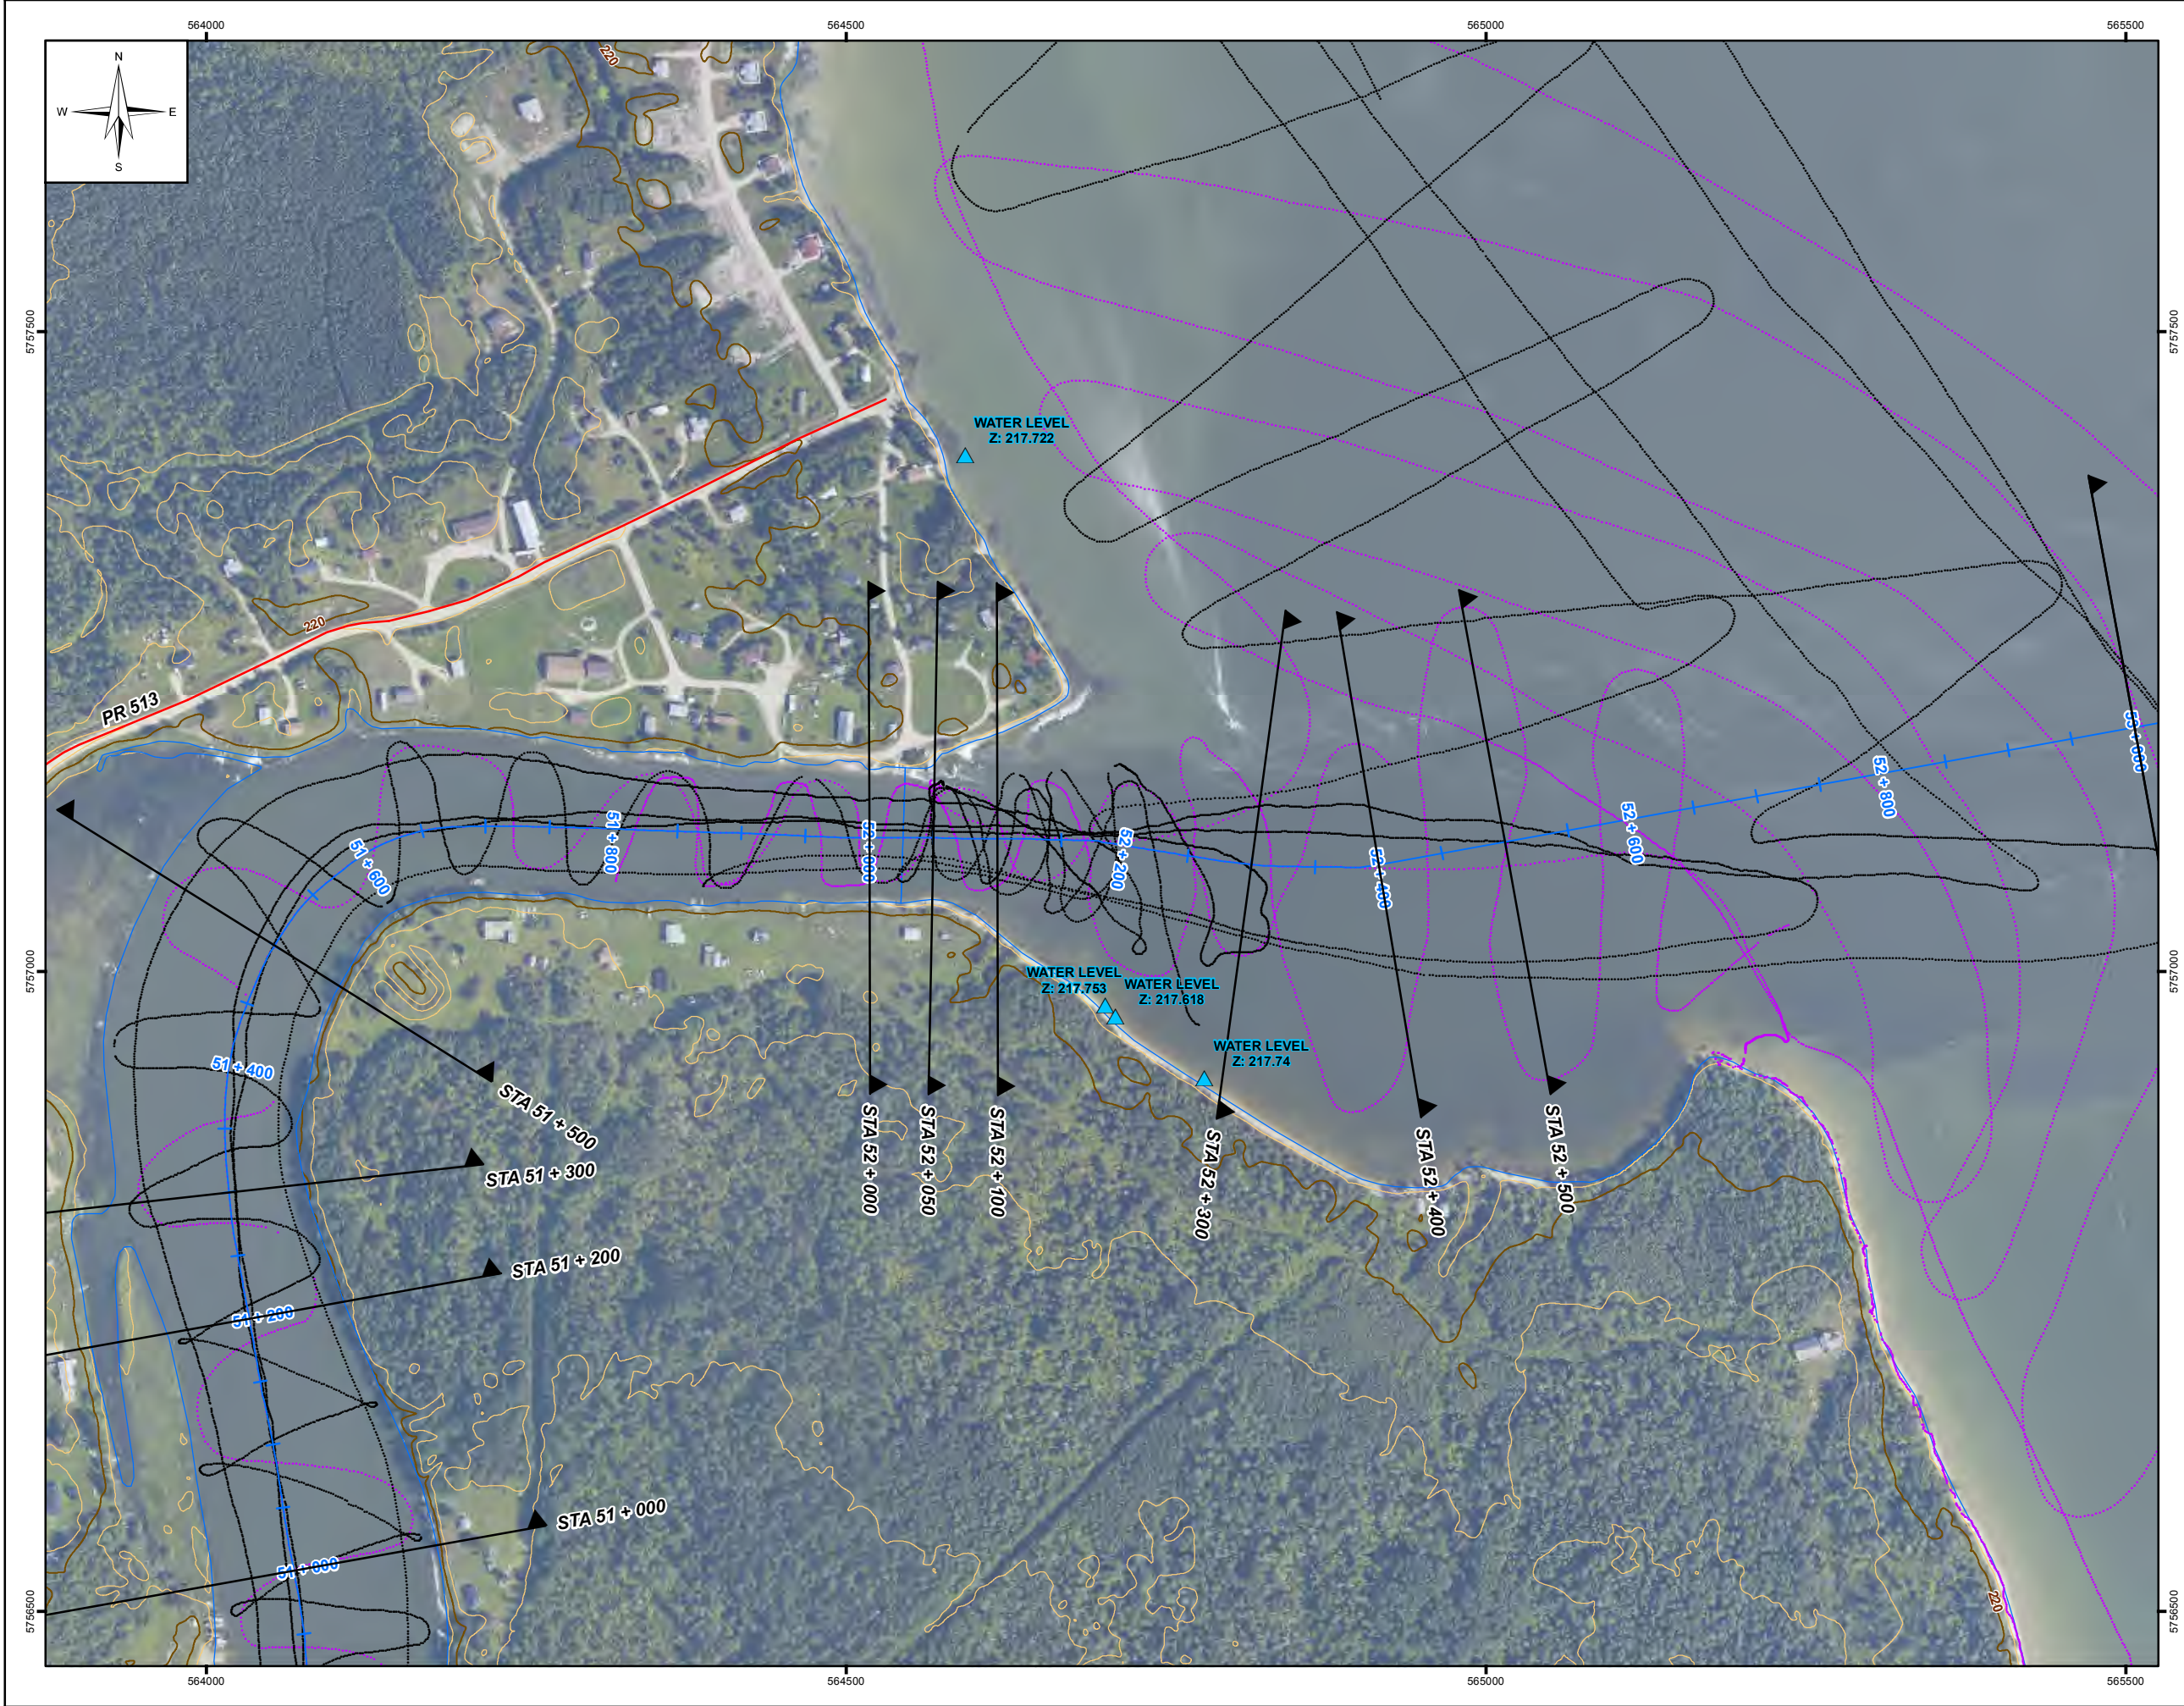
EMERGENCY REDUCTION OF
LAKE MANITOBA AND
LAKE ST. MARTIN WATER LEVELS
DAUPHIN RIVER OUTLET BATHYMETRY
(SHEET 1 OF 4)

The completed bathymetric survey was compiled and compared against the 2011 survey data collected for the same reach length collected in June 2012. Figure 2 shows the locations of the sonar tracks collected from both years from Station 46+200 to 53+200. The bathymetry data was interpolated to produce a bottom profile of the Dauphin River from Station 48+000 to Station 53+200 for both the 2011 and 2012 data. The water level was on average 0.5 metre lower during the 2012 investigation than the previous water level during the 2011 program for the downstream reach of the river. The average depth of water observed at different locations in the river during the 2012 survey is outlined below:

- 0.7 m from Station 46+000 to Station 47+300,
- 1.4 m from Station 47+300 to Station 50+500,
- 2.7 m from Station 50+500 to Station 52+000,
- 3.0 m from Station 52+000 to the mouth of the river.
