RE: Emergency Reduction of Lake Manitoba and Lake St. Martin Water Levels
Dauphin River Bathymetric Survey Investigation - FINAL

1.0 INTRODUCTION

EMERGENCY REDUCTION OF
LAKE MANITOBA AND
LAKE ST. MARTIN WATER LEVELS
LOWER DAUPHIN RIVER BATHYMETRY
OVERVIEW

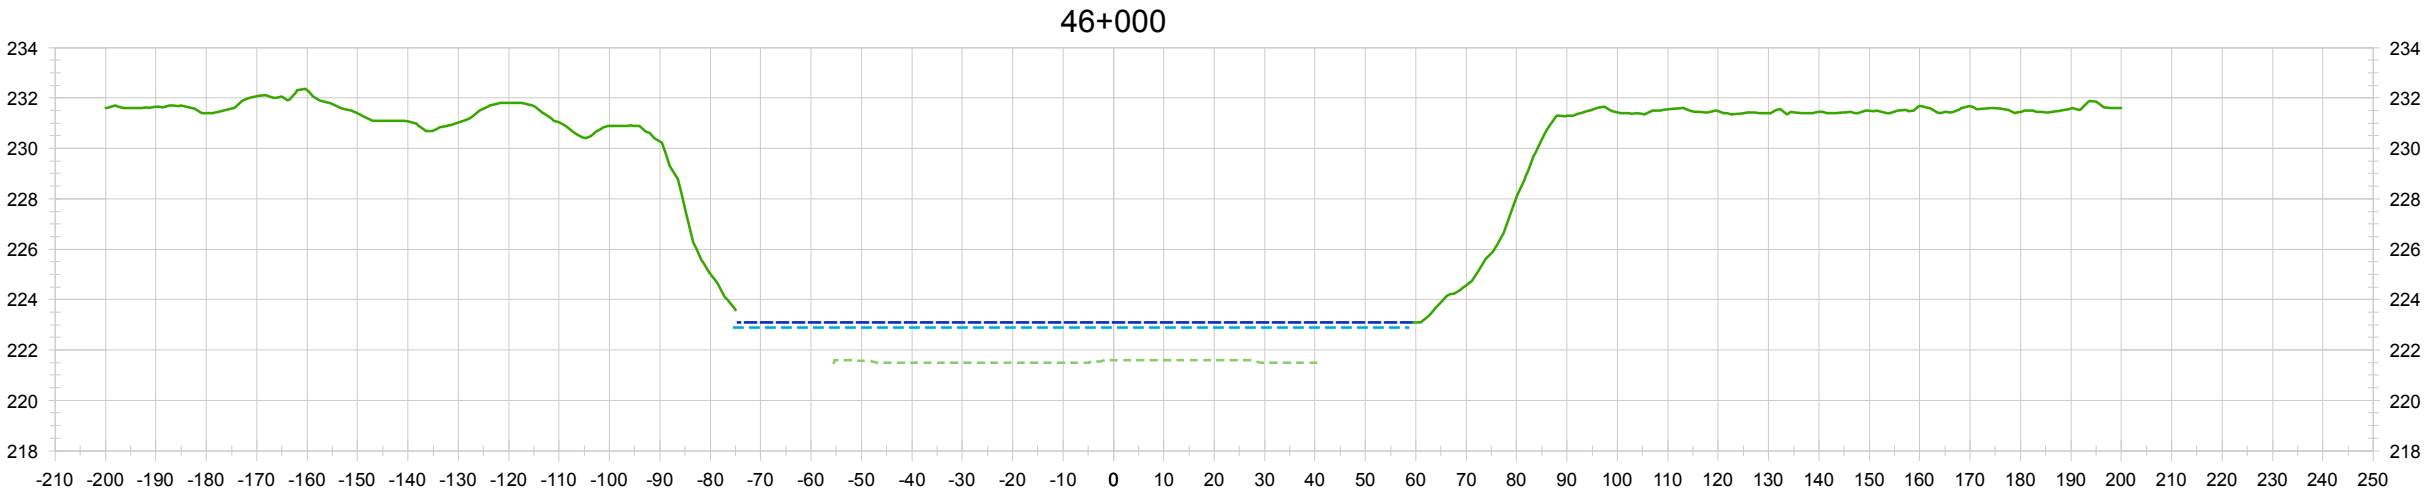
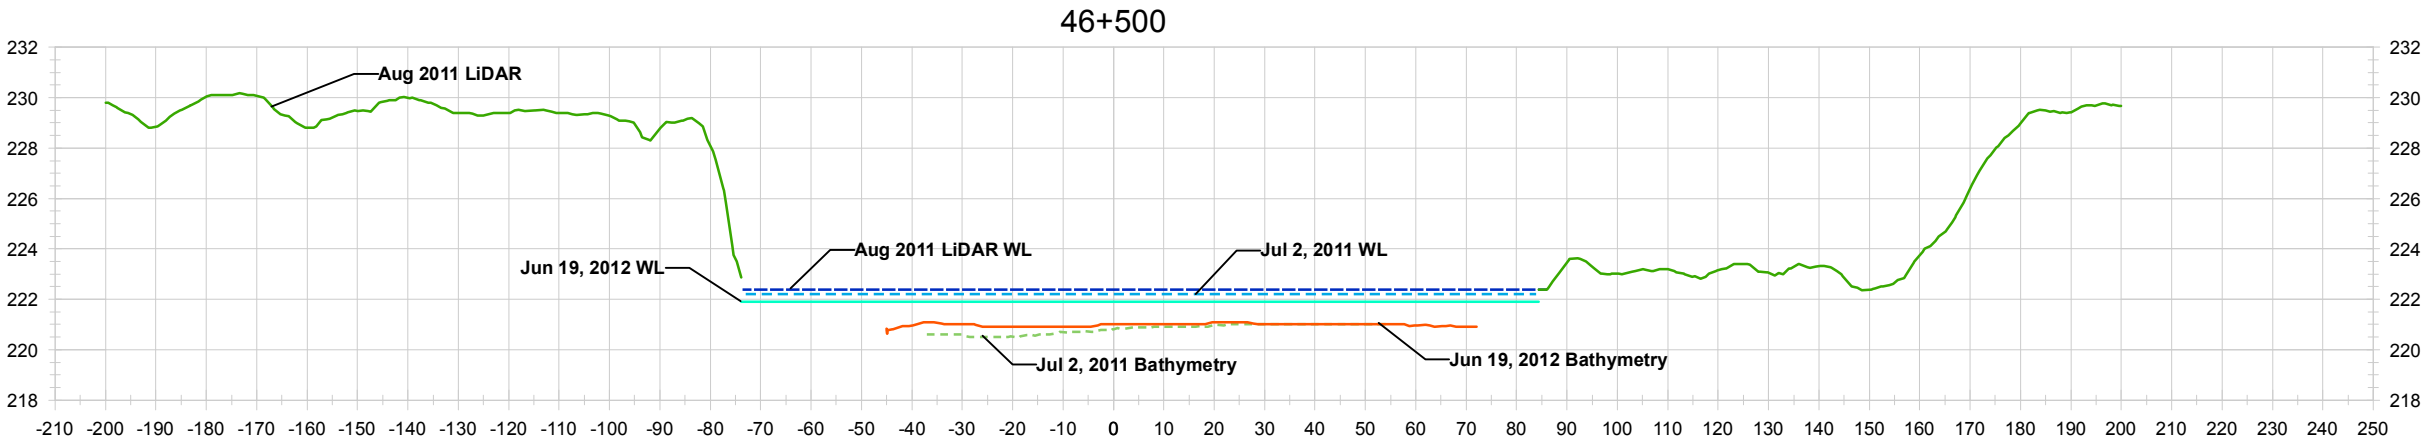
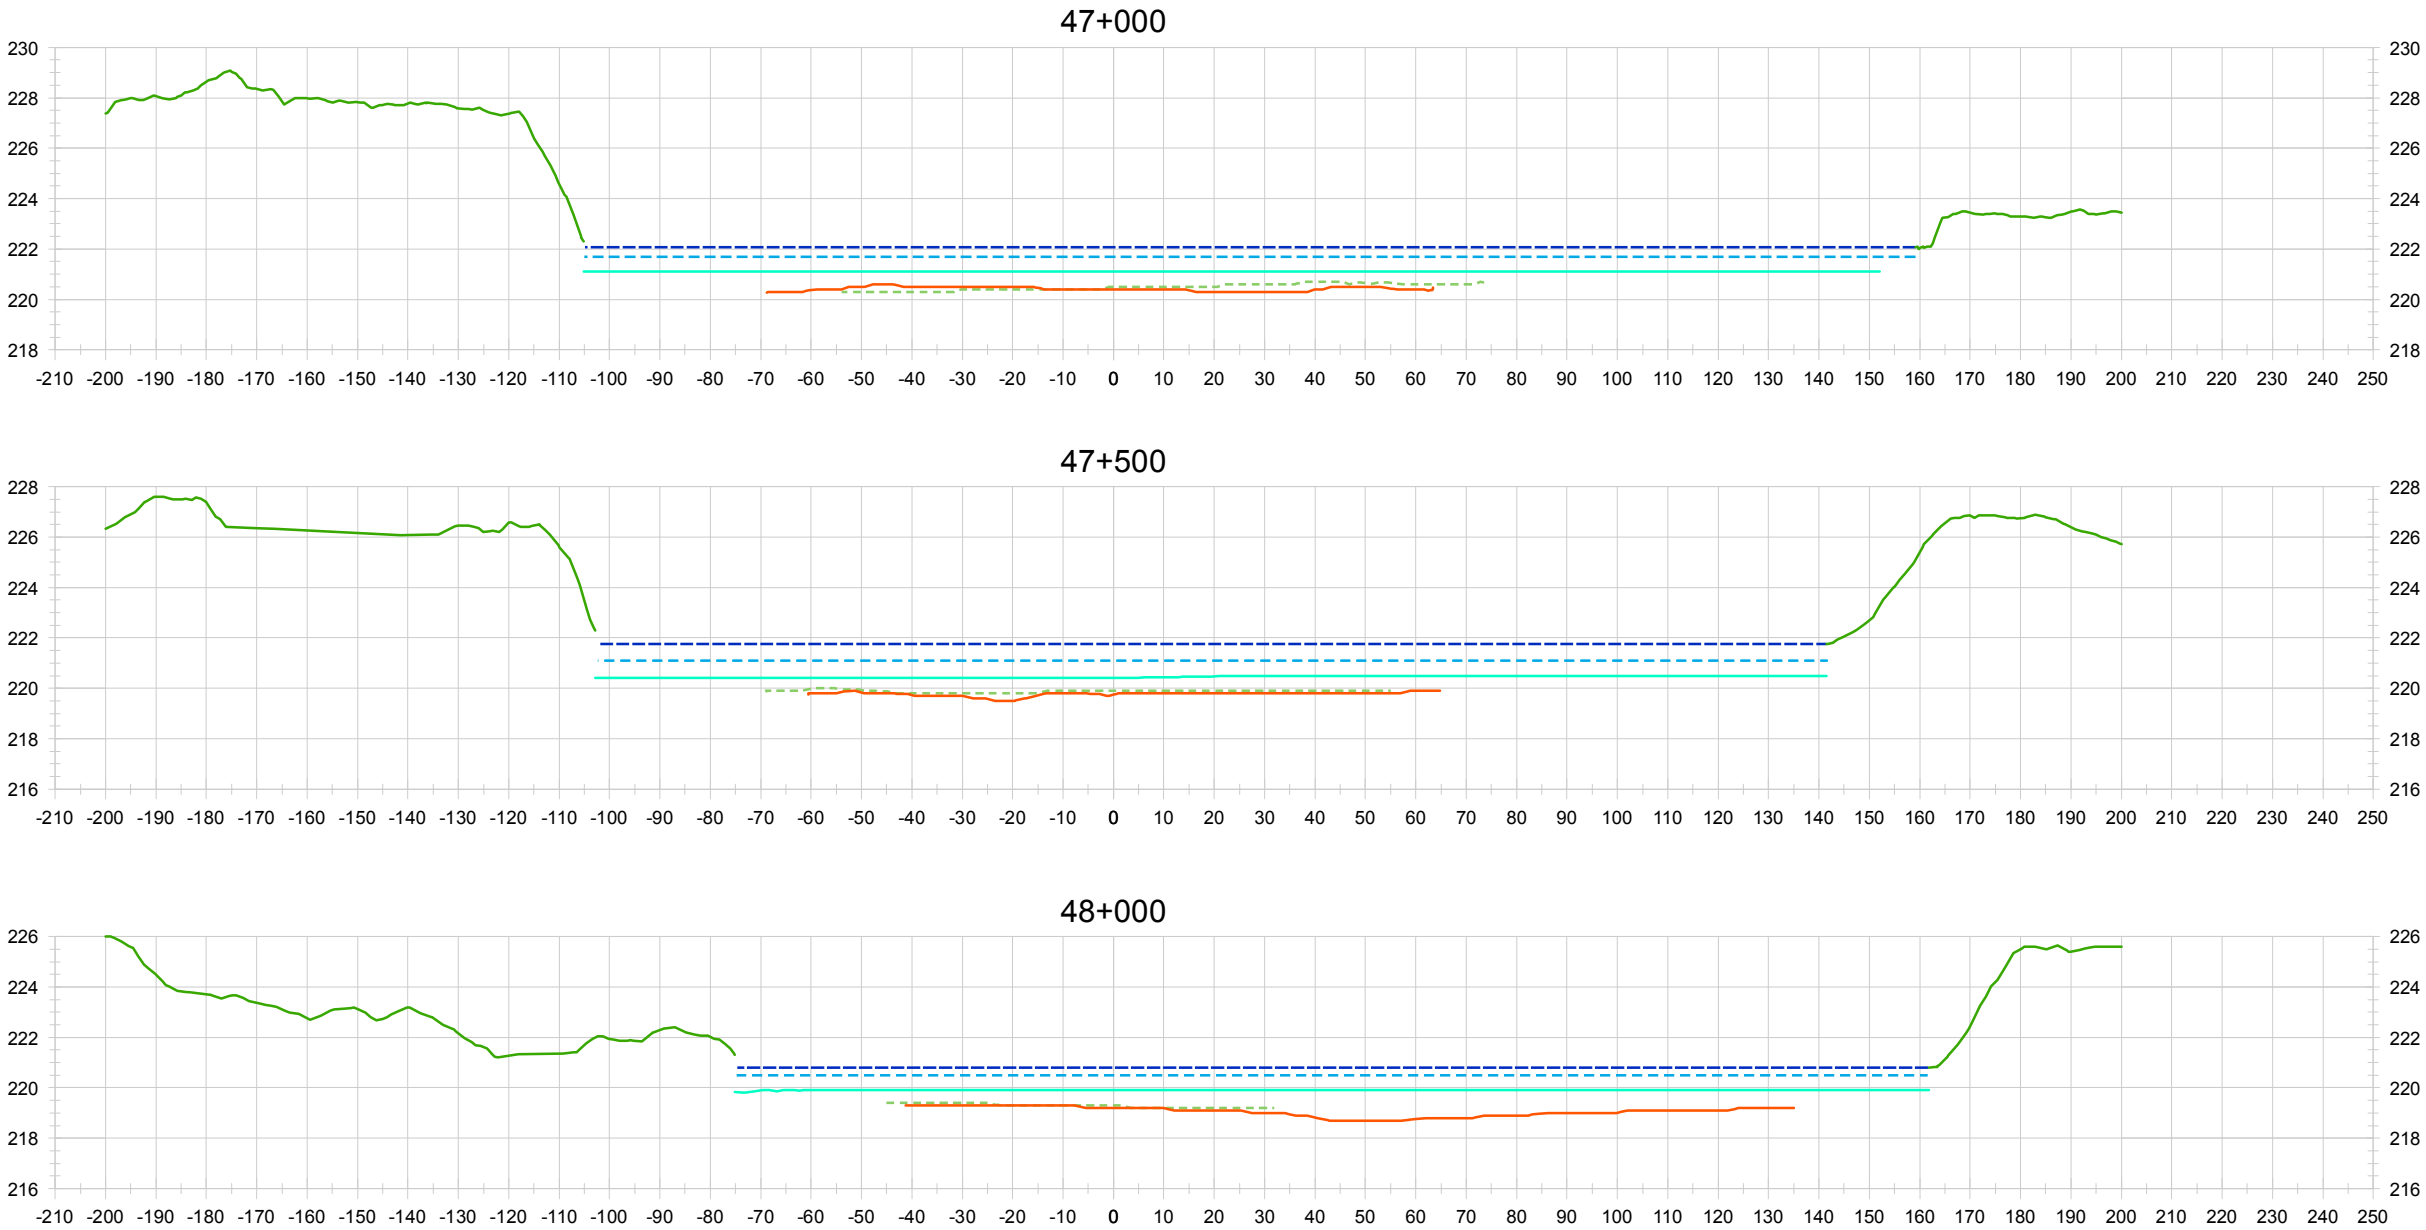
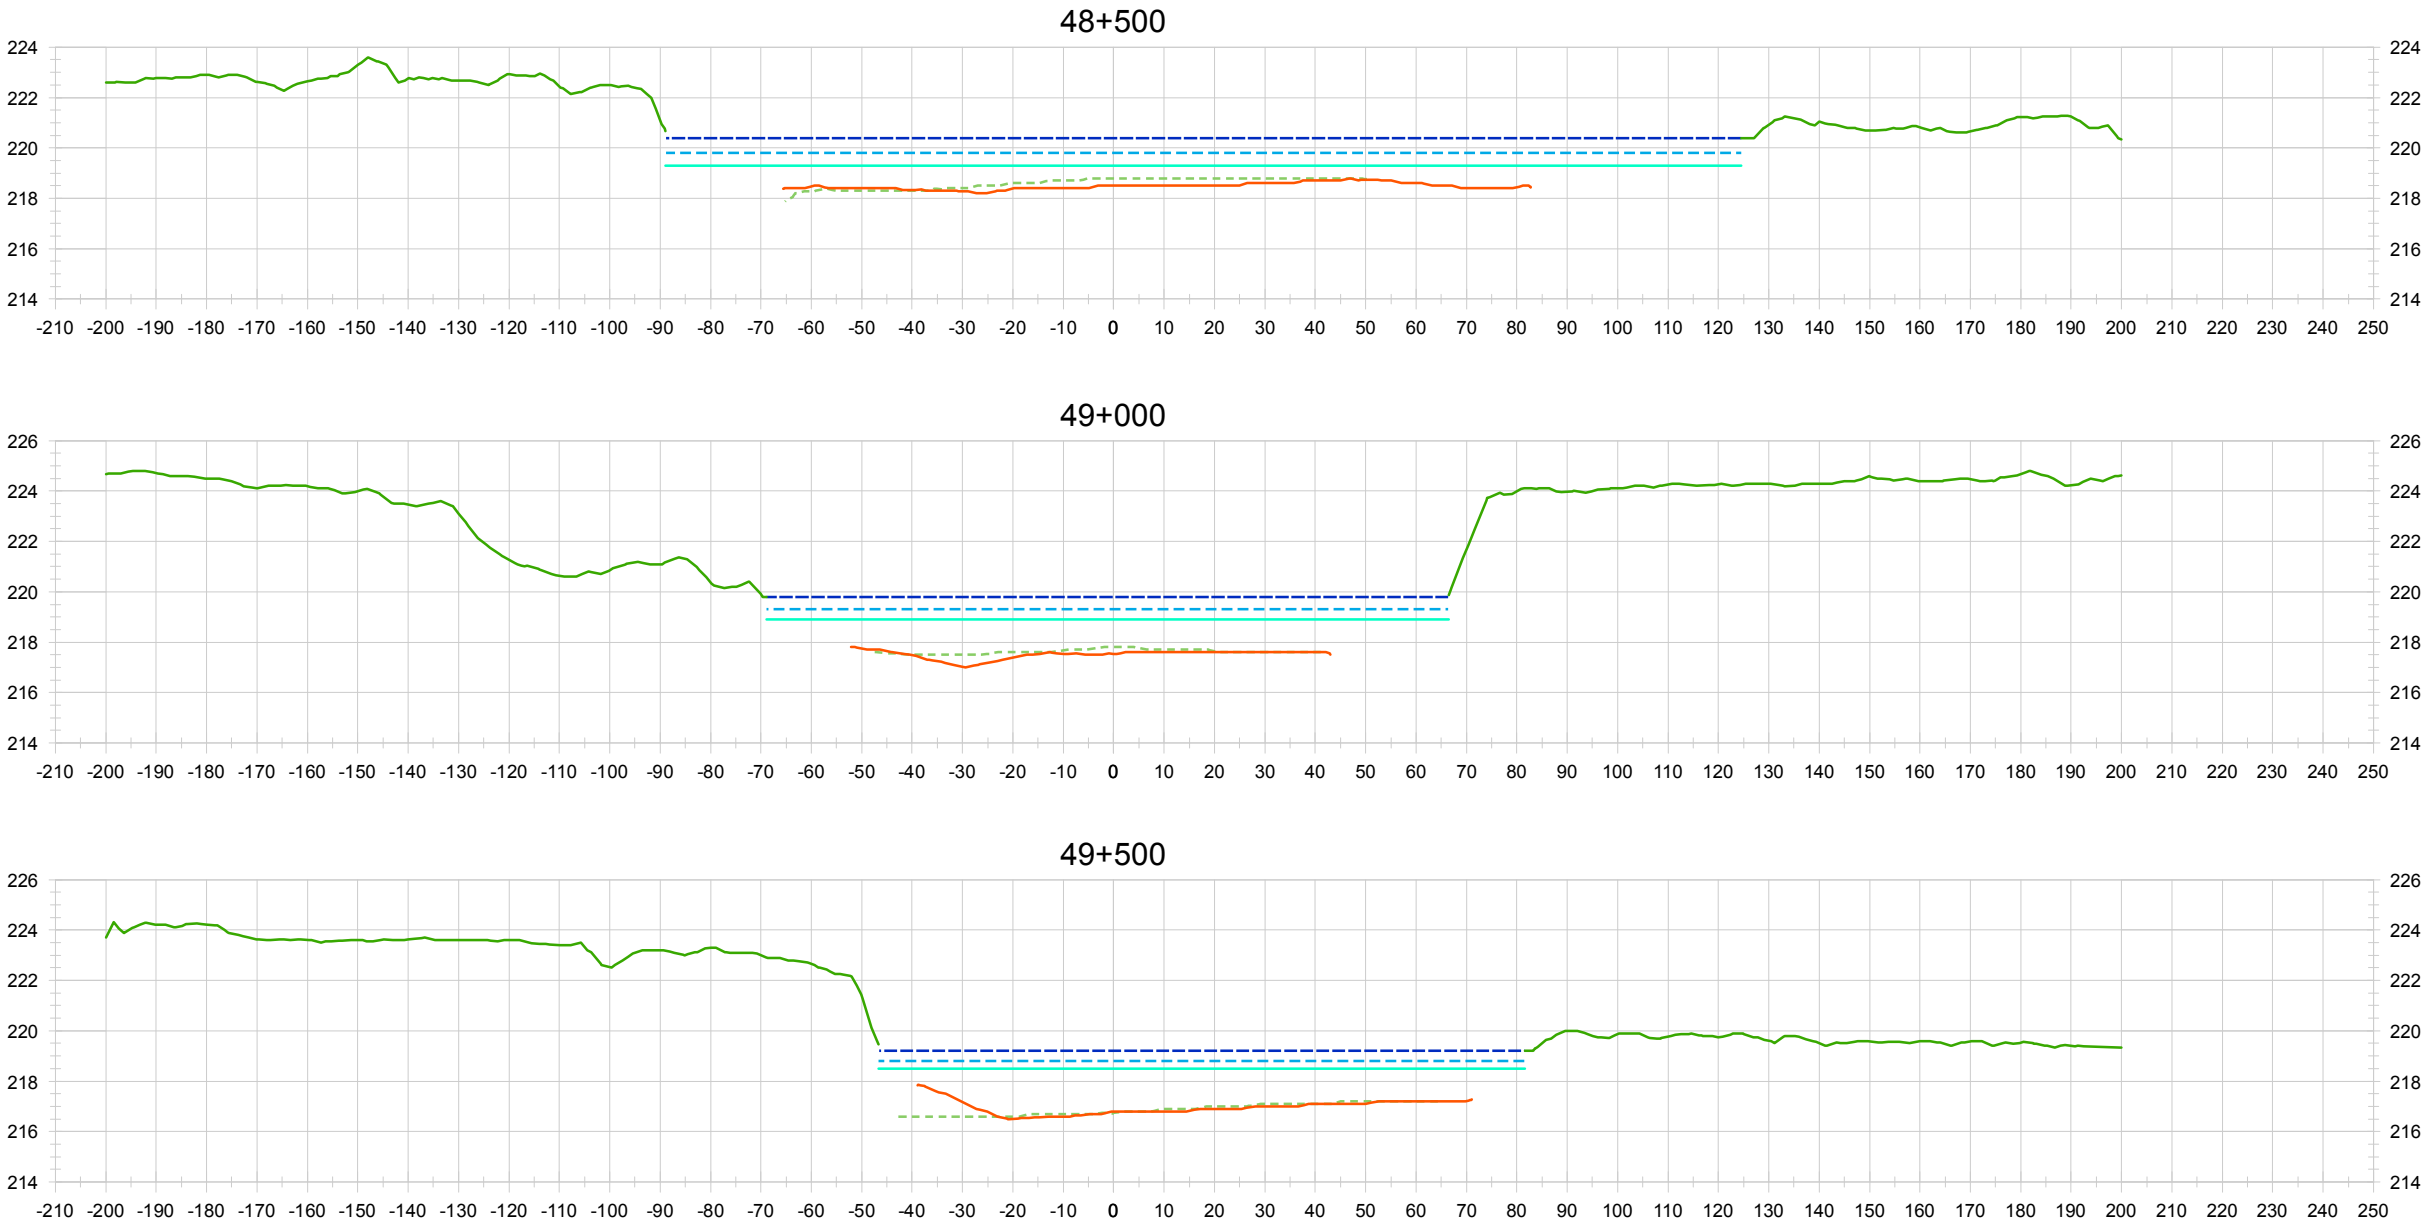
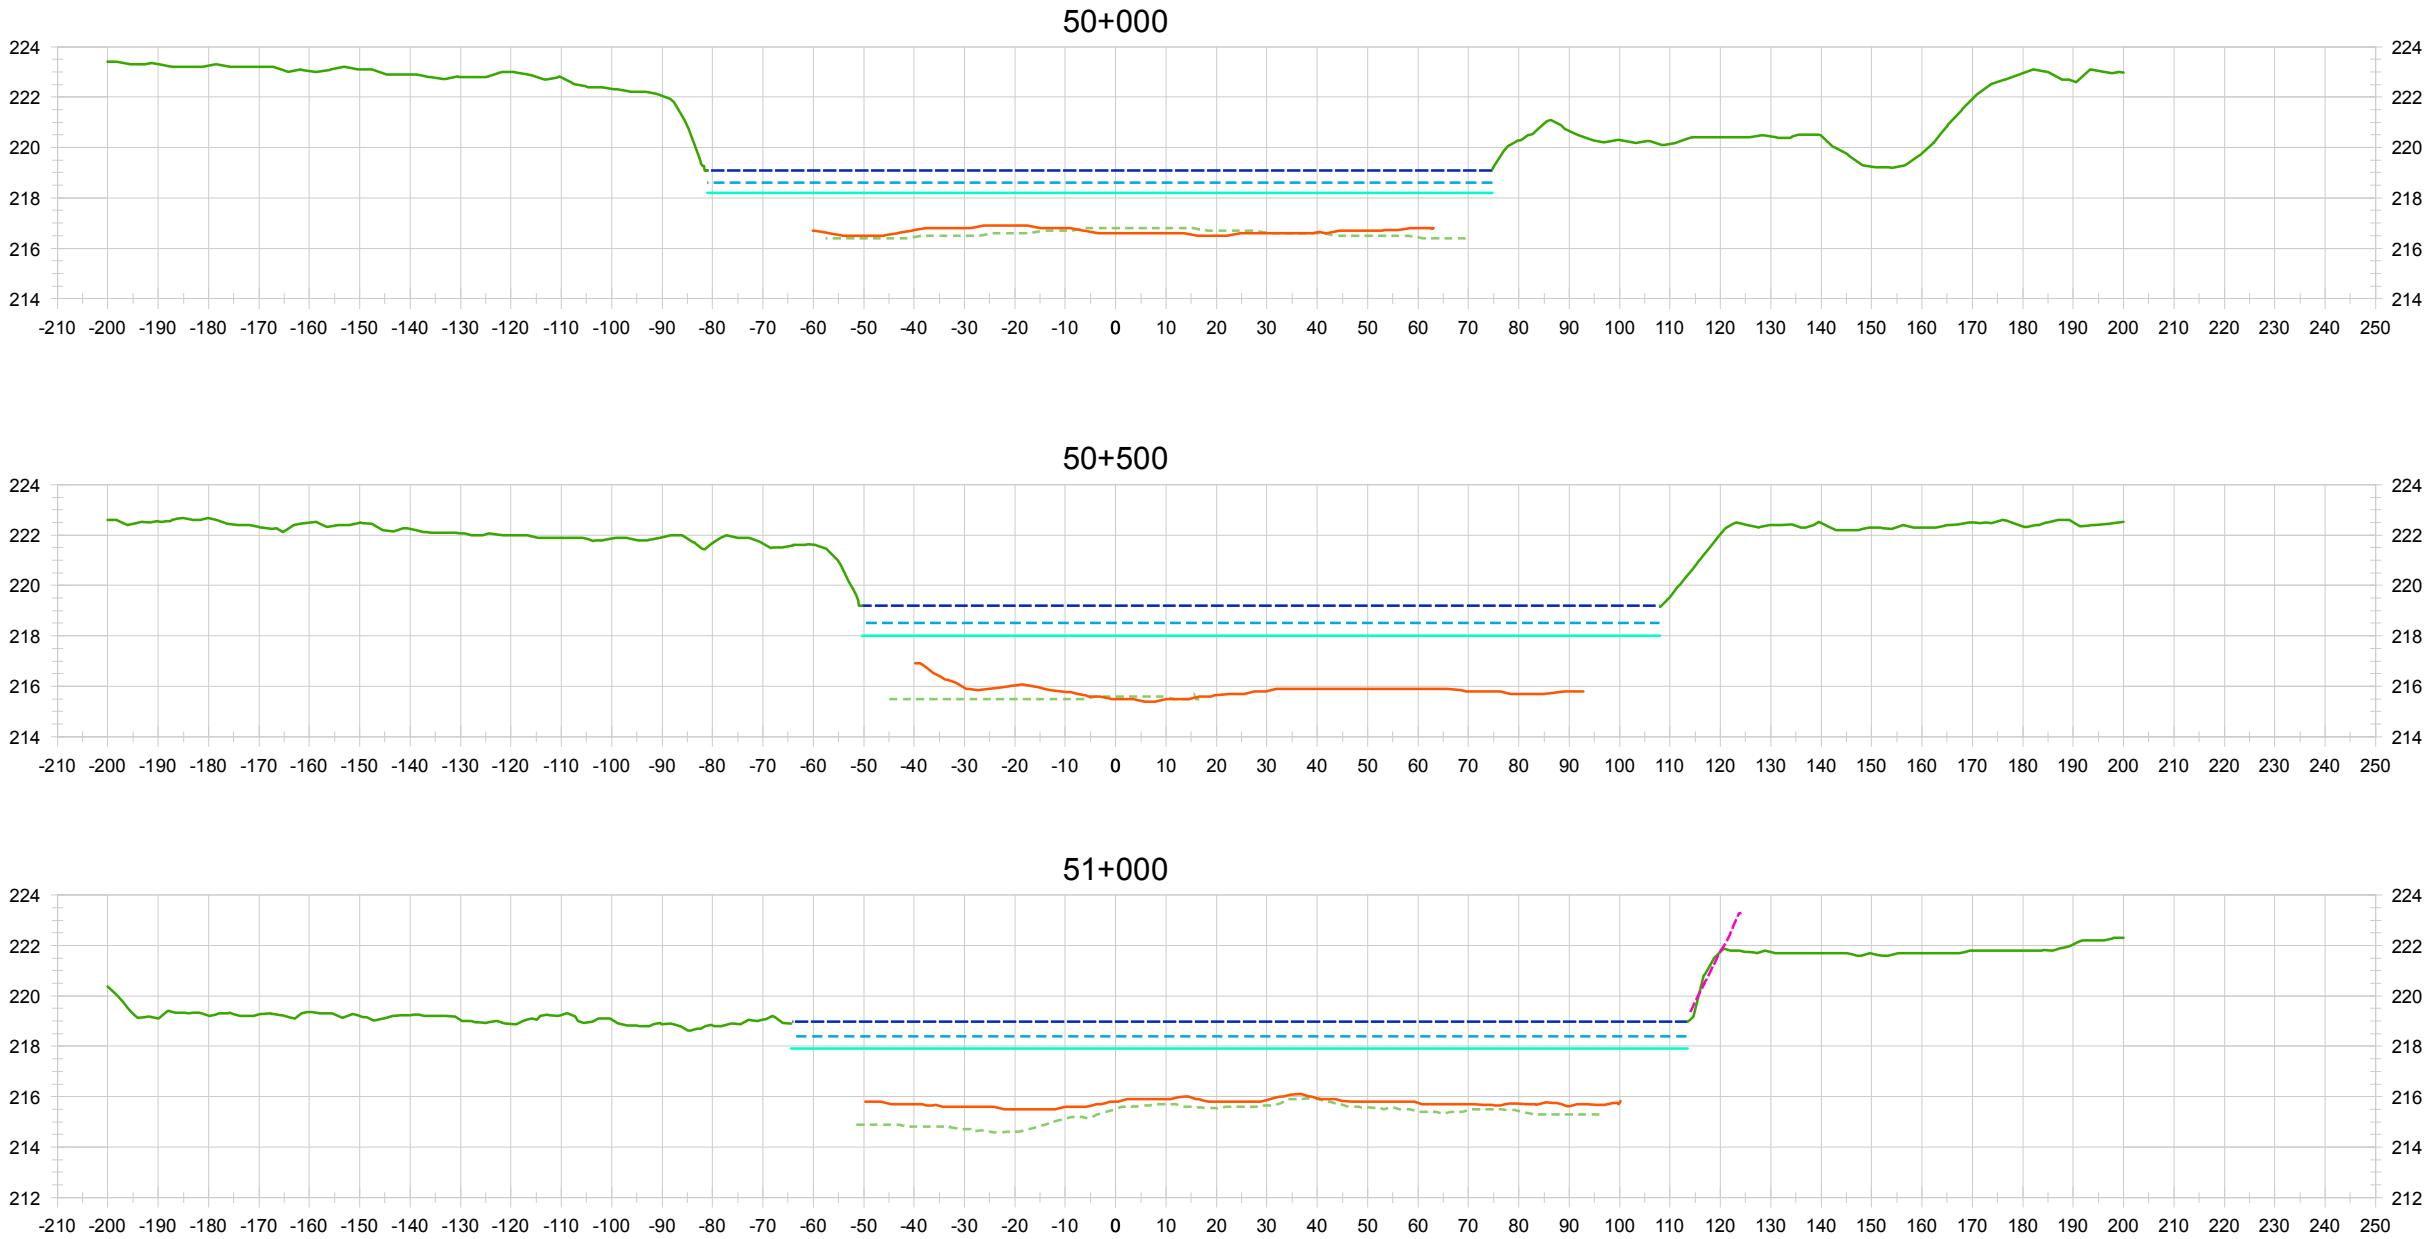
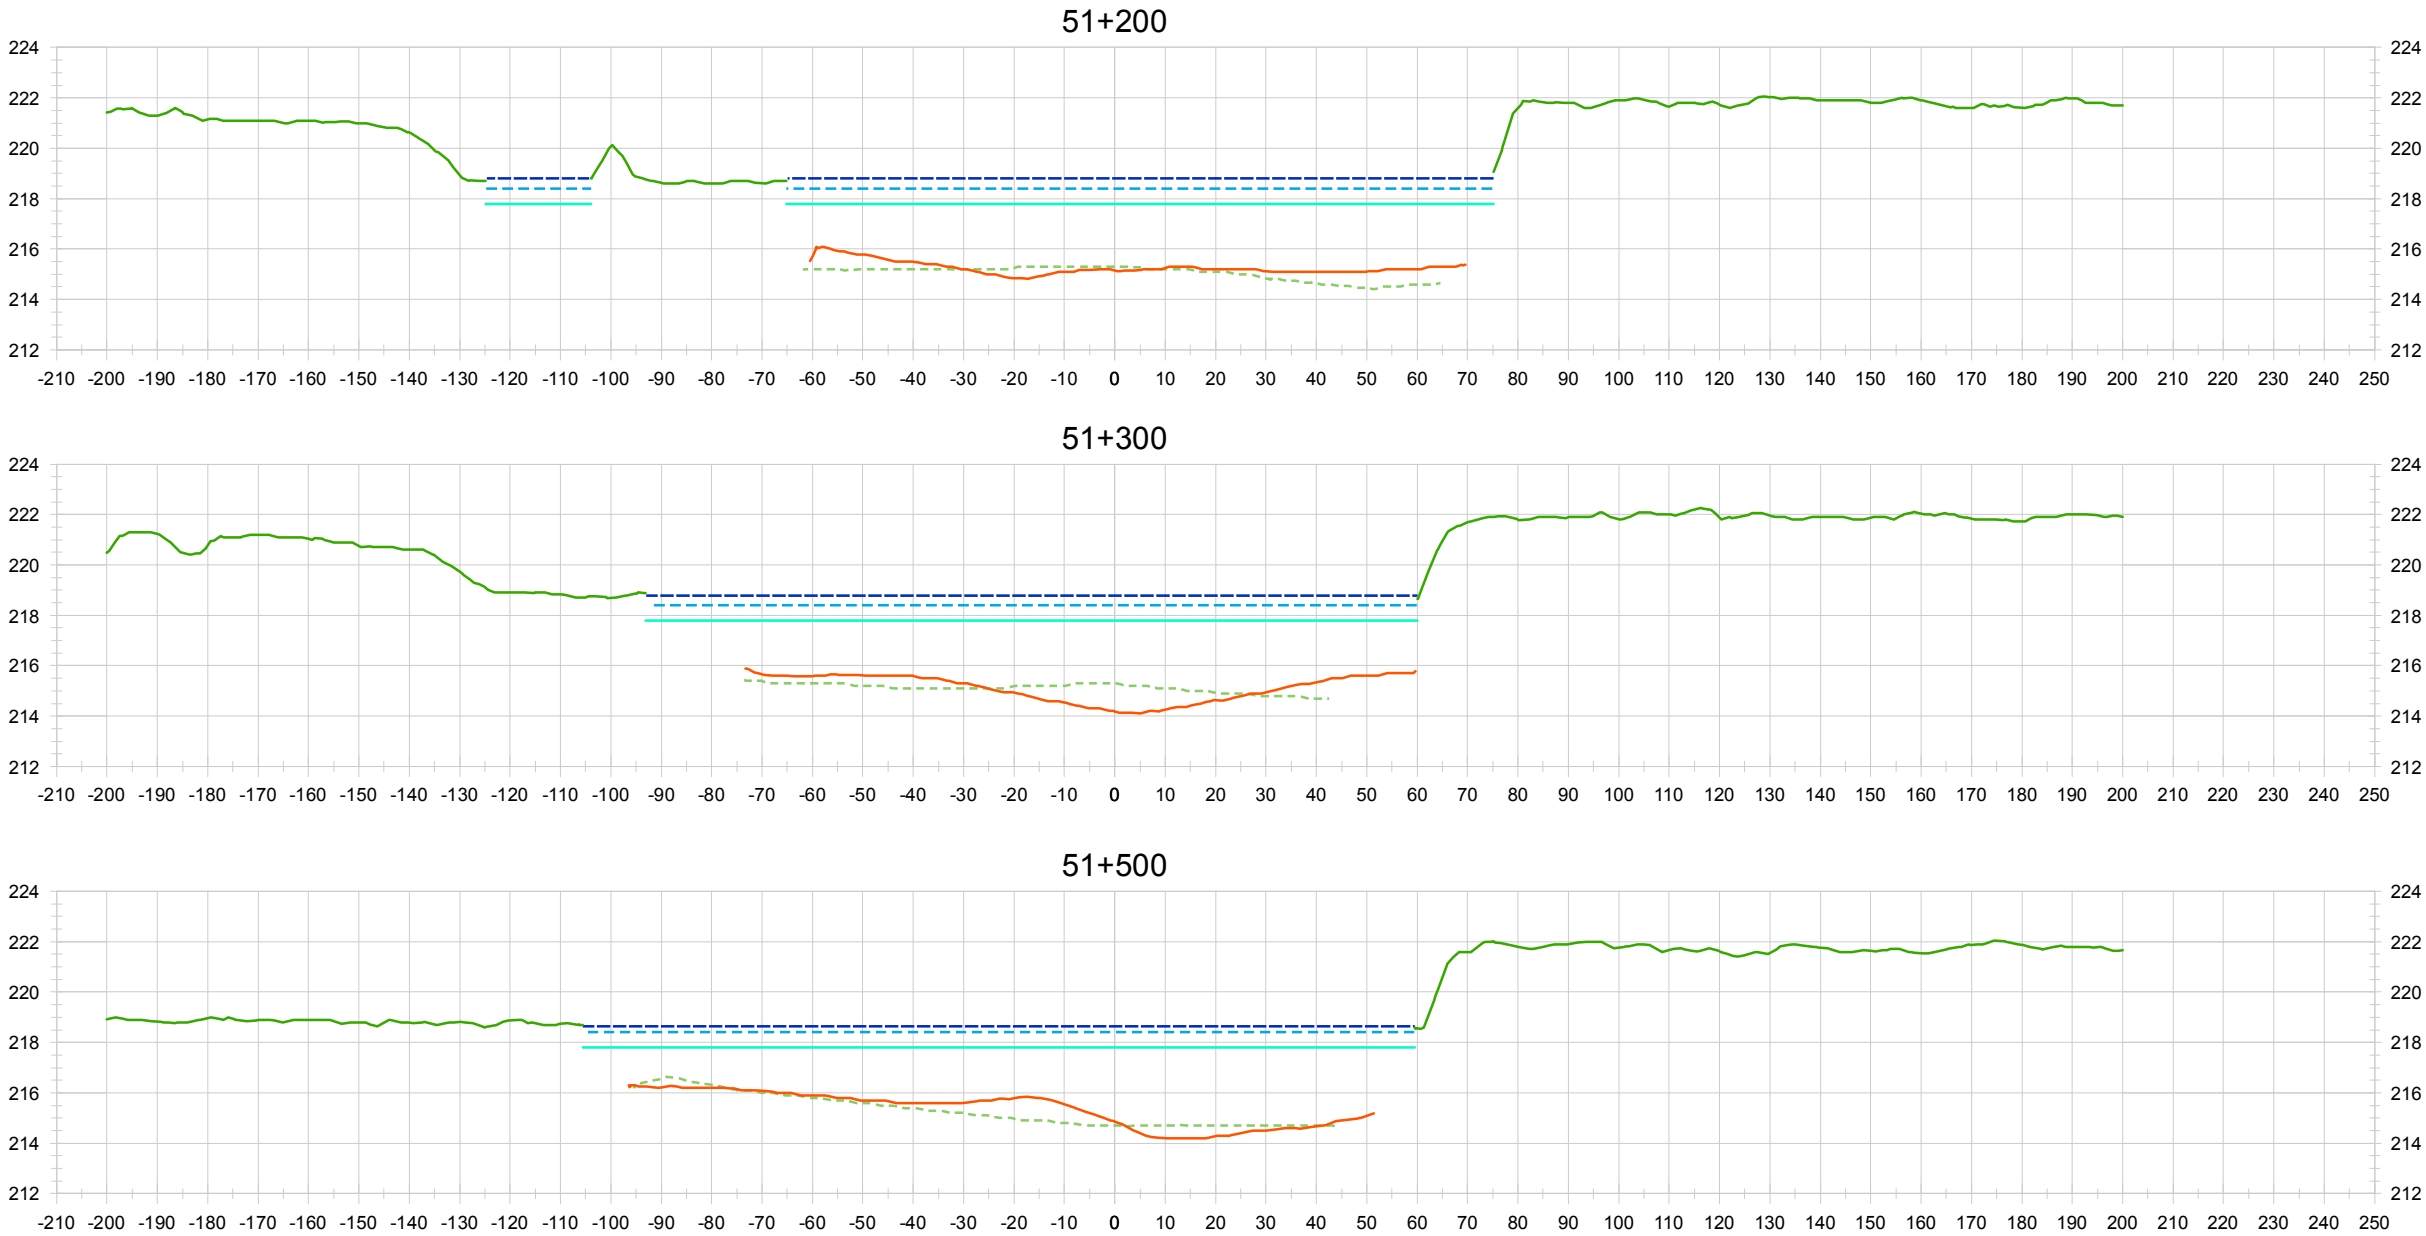
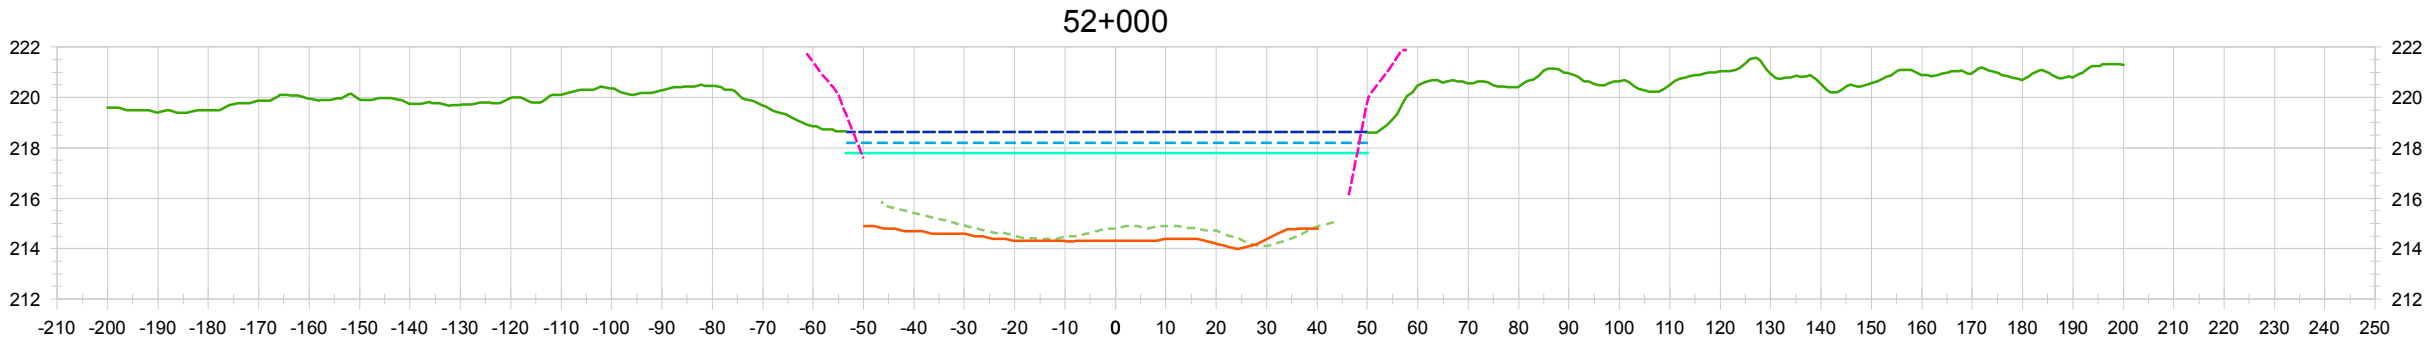
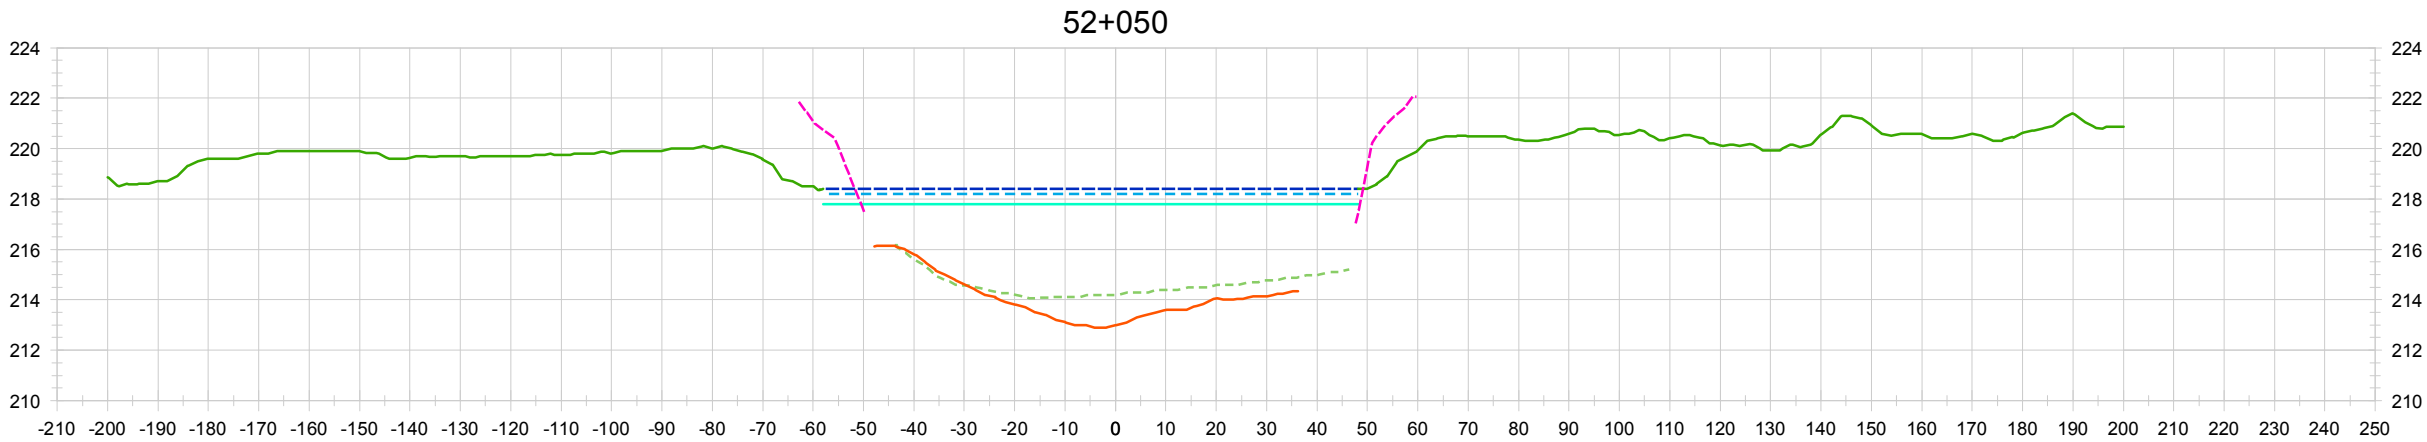
EMERGENCY REDUCTION OF
LAKE MANITOBA AND
LAKE ST. MARTIN WATER LEVELS
DAUPHIN RIVER OUTLET BATHYMETRY
CROSS SECTIONS
(SHEET 4 OF 9)

Cross sections were computed from the 2011 and 2012 bathymetric data and also from LiDAR data collected for the project and are shown on Figure 3. The sections are shown at 500 m intervals and also at additional locations where there was a noticeable change in bathymetry between the 2011 and 2012 surveys (i.e. station 51+250 and 52+050). The section locations are shown on Figure 1. The rock rip-rap placed during the construction of the DRFN emergency diking has been shown on sections where rock was placed.
