RE: Emergency Reduction of Lake Manitoba and Lake St. Martin Water Levels
Dauphin River Bathymetric Survey Investigation - FINAL

1.0 INTRODUCTION

EMERGENCY REDUCTION OF
LAKE MANITOBA AND
LAKE ST. MARTIN WATER LEVELS
LOWER DAUPHIN RIVER BATHYMETRY
OVERVIEW

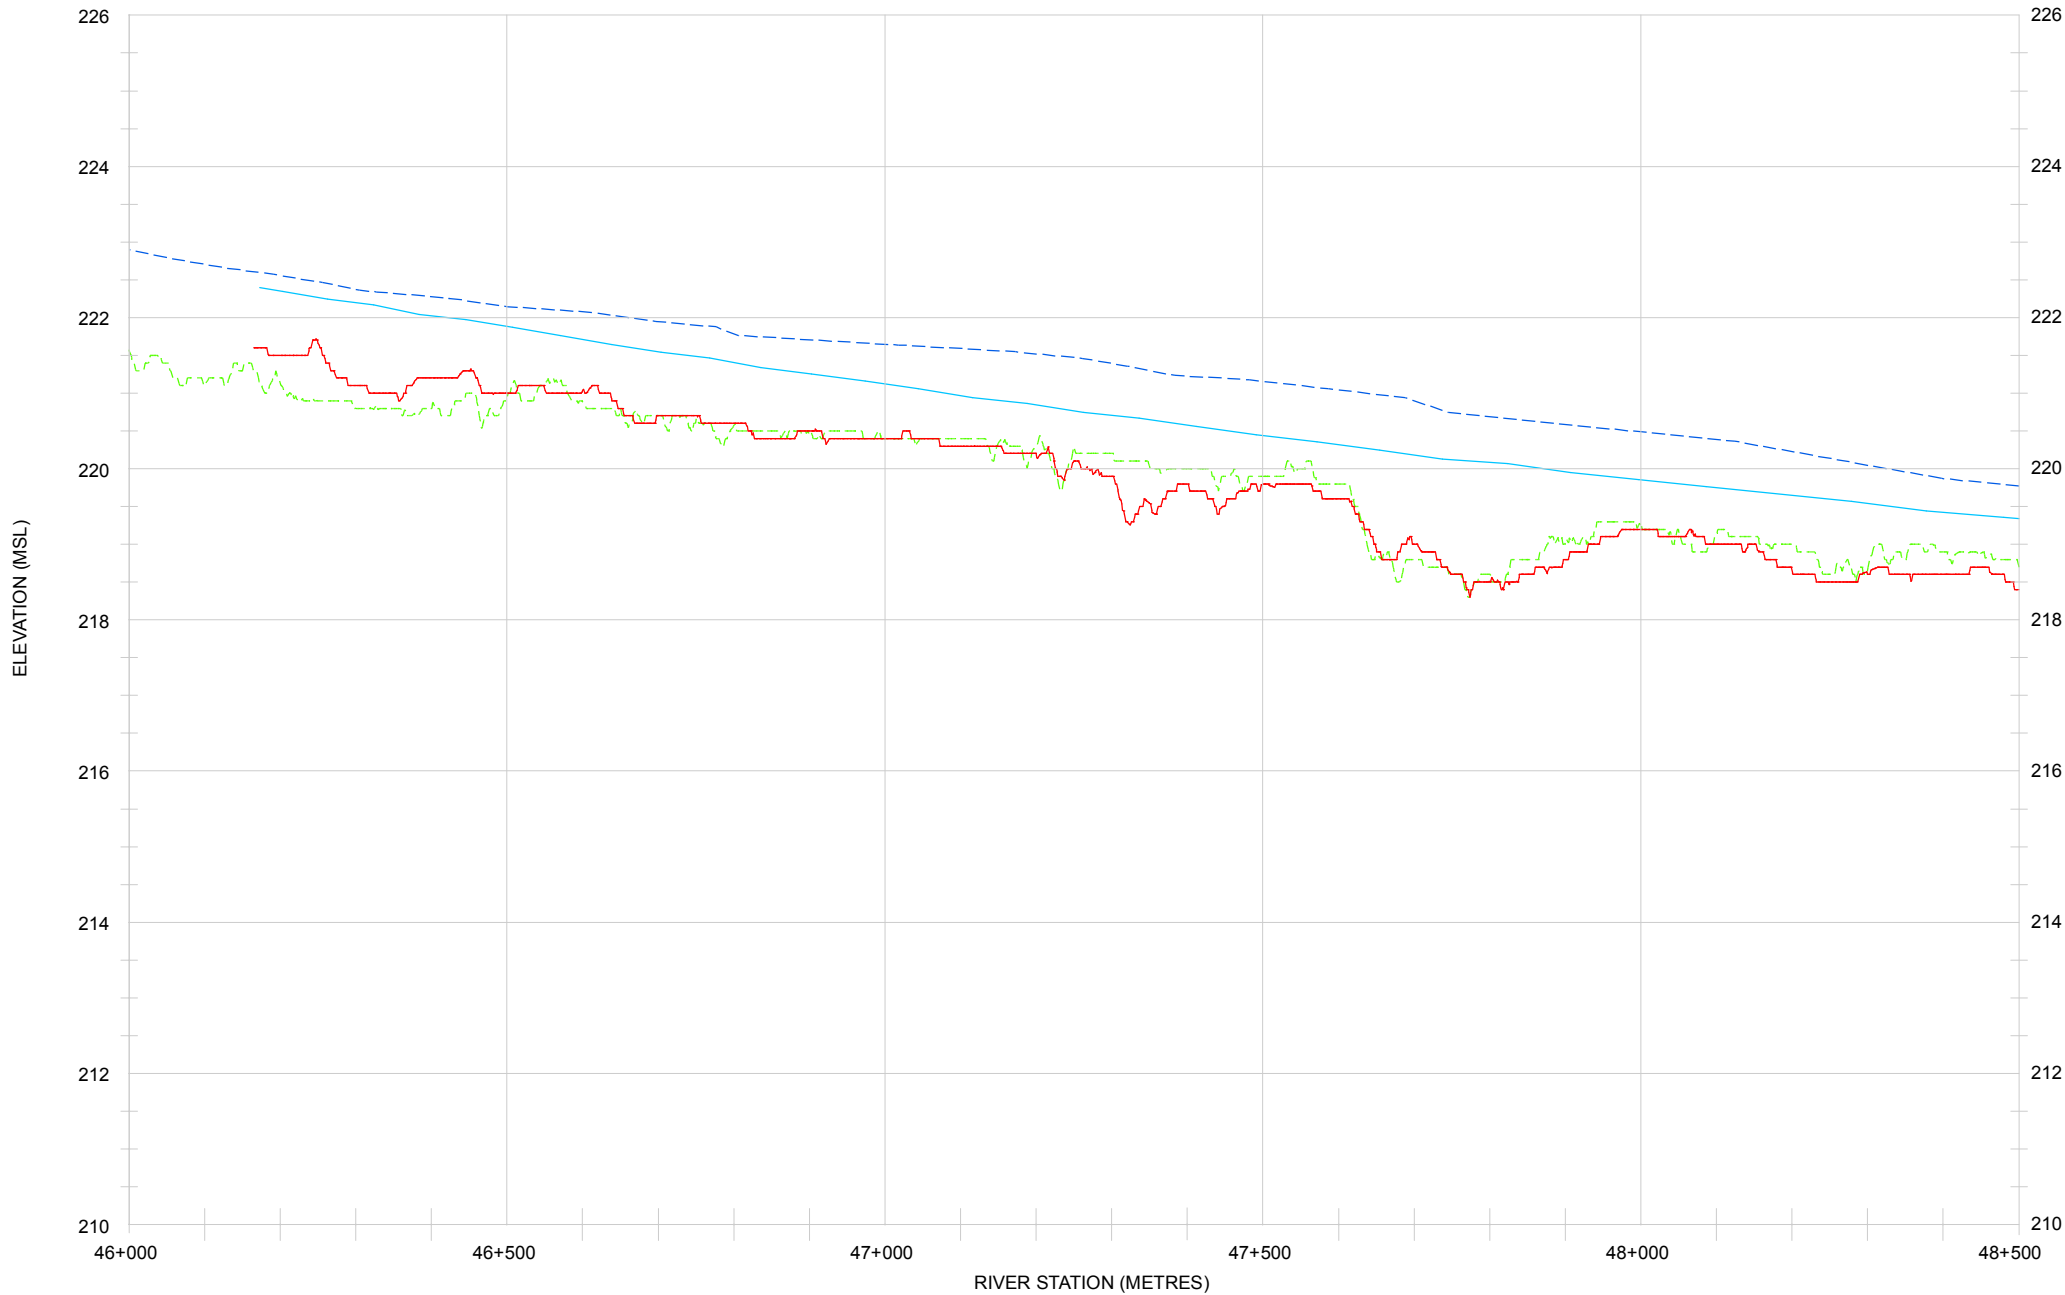
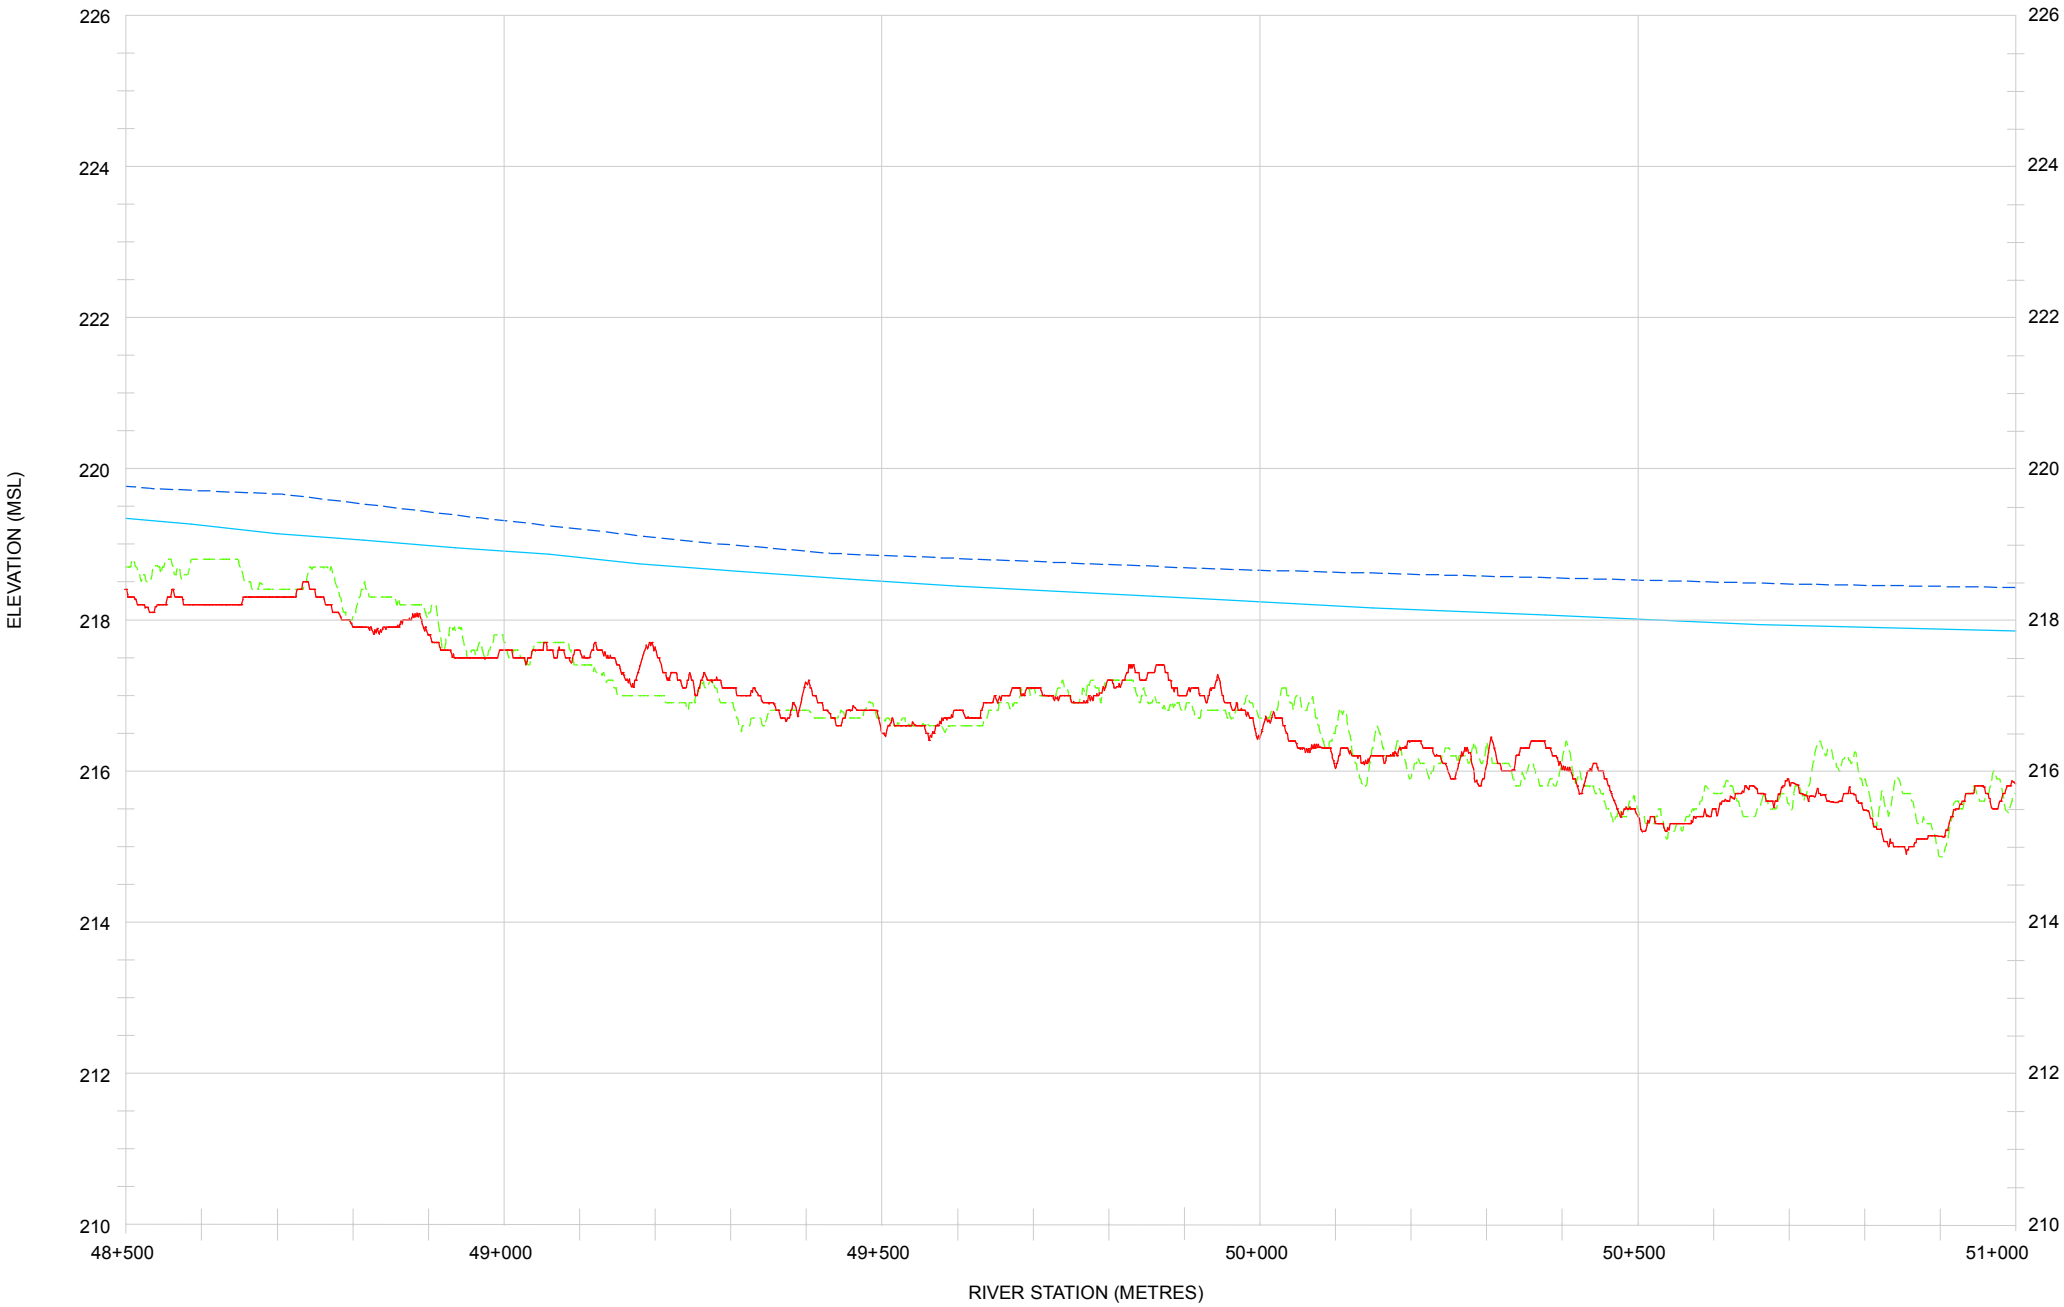
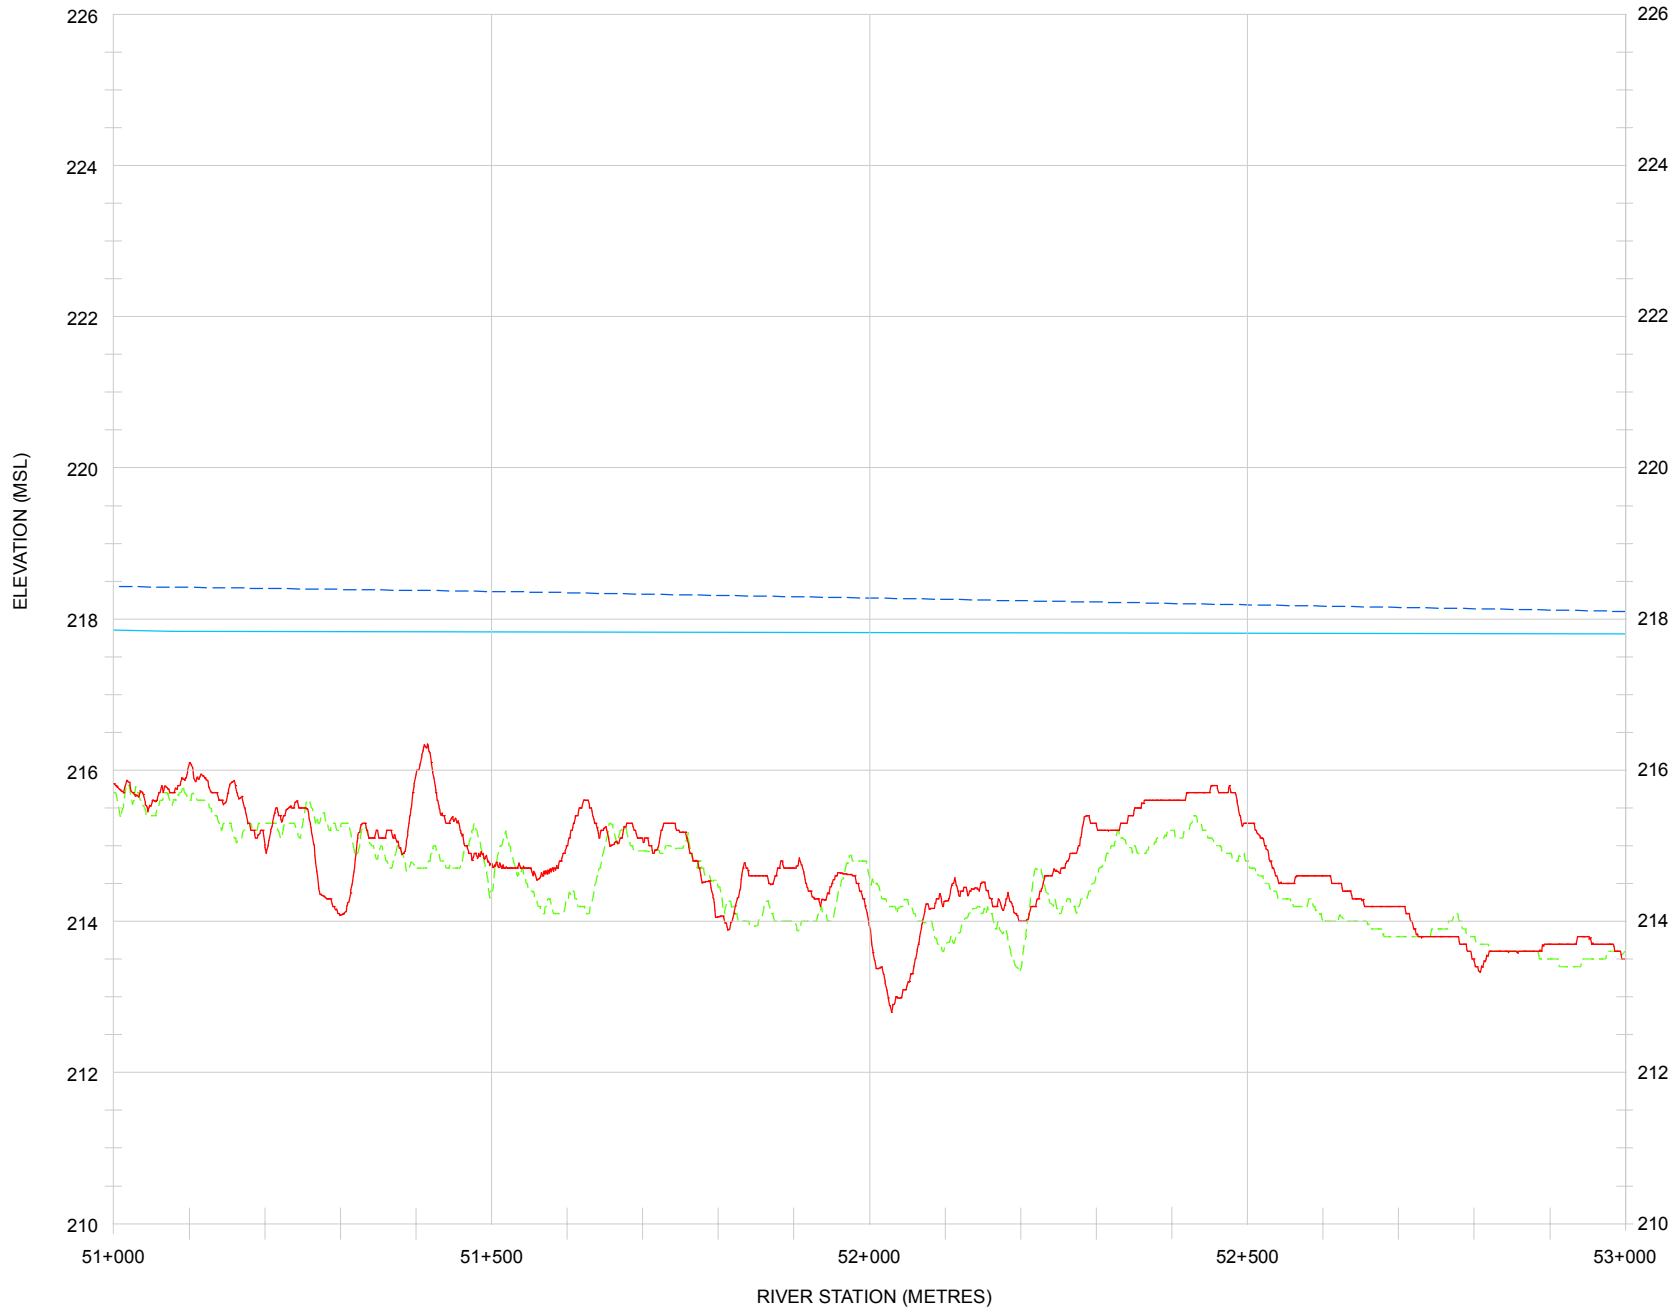
EMERGENCY REDUCTION OF LAKE MANITOBA AND LAKE ST. MARTIN WATER LEVELS DAUPHIN RIVER BATHYMETRY PROFILE (SHEET 1 OF 3)			
JANUARY 2013		FIGURE 04	REV: 0

A centreline profile of the river from station 46+000 to the mouth of the river is provided on Figure 4. The profile shows the water surface of the river during each survey as well as the channel bottom at

the centre of the channel captured during each survey (the profile does not necessarily represent the invert as this may meander away from the centre of the channel).

When looking at the centreline profile (Figure 4), the river bed elevation in 2012 is on average similar to the bed elevation in 2011 upstream of station 51+250. Downstream of station 51+250 the river bed elevation in 2012 is more variable and alternates between lower and higher elevations when compared to the 2011 river bed. This is consistent with preliminary substrate surveys of the area completed by North/South Consultants, which indicated that the river bed material downstream of station 51+250 was comprised mostly of gravels and sands compared to the material upstream of 51+250 which was more compact and contained more cobbles and boulders. A river bed which has a material containing more sands is more likely to experience movement, and therefore changes in bed elevations.

An area of degradation was noted at the mouth of the river where the 2012 bed elevations were lower than the 2011 bed elevations (station 52+100). However, this area is only approximately 150 m long and the bed levels upstream and downstream from this location are higher in 2012. Also the lake bottom elevations from 52+100 to 53+000 are generally higher in 2012. This could be caused a number of ways including the effect of littoral drift in the bay with lower stream flow current influences in 2012, allowing movement of sand in the lake to occur.

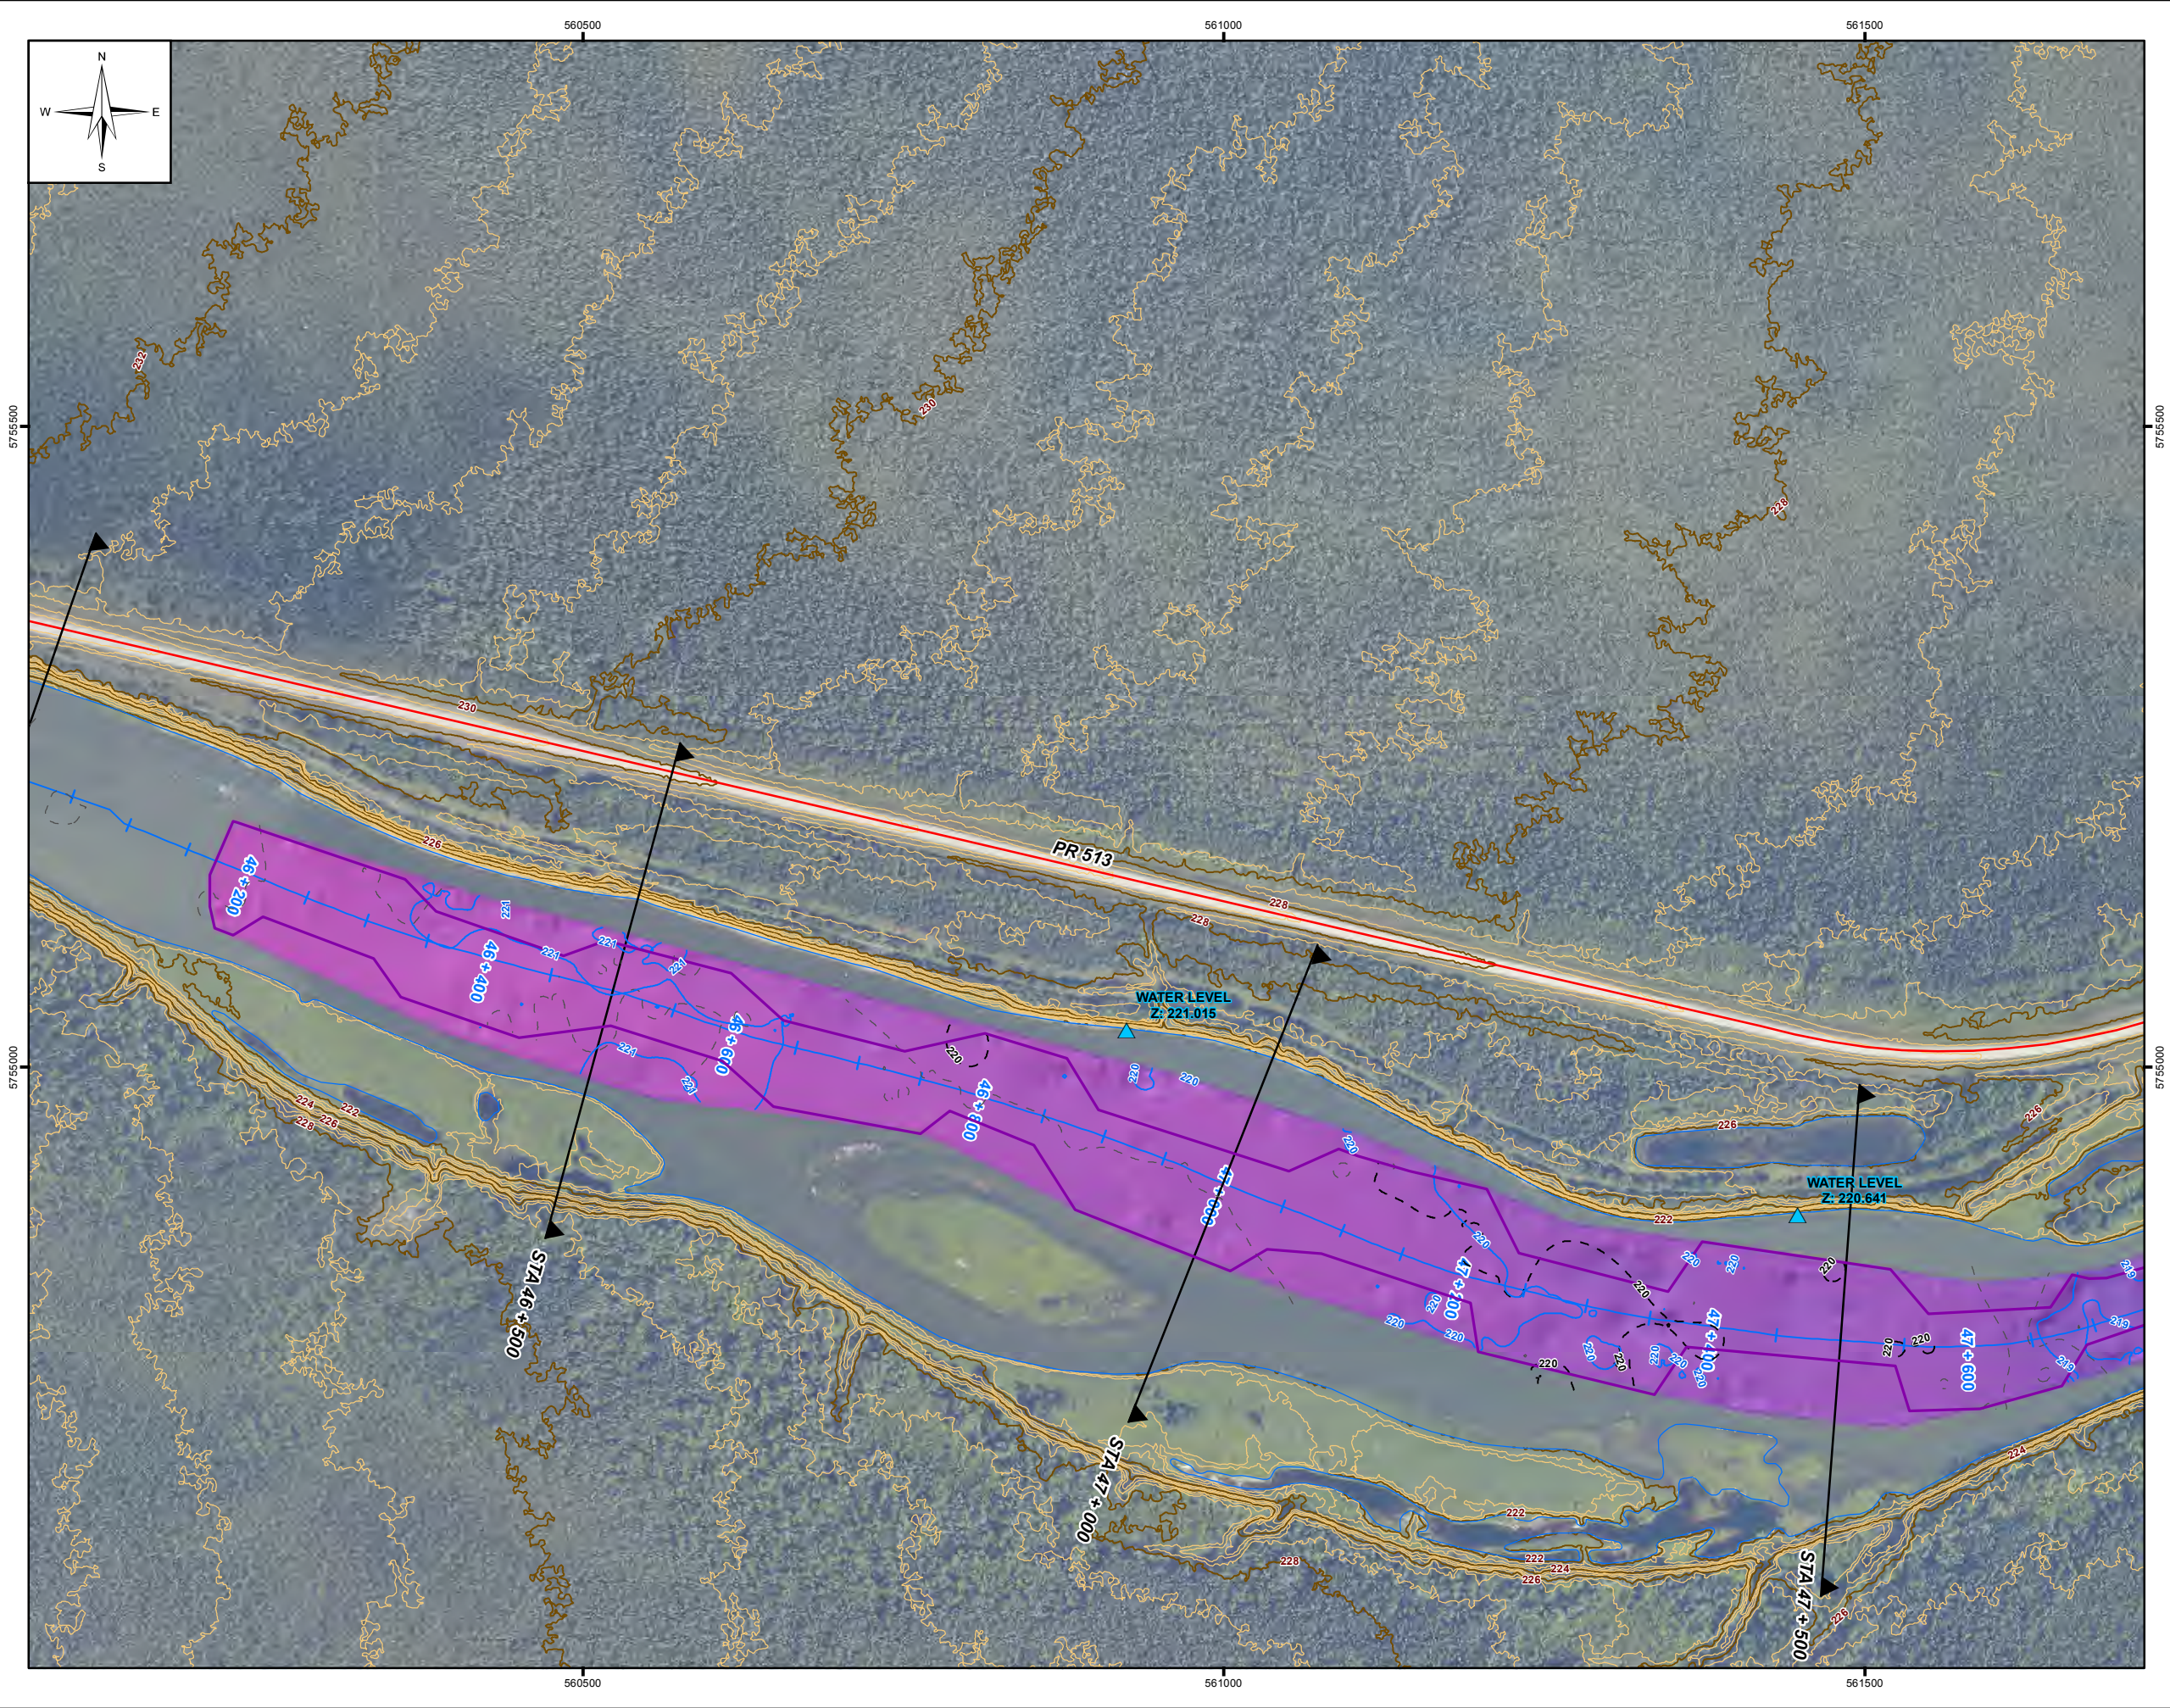
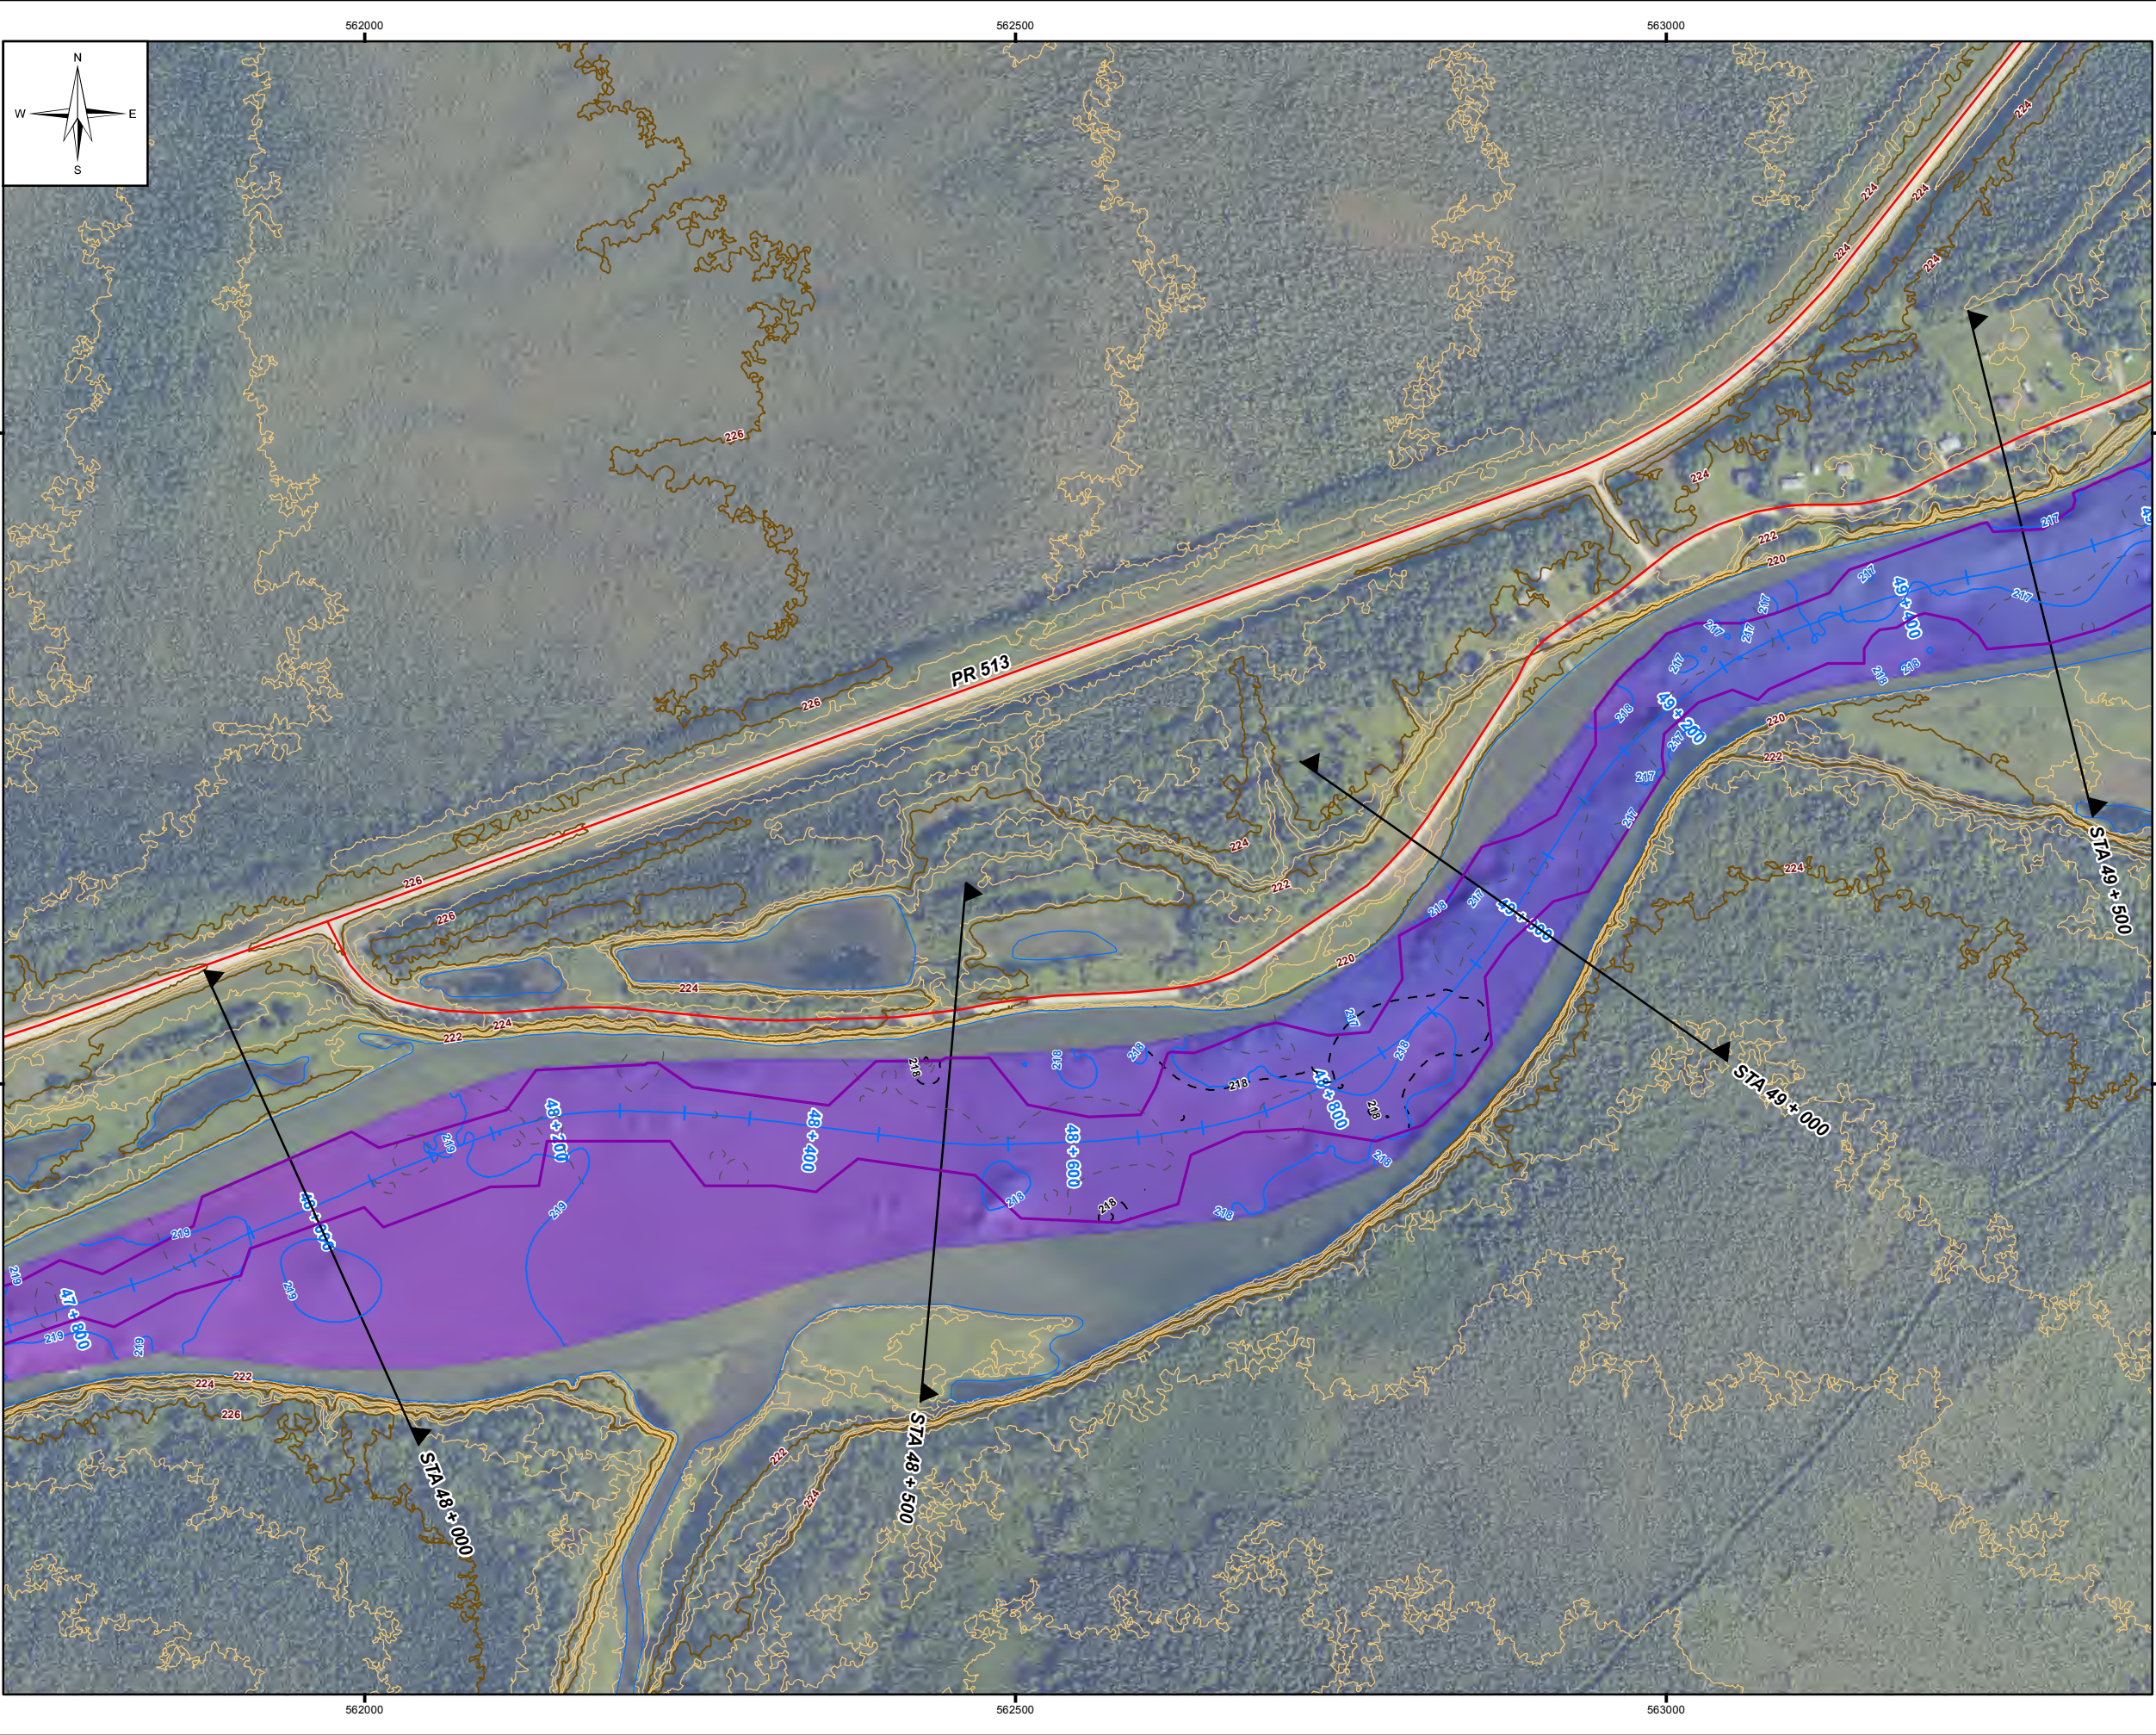
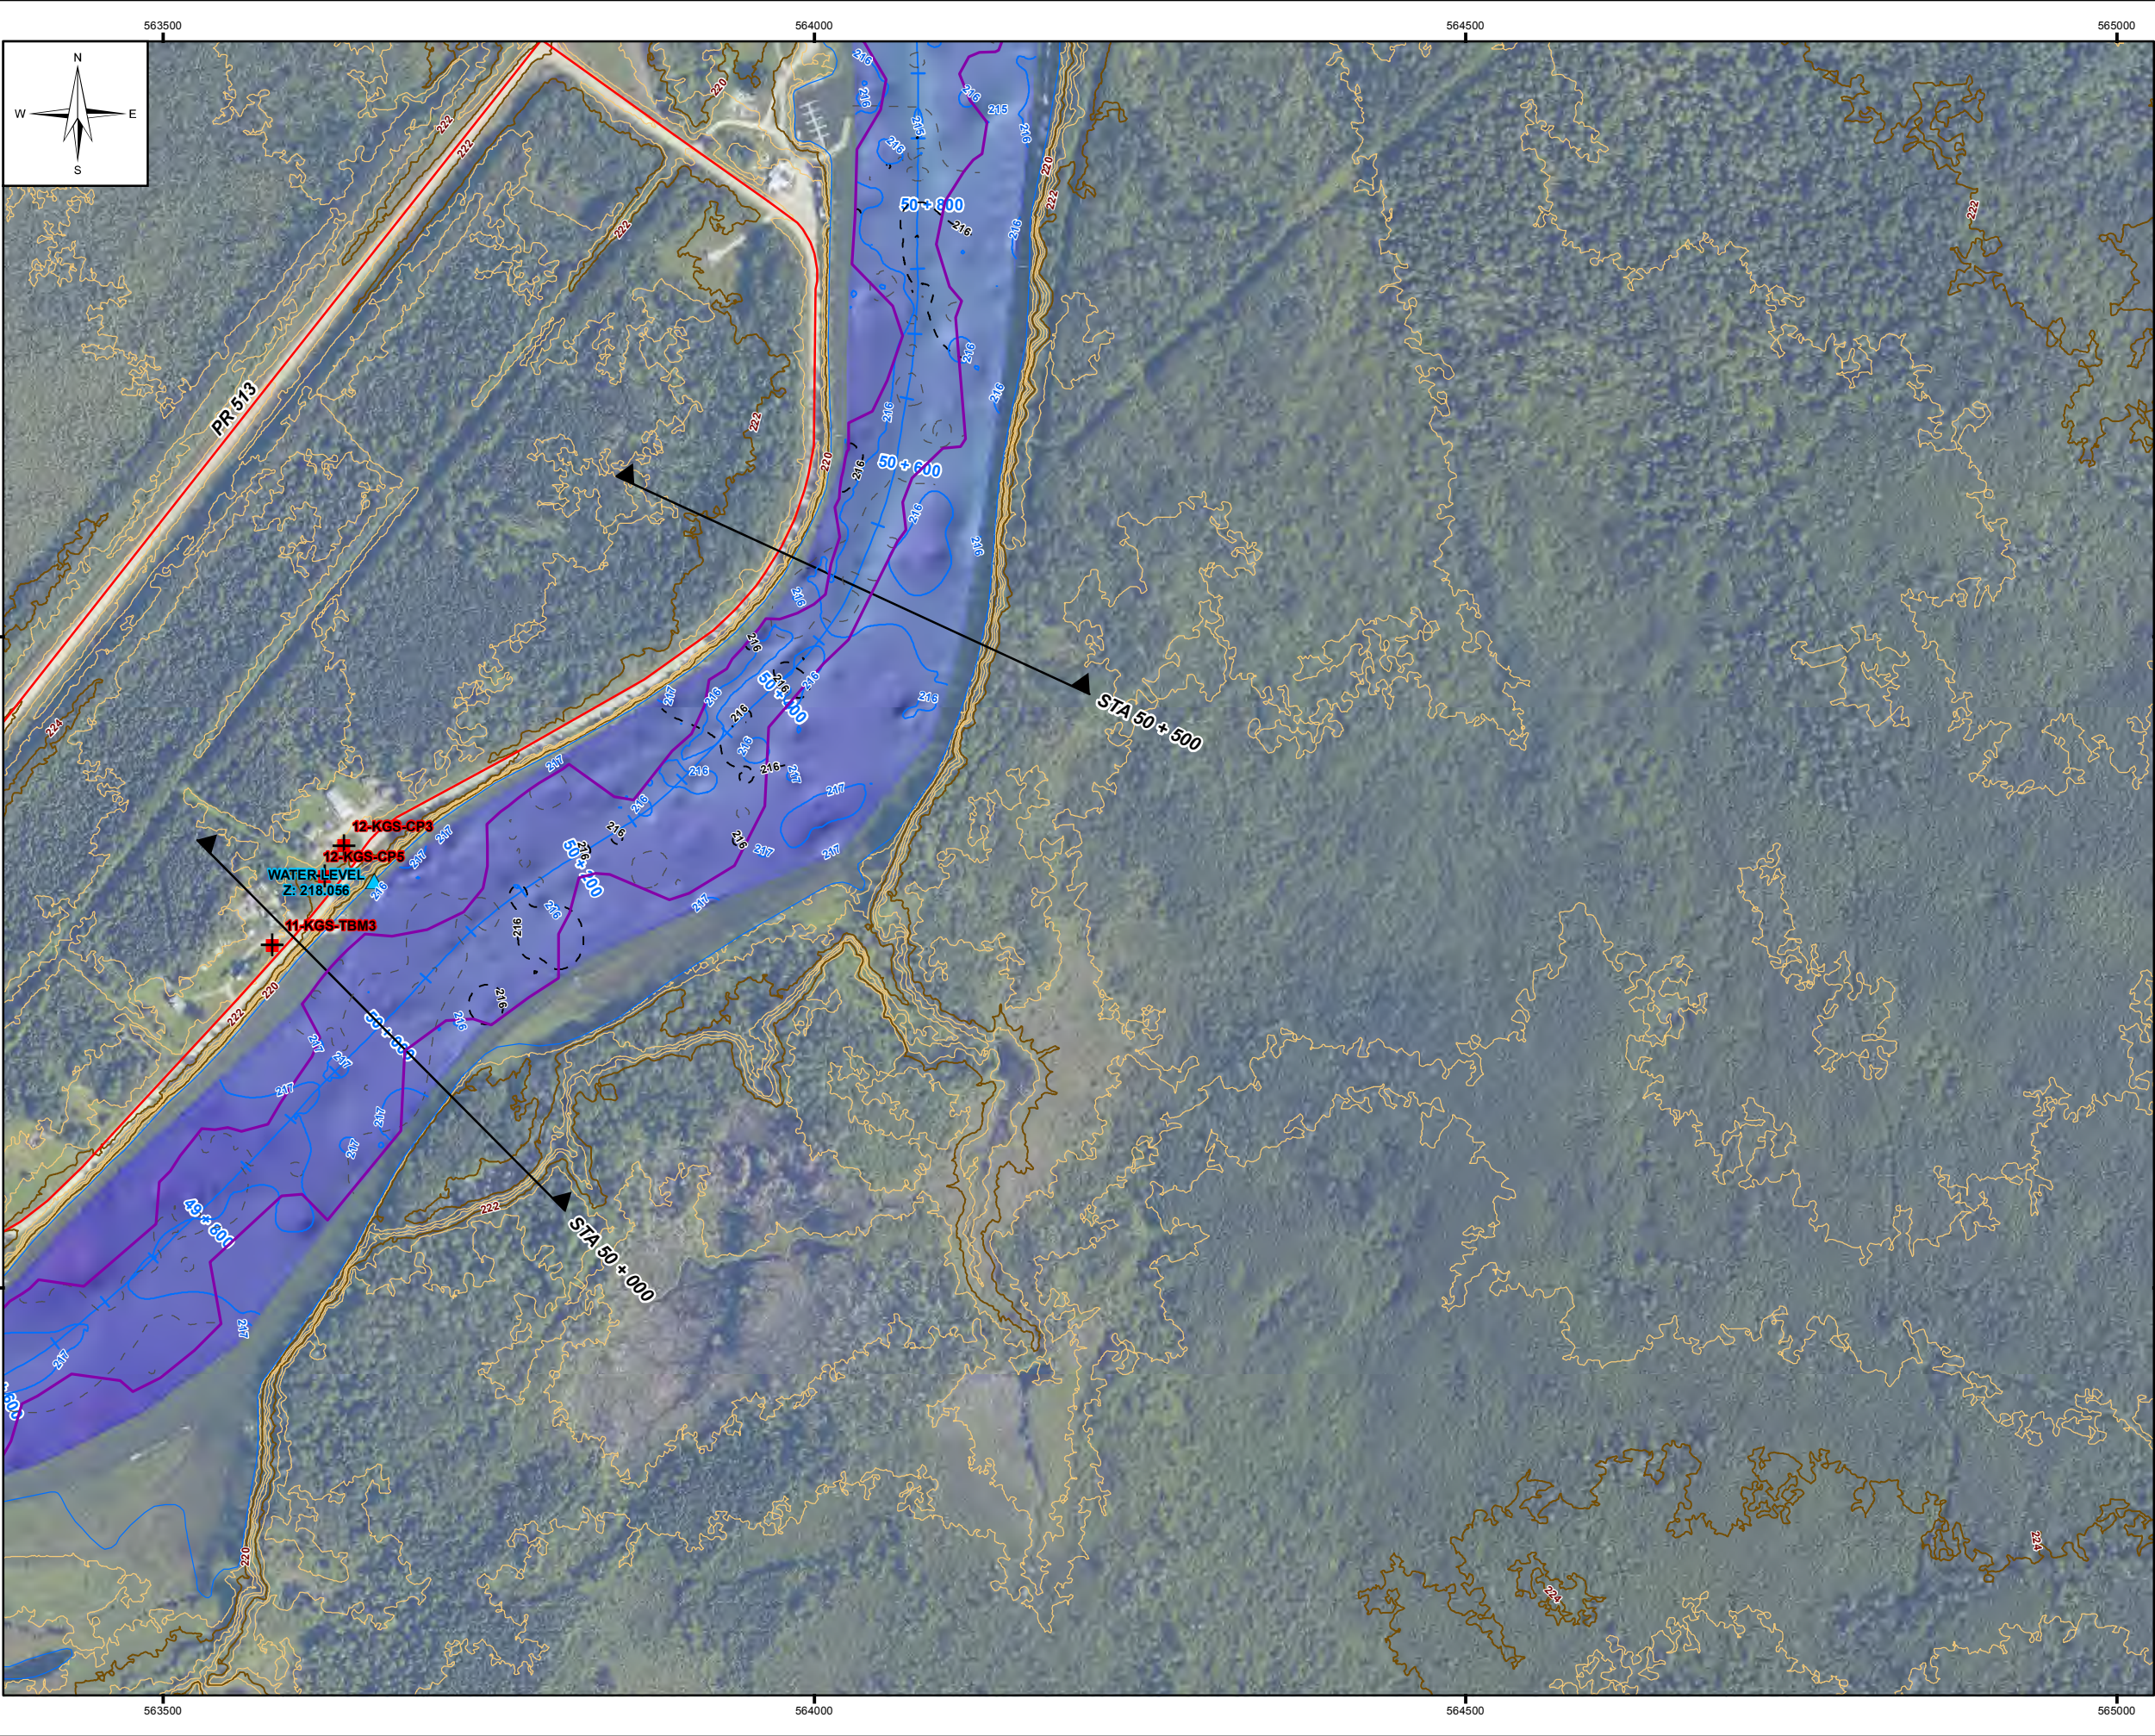
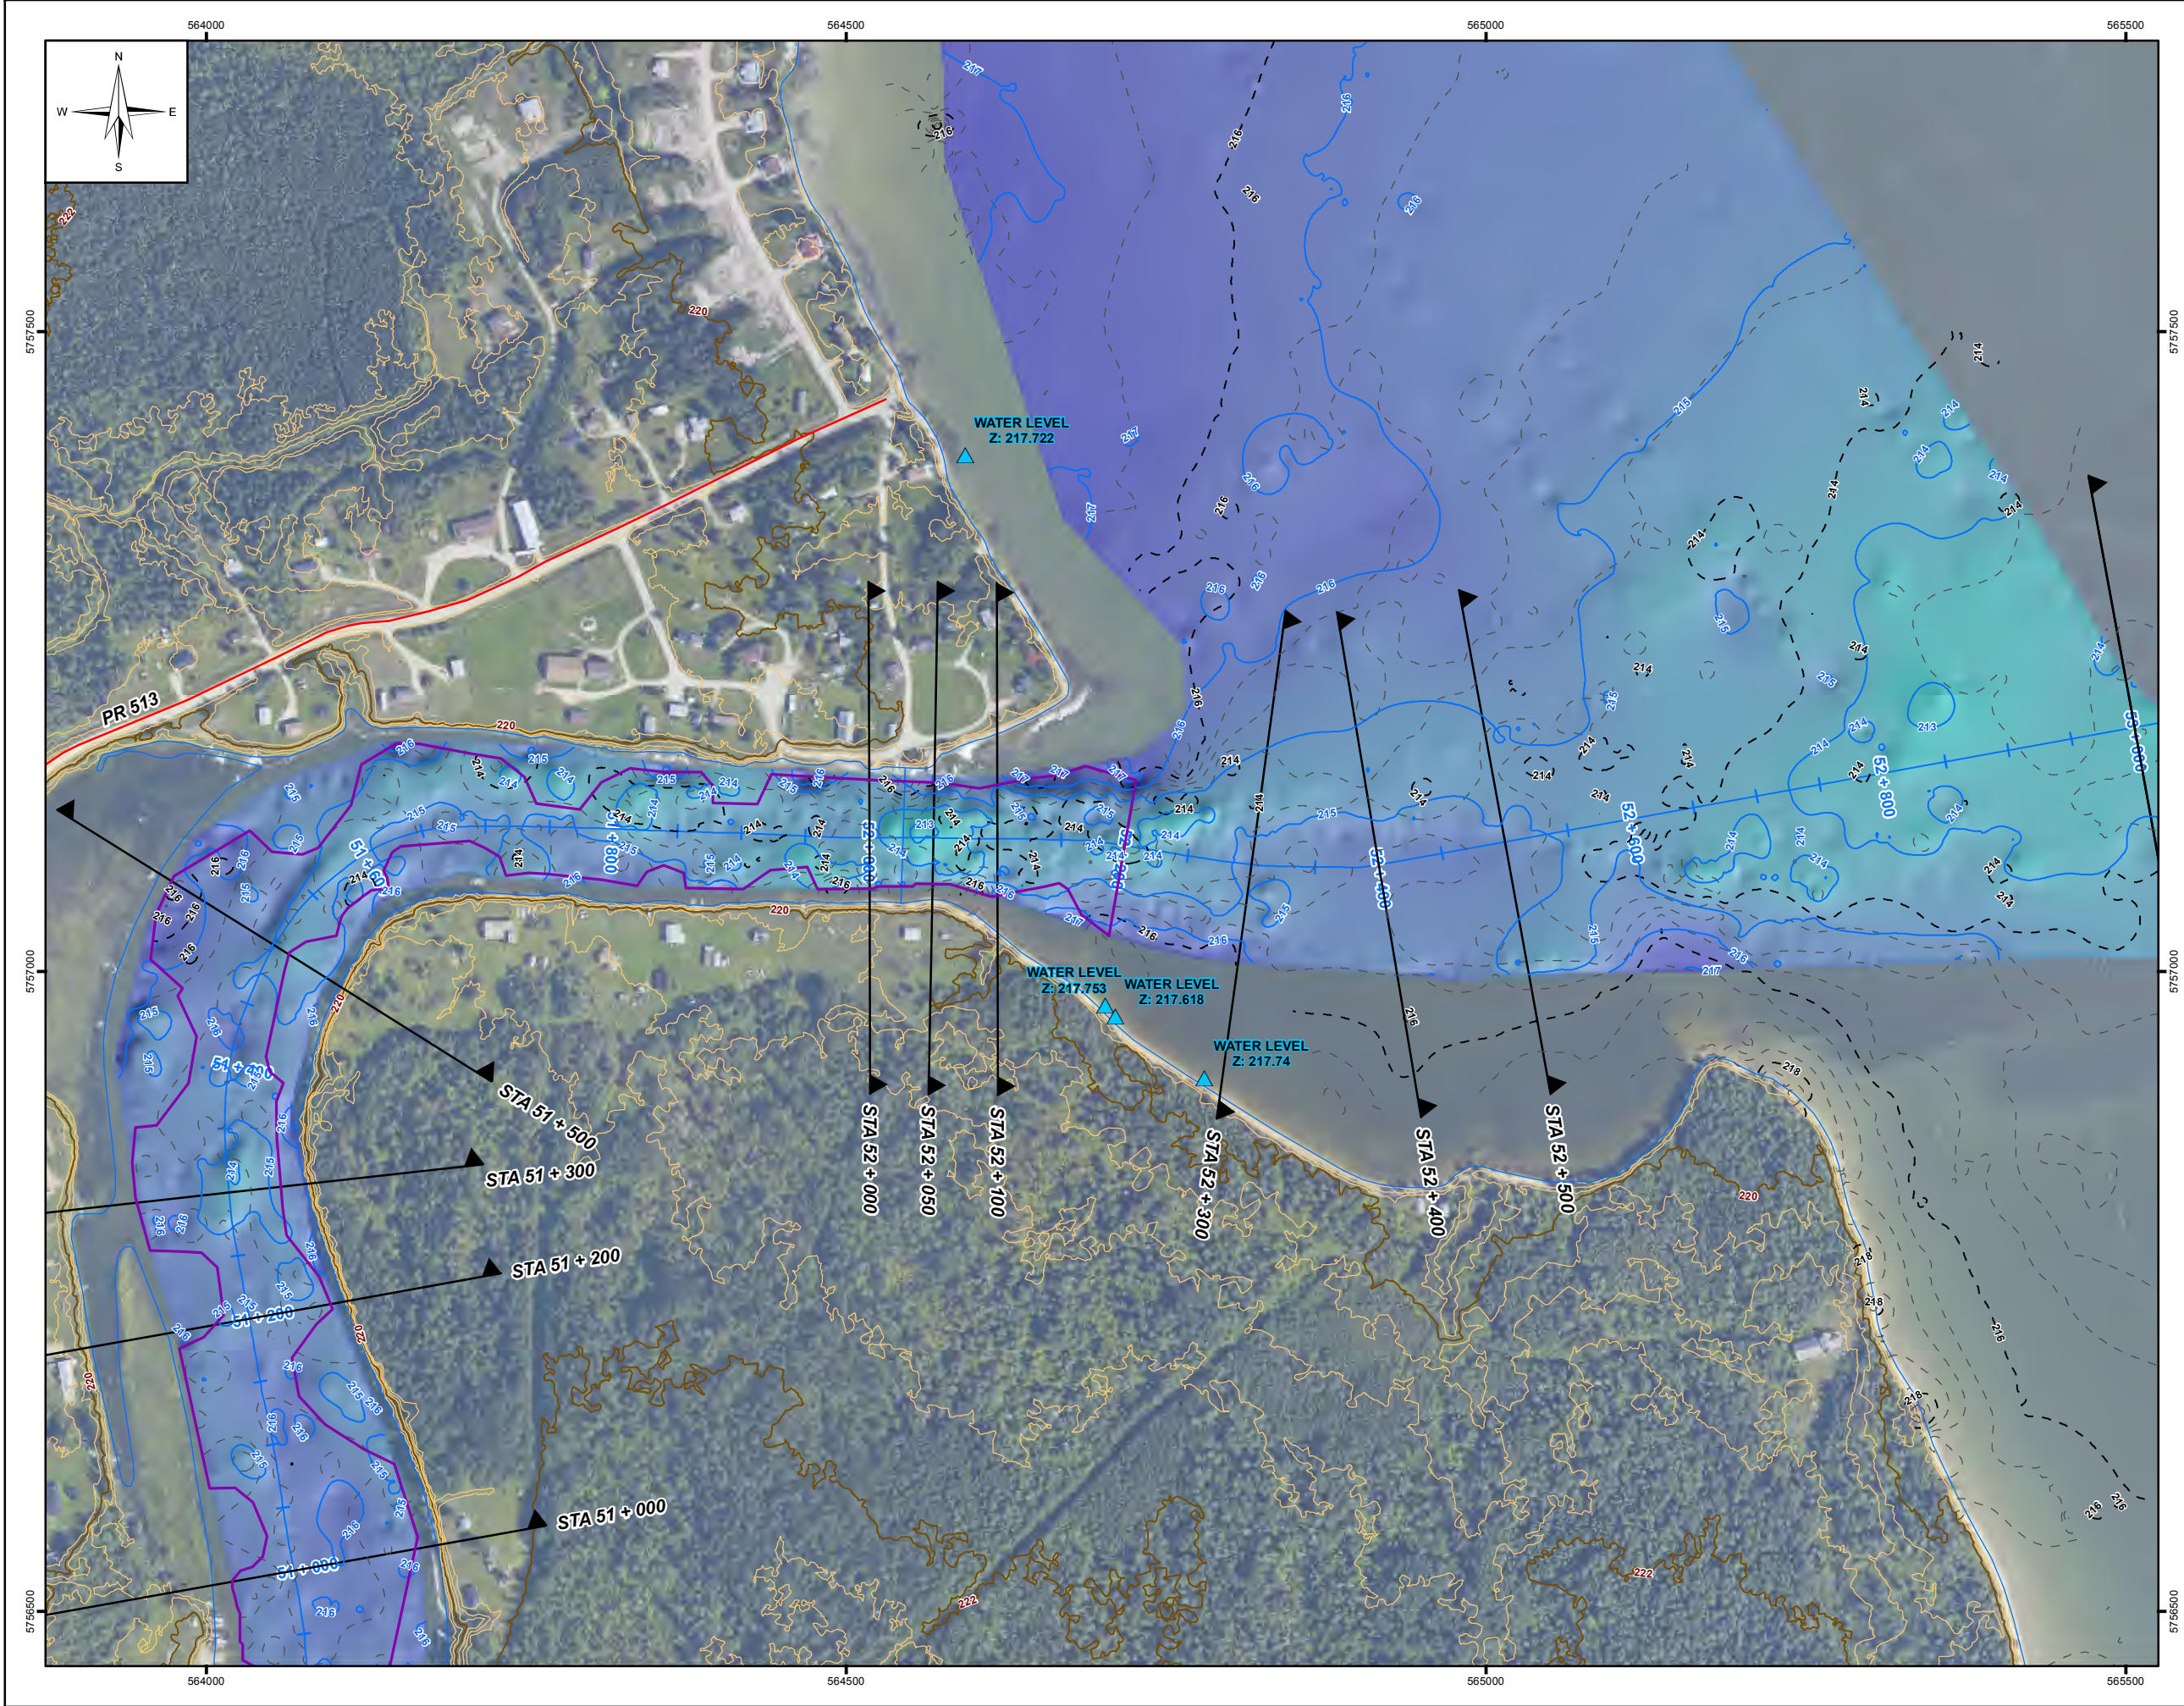
EMERGENCY REDUCTION OF
LAKE MANITOBA AND
LAKE ST. MARTIN WATER LEVELS
LOWER DAUPHIN RIVER BATHYMETRY
COMPARISON OF 2011 TO 2012
(SHEET 1 OF 4)

River bottom bathymetric contours with geodetic elevations for the 2011 and 2012 surveys, and a plan showing incremental changes in bathymetry between the surveys with depth ranges coded in colour have been developed for the lower Dauphin River (Figures 5 and 6).

The comparison between the 2011 and 2012 bathymetry show that there were areas which saw an increase in the river bed elevation and other areas which saw a decrease in elevation. This is shown on the cross sections, the profile and the bathymetry comparison attached with this memo (Figures 3, 4 and 6). The difference in elevation appears to occur at random throughout the surveyed portion of the Dauphin River, as made evident on Figure 6, and does not show obvious or consistent patterns in changes to the river bed.
