RE: Emergency Reduction of Lake Manitoba and Lake St. Martin Water Levels
Dauphin River Bathymetric Survey Investigation - FINAL

1.0 INTRODUCTION

EMERGENCY REDUCTION OF
LAKE MANITOBA AND
LAKE ST. MARTIN WATER LEVELS
LOWER DAUPHIN RIVER BATHYMETRY
OVERVIEW

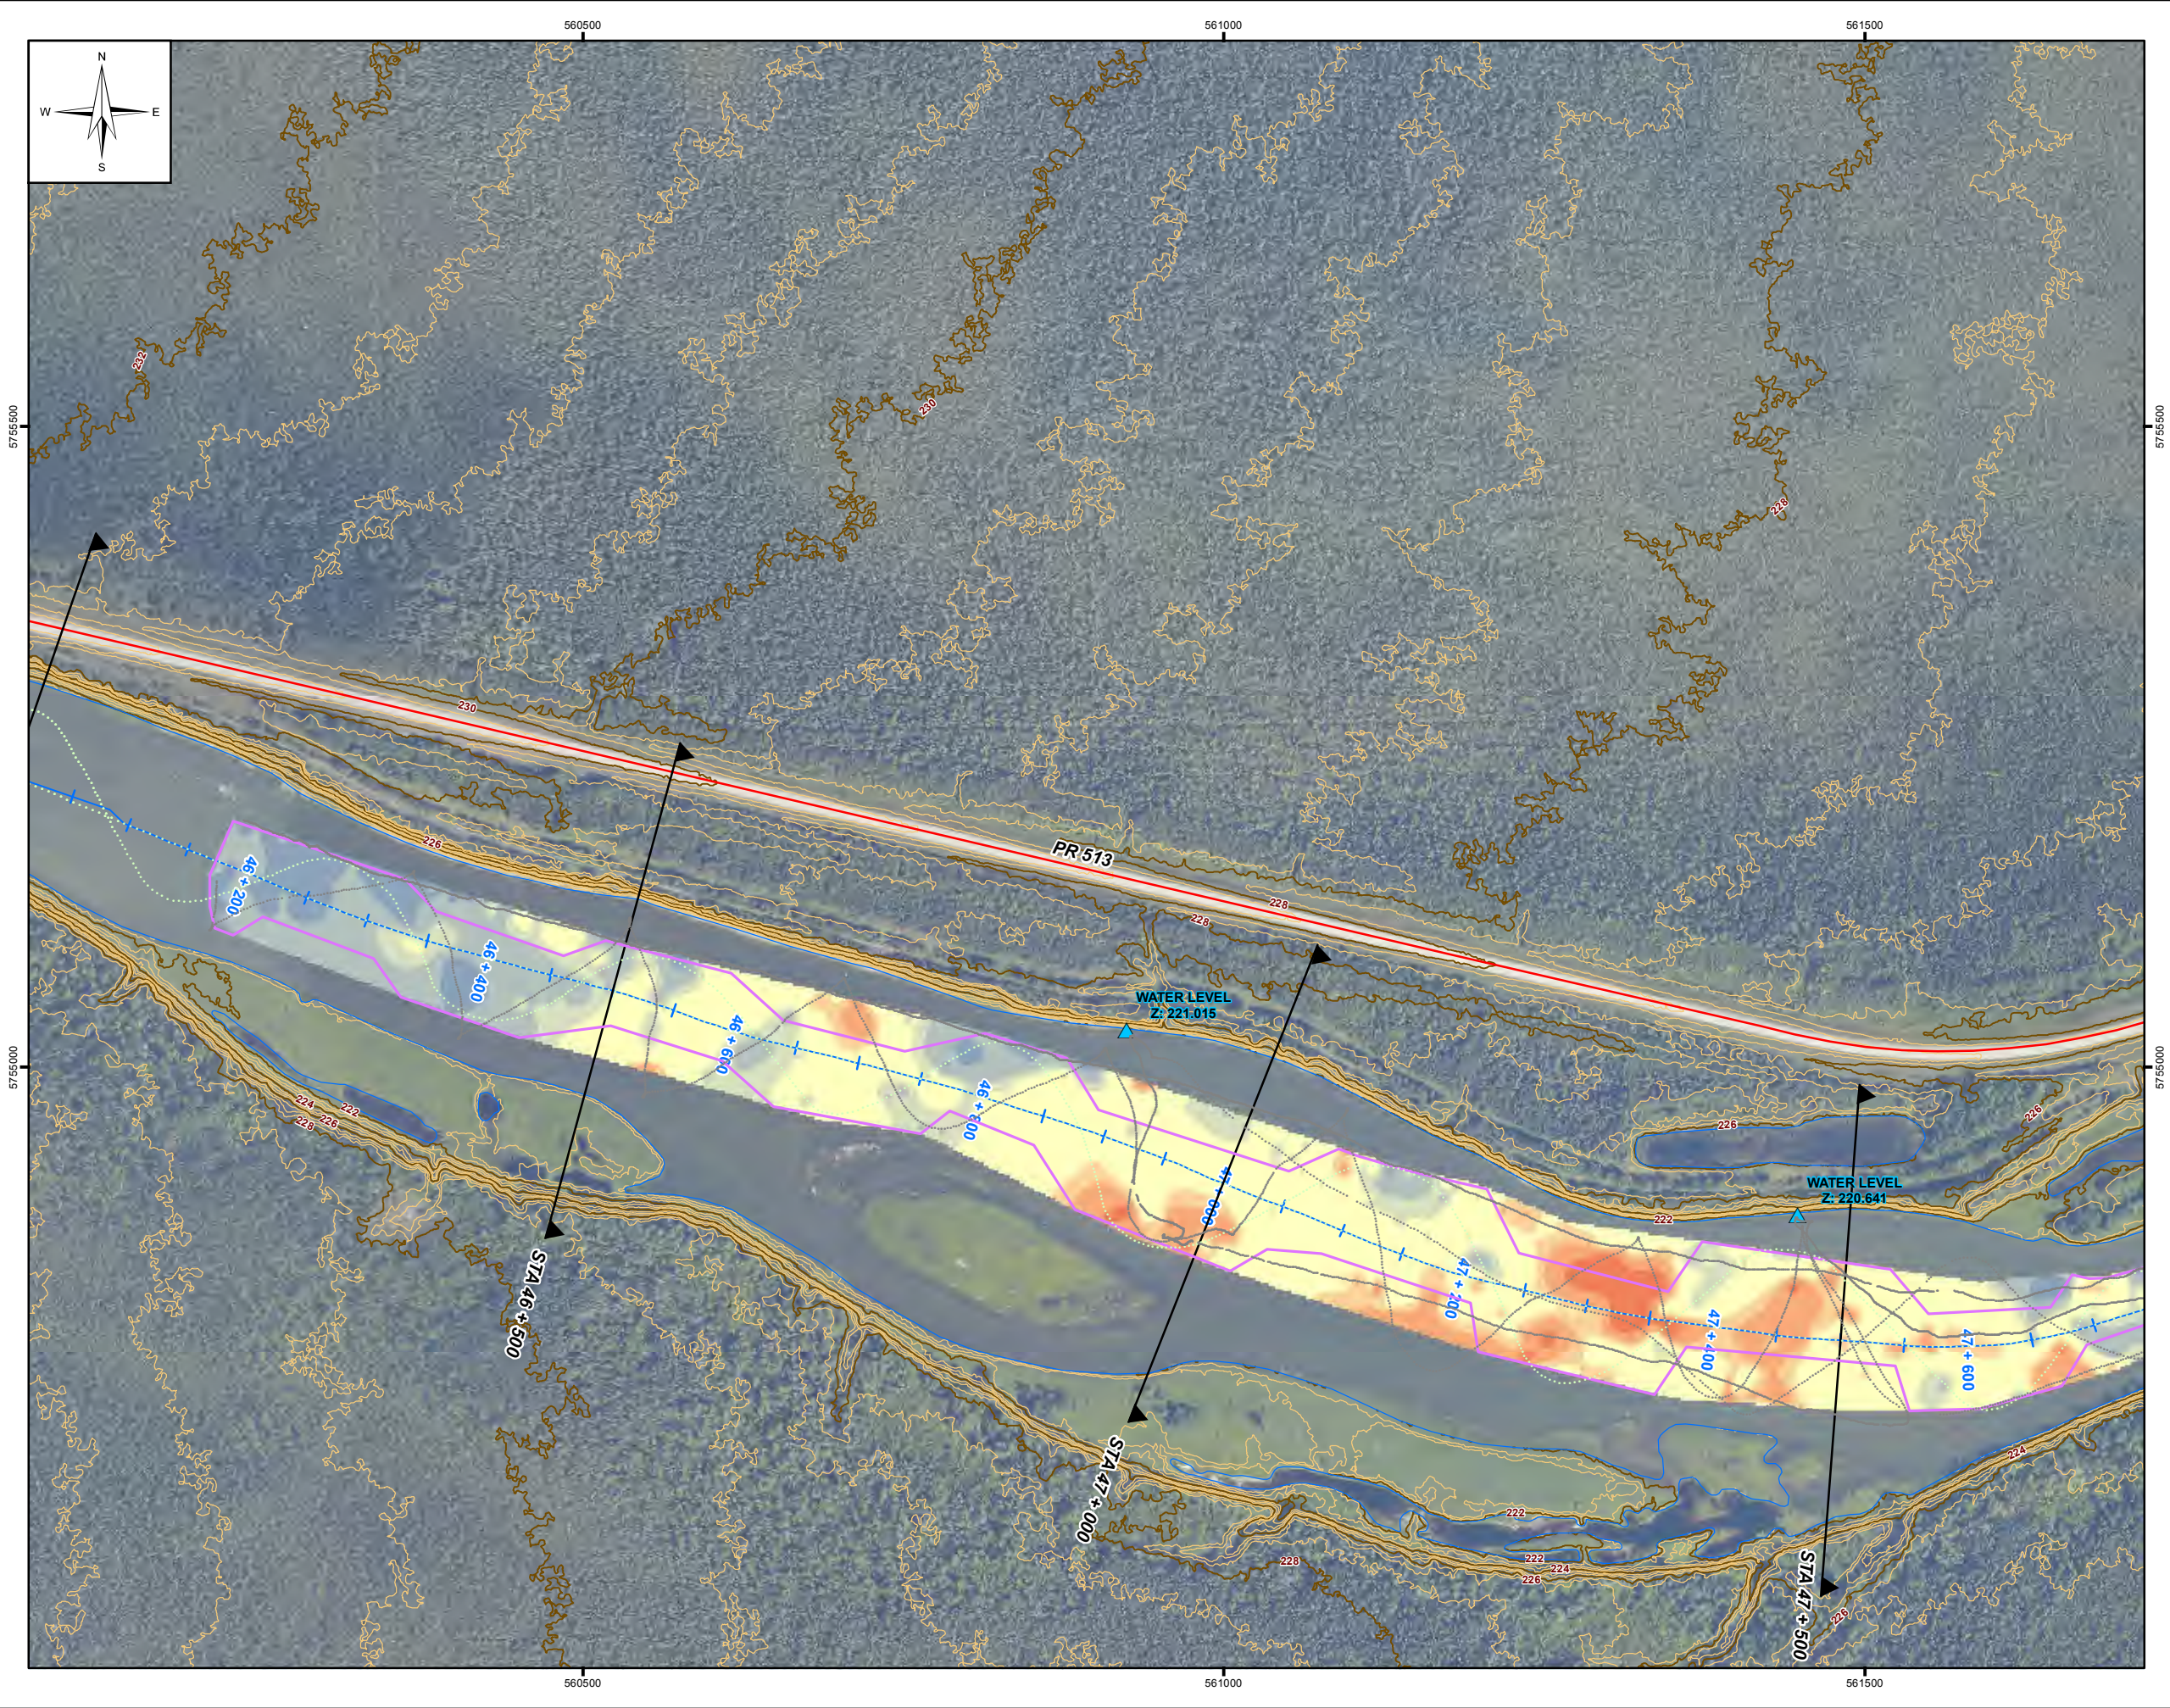
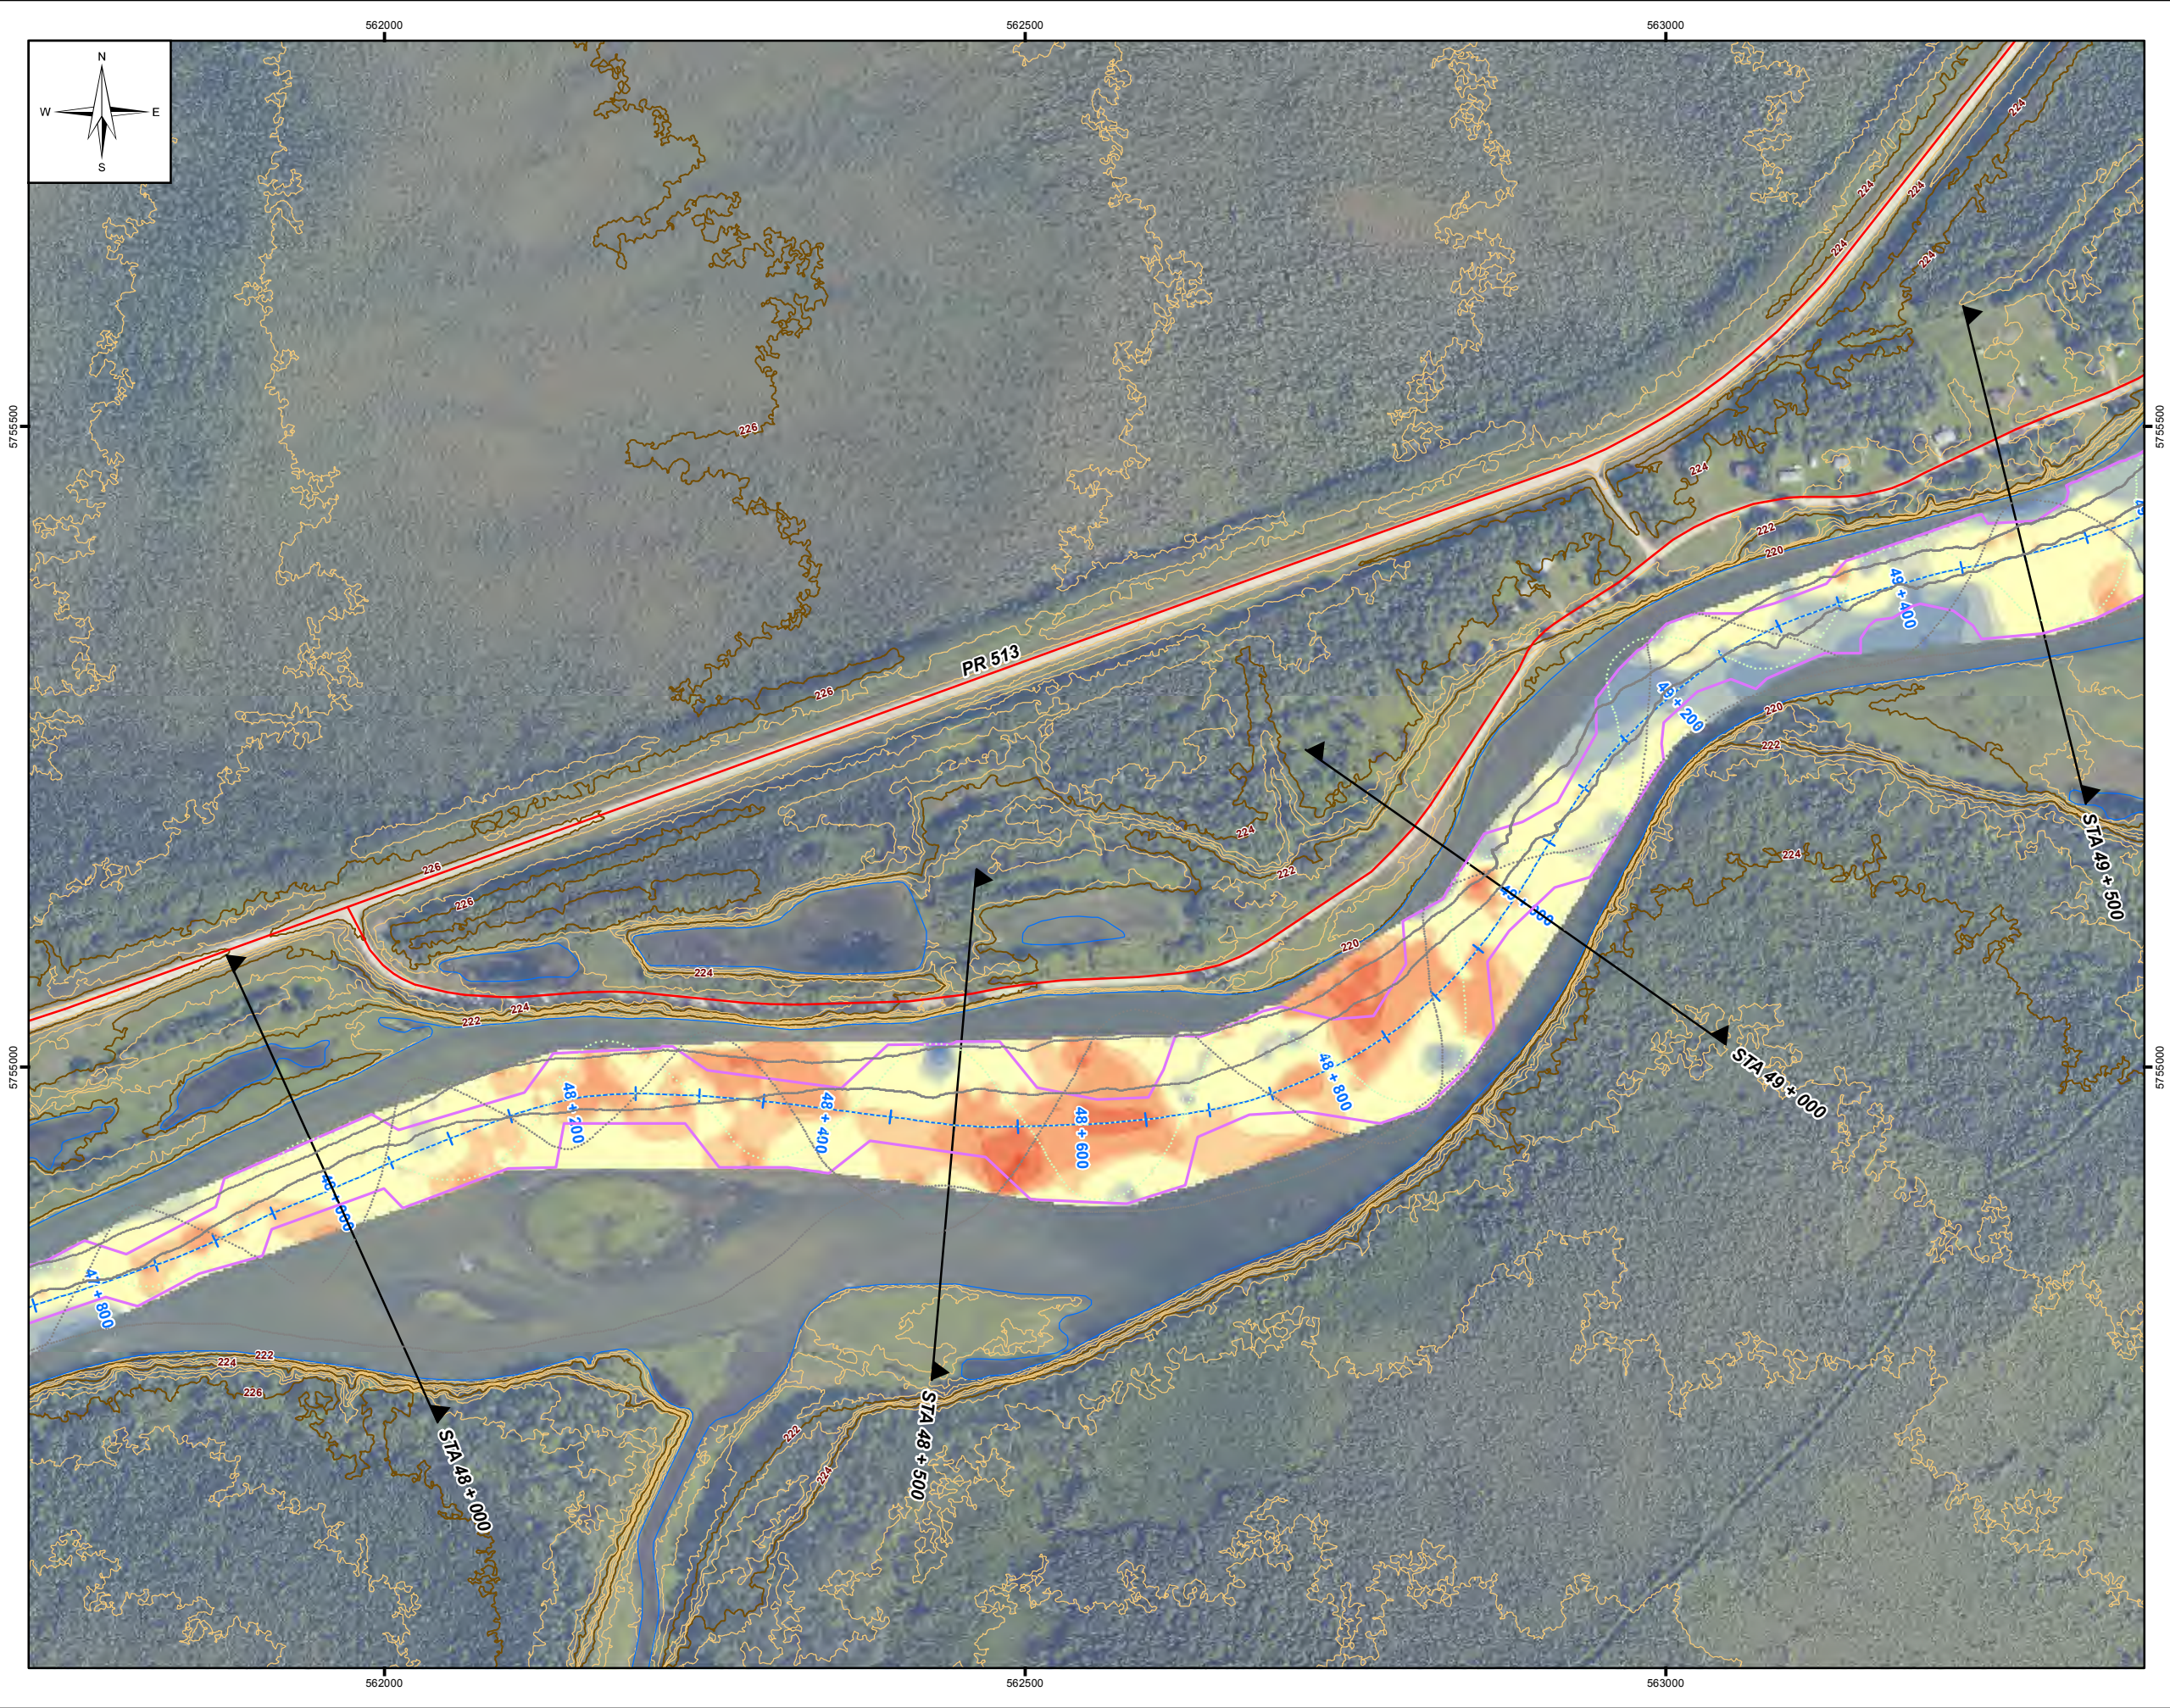
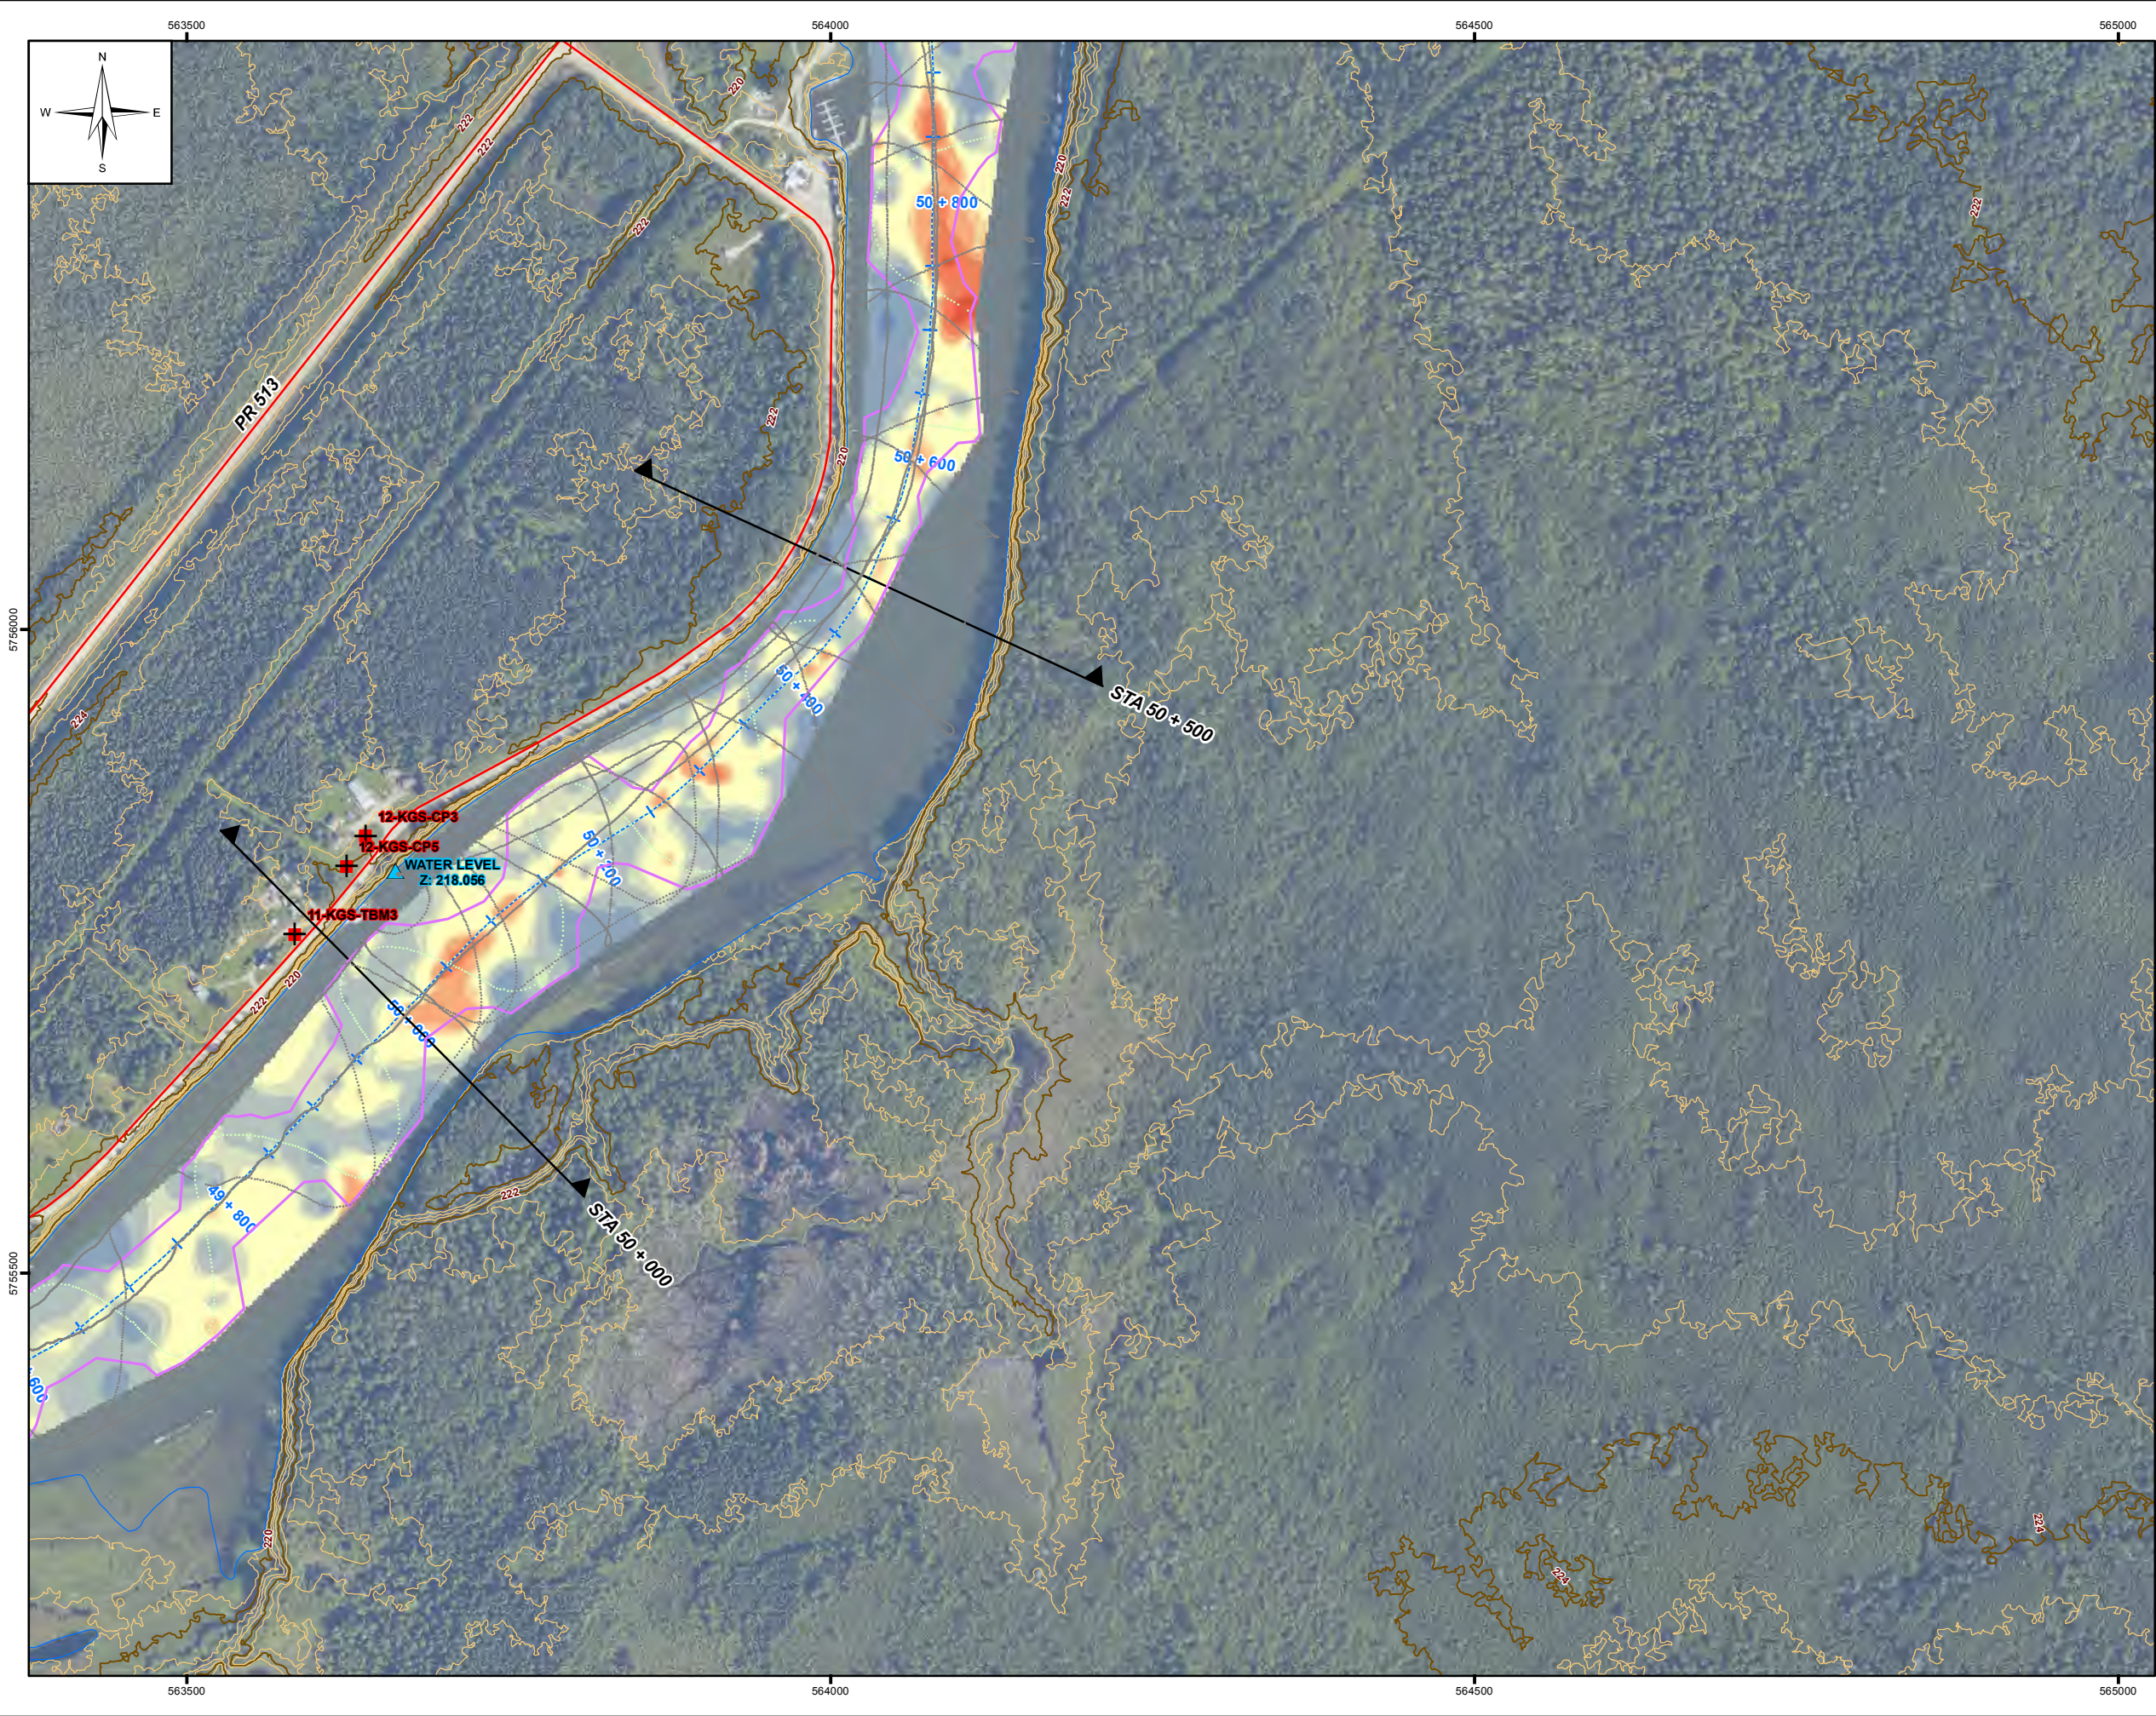
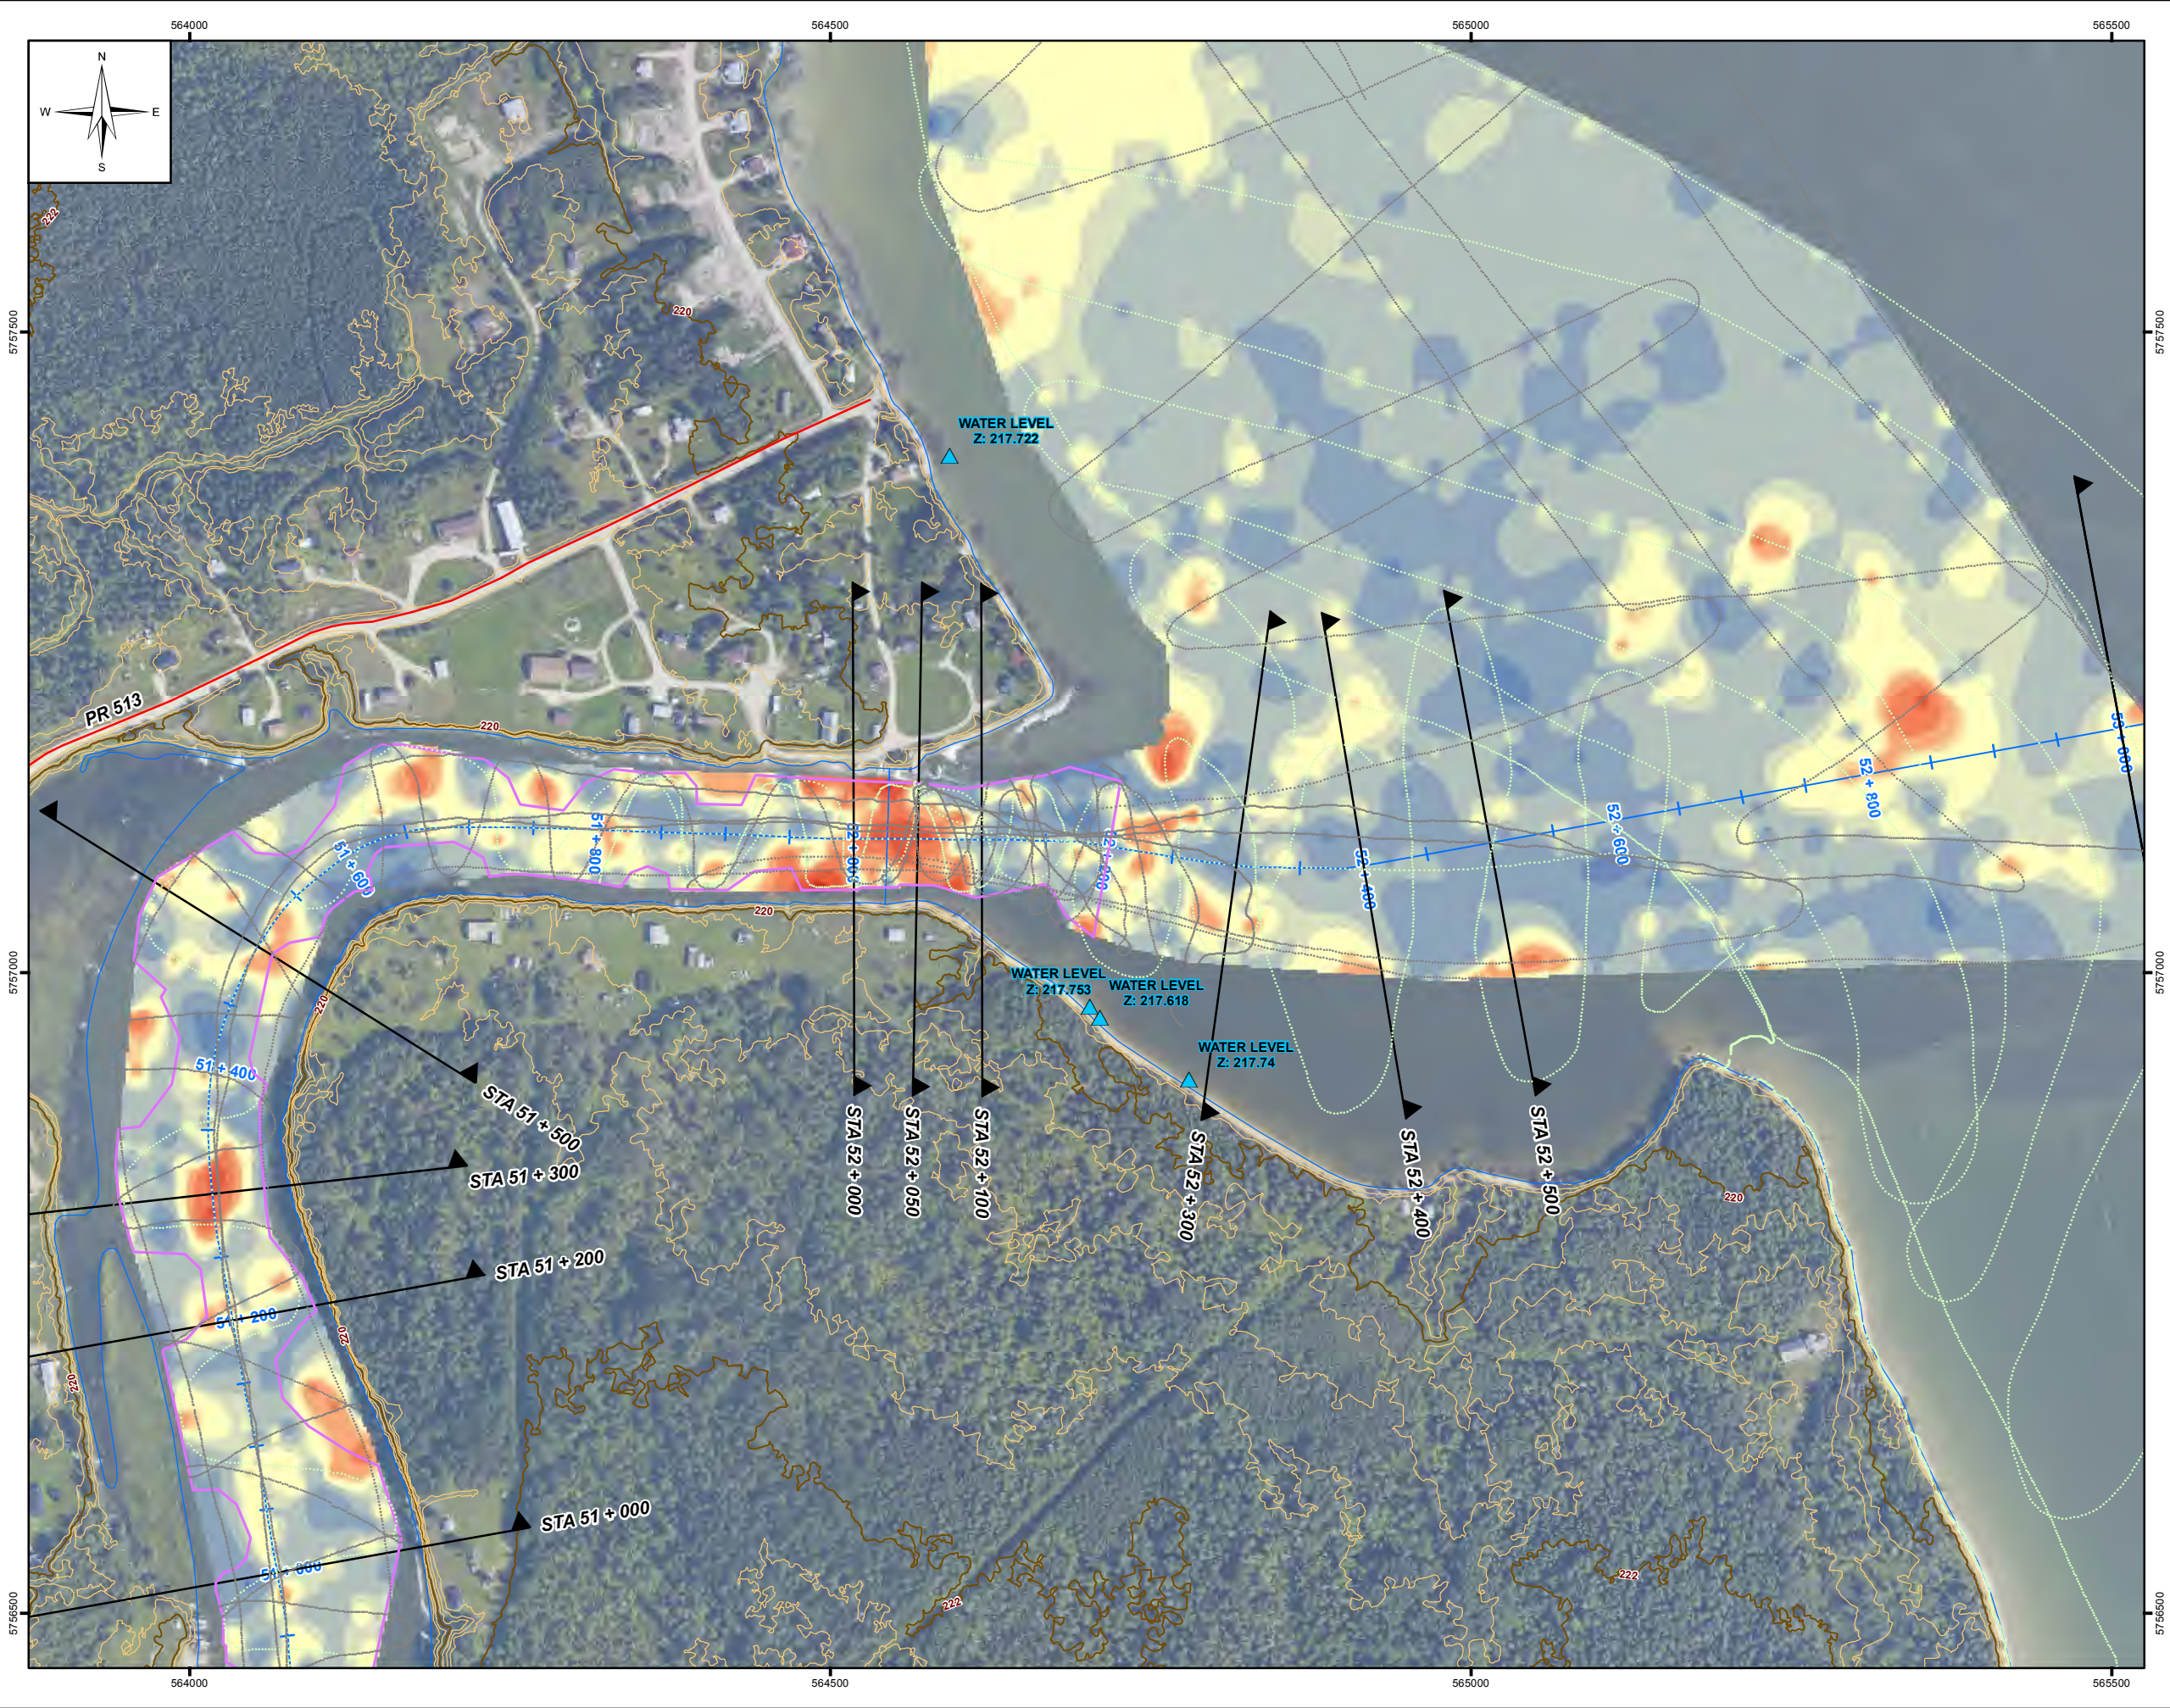
EMERGENCY REDUCTION OF
LAKE MANITOBA AND
LAKE ST. MARTIN WATER LEVELS
LOWER DAUPHIN RIVER BATHYMETRY
DIFFERENCES OF 2011 TO 2012
(SHEET 1 OF 4)

River bottom bathymetric contours with geodetic elevations for the 2011 and 2012 surveys, and a plan showing incremental changes in bathymetry between the surveys with depth ranges coded in colour have been developed for the lower Dauphin River (Figures 5 and 6).

A preliminary volumetric comparison was completed from Station 46+000 to 52+000 and an approximate net difference of 39,600 m³ was calculated. Table 1 shows the net and cumulative difference in volume every 200 m detected in 2012 compared to 2011. The calculated volumes are based only on sonar data located within the "volume boundary" shown on Figures 5 and 6 as this is considered to be the most reliable data. The lack of reliable data at the edge of the survey may result in a substantial variation to the actual and calculated volumes.

Results from Table 1 show a net increase in volume between station 46+000 to 52+000. This is consistent with the preliminary sediment transport analysis of the Dauphin River completed by KGS Group which indicated a decrease in total sediment runoff in this reach of the river. However, the calculated volumes are based on the sonar data located within the "volume boundary" as discussed in the results. The volume does not account for changes that may have occurred outside the boundary.
