State of the Watershed Report

East Holland River Subwatershed

completed by
The Lake Simcoe Region Conservation Authority
2000

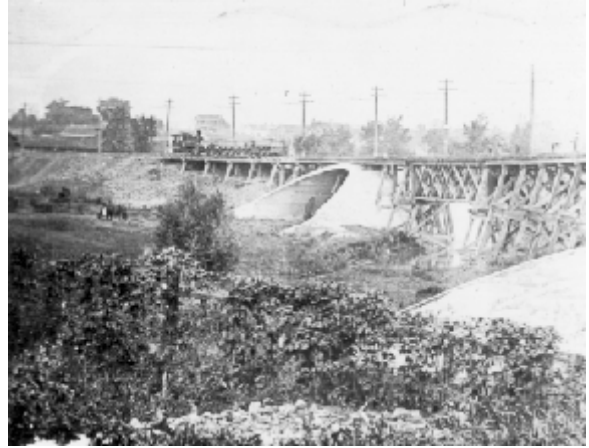
Concrete arch spanning the East Holland River for the Radial Railway.

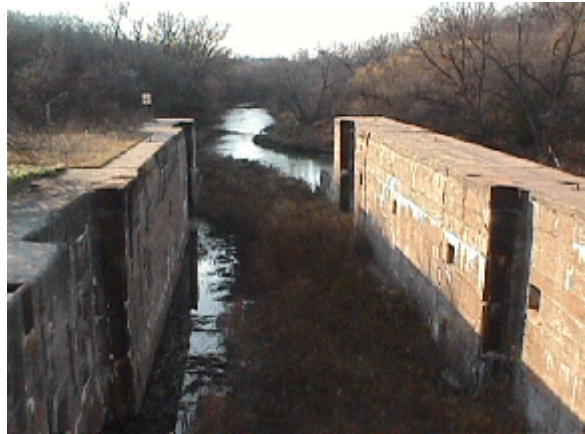
Lock #2 at Rogers Reservoir today.

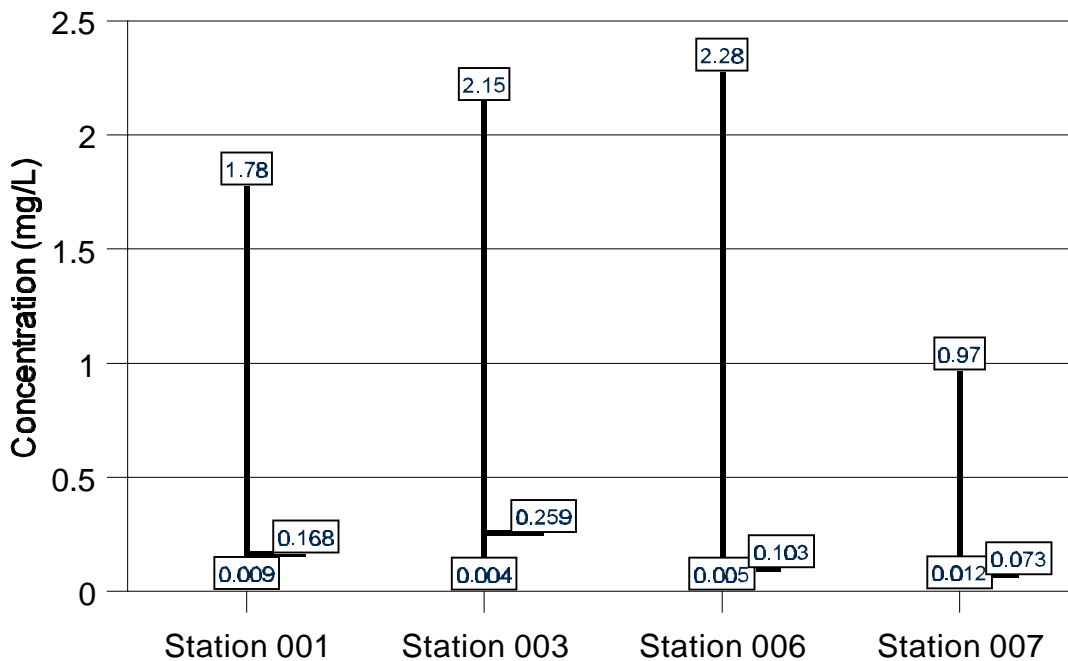
Figure 7.2: High/Low graph illustrating Total Phosphorus concentrations at four sampling sites over a 14 year period.

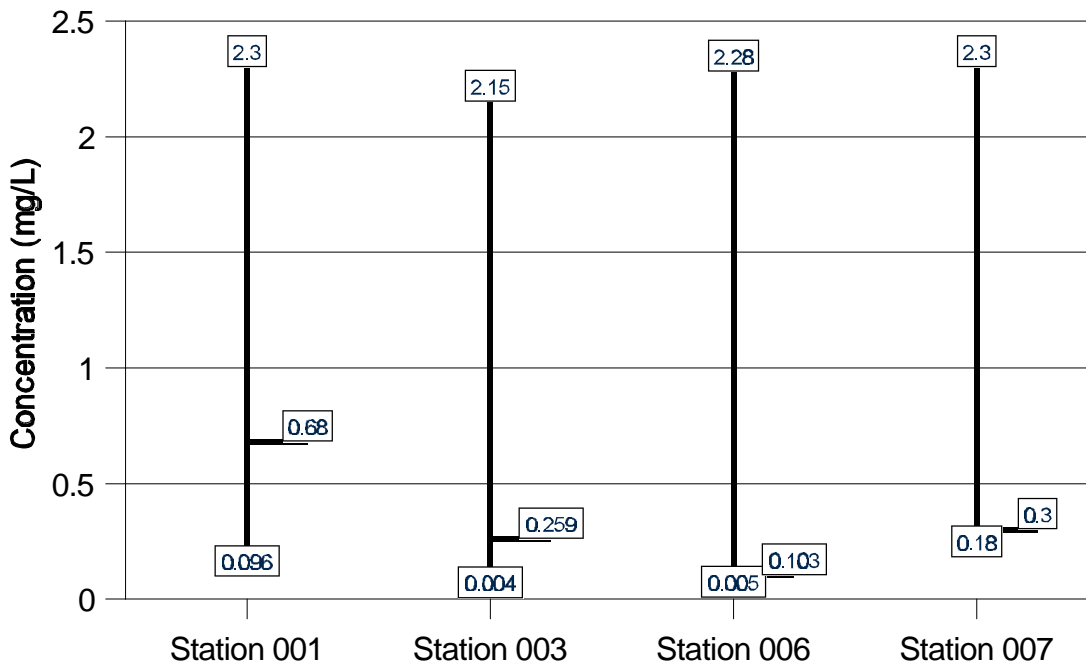
Figure 7.4: High/Low graph illustrating Iron concentrations at four sampling sites over a 14 year period.

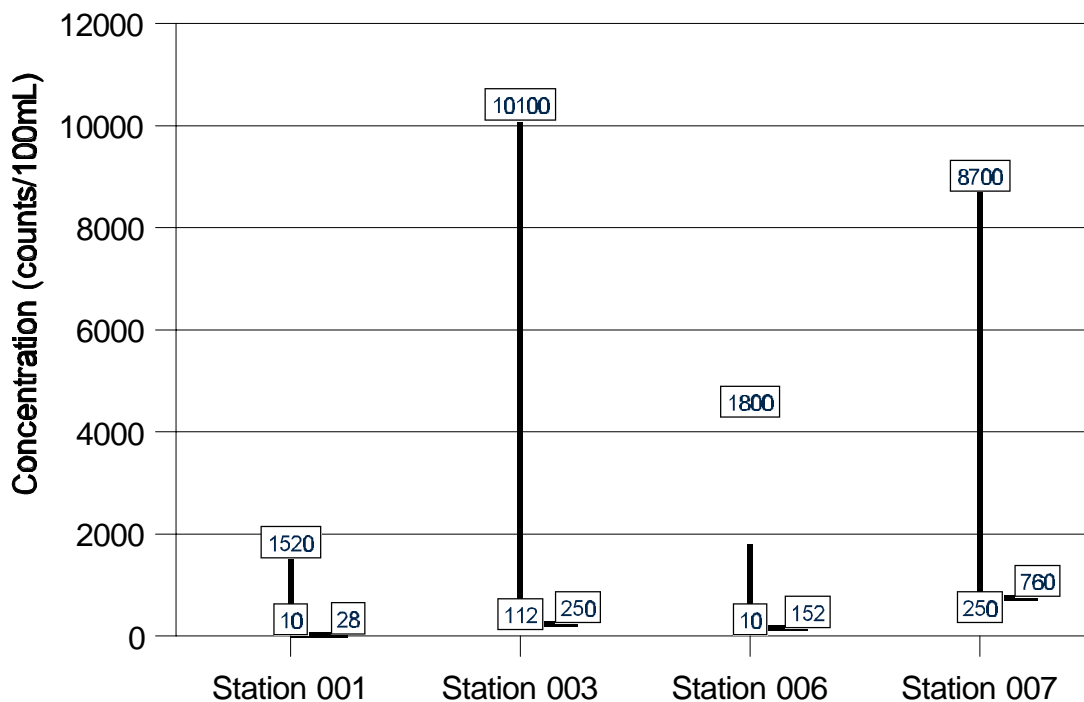
Figure 7.6: High/Low graph illustrating *E. coli* concentrations at four sampling sites.

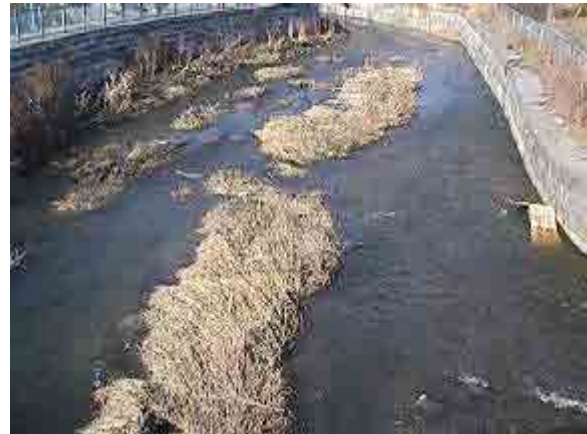
The East Holland River at Davis Drive provides an example of a braided channel.

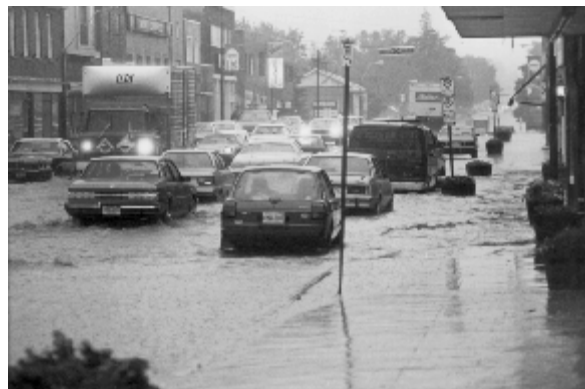
Flooding in the Town of Aurora.
