**Fluvial Geomorphology Assessment
of Blairmore Creek and Gold Creek**

Grassy Mountain Coal Project

December 22, 2016

Prepared For:
Hatfield Consultants

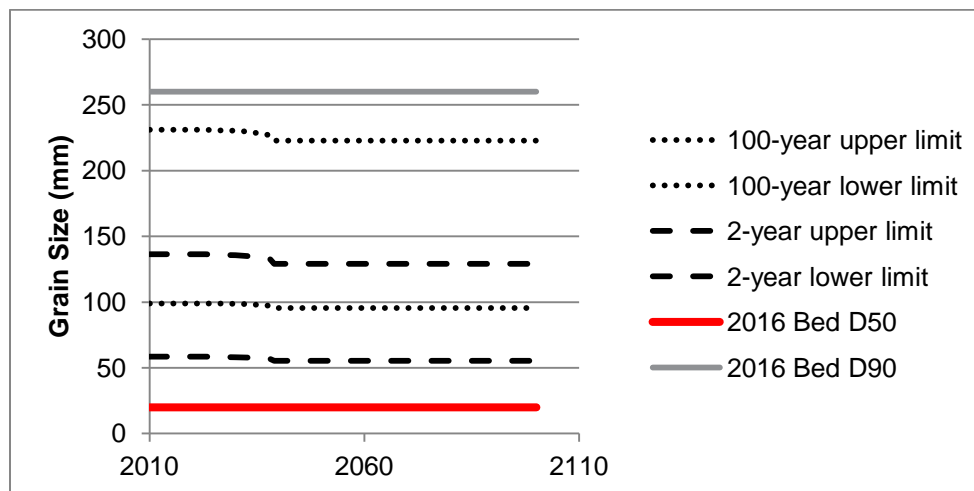
Data for cross-section GC-22 (SNC-Lavalin G1-16) were collected at the location of Node GC-10 in the upstream part of a riffle pool reach. Median grain size on the bed is 20 mm and the largest grain size measure in the channel is 260 mm. Under the current hydraulic regime, flows associated with bankfull conditions, the sediment mobility threshold ranges from 60 to 140 mm, and under 100-year flow conditions, it ranges from 100 to 230 mm. Flow decreases will result in a decrease in the mobility thresholds to 55 to 130 mm under bankfull flows, and to 95 to 225 mm under 100-year flow conditions (Figure 4-12). D_{50} bed material is predicted to be mobile during 2-year flows; however, D_{90} bed material is not predicted to be mobile, even during 100-year flows.

Figure 4-12: Sediment entrainment threshold ranges for cross-section GC-22.

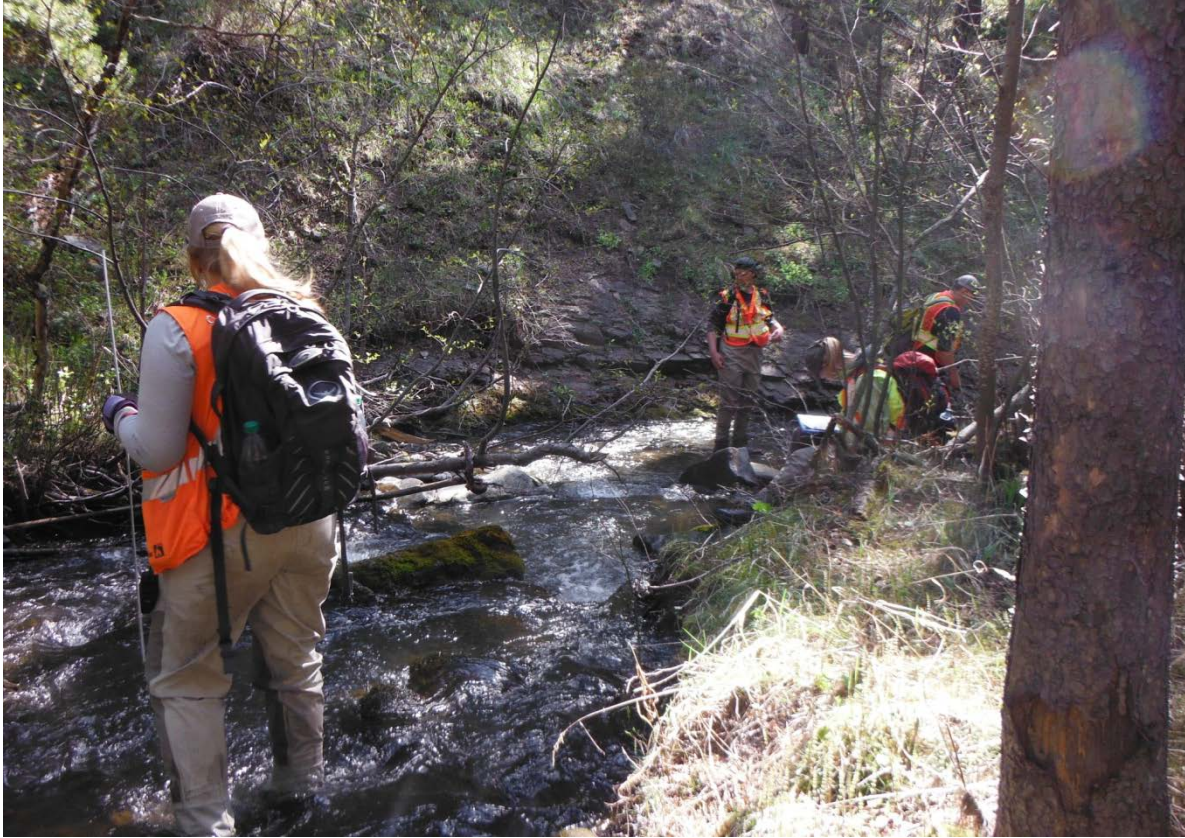
F- 2 Cascade flowing into a riffle section near site B1-04.

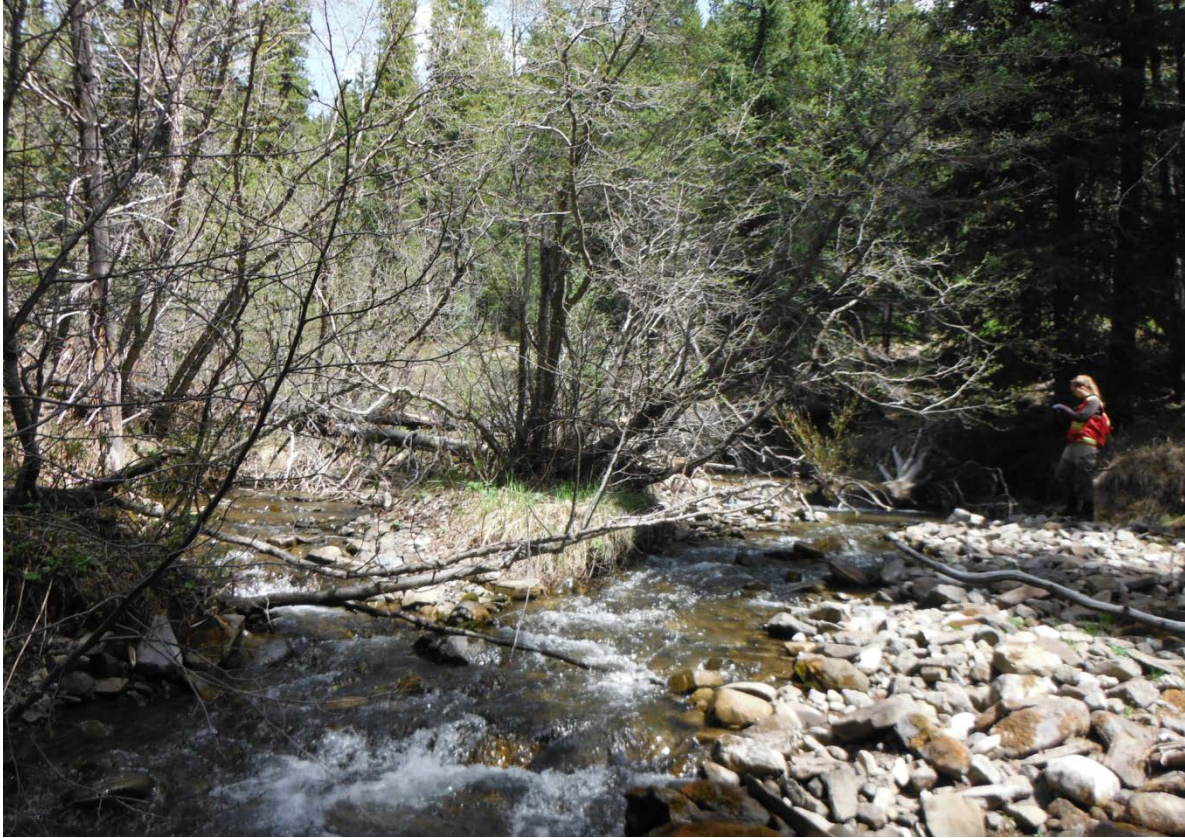
F- 3 Rejoining of a bifurcation in a cascade-riffle pool reach on Blairmore Creek near B1-07.

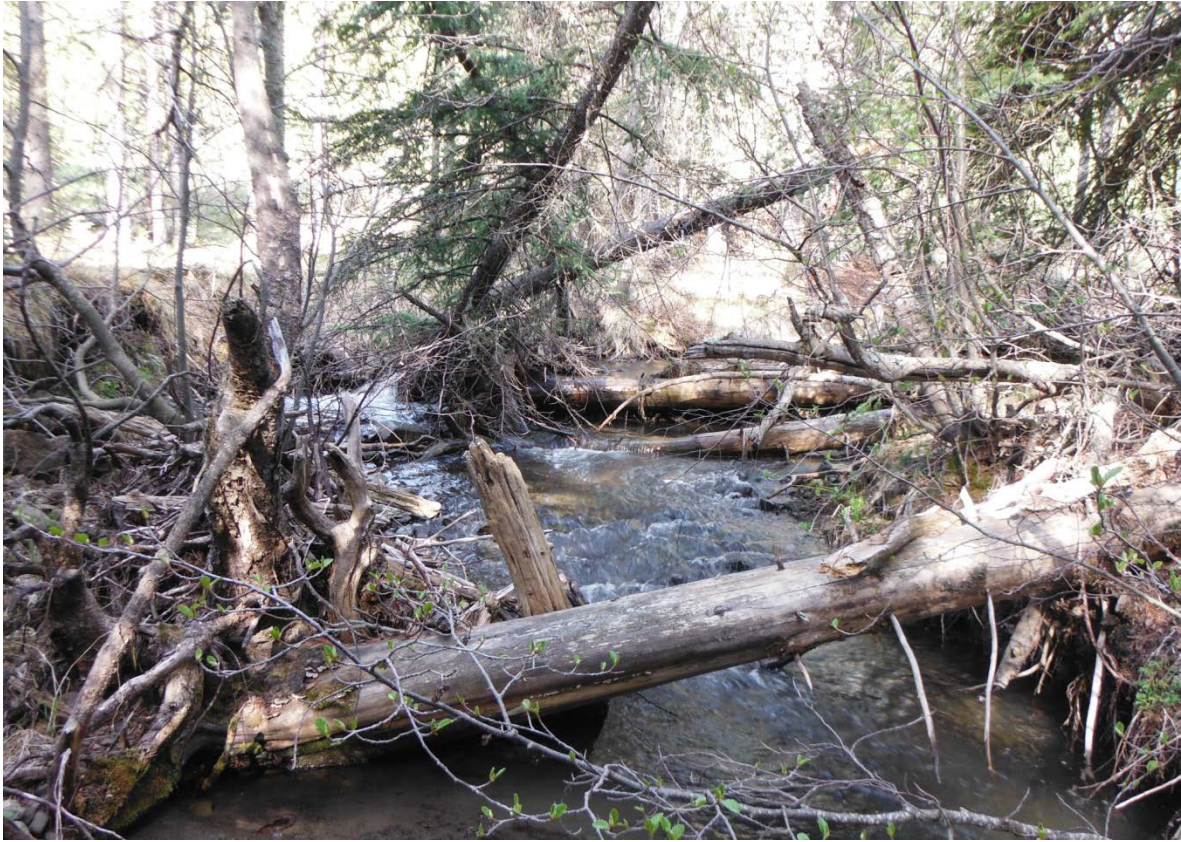
F- 1 LWD-forced cascade-riffle section on Blairmore Creek near B1-02.

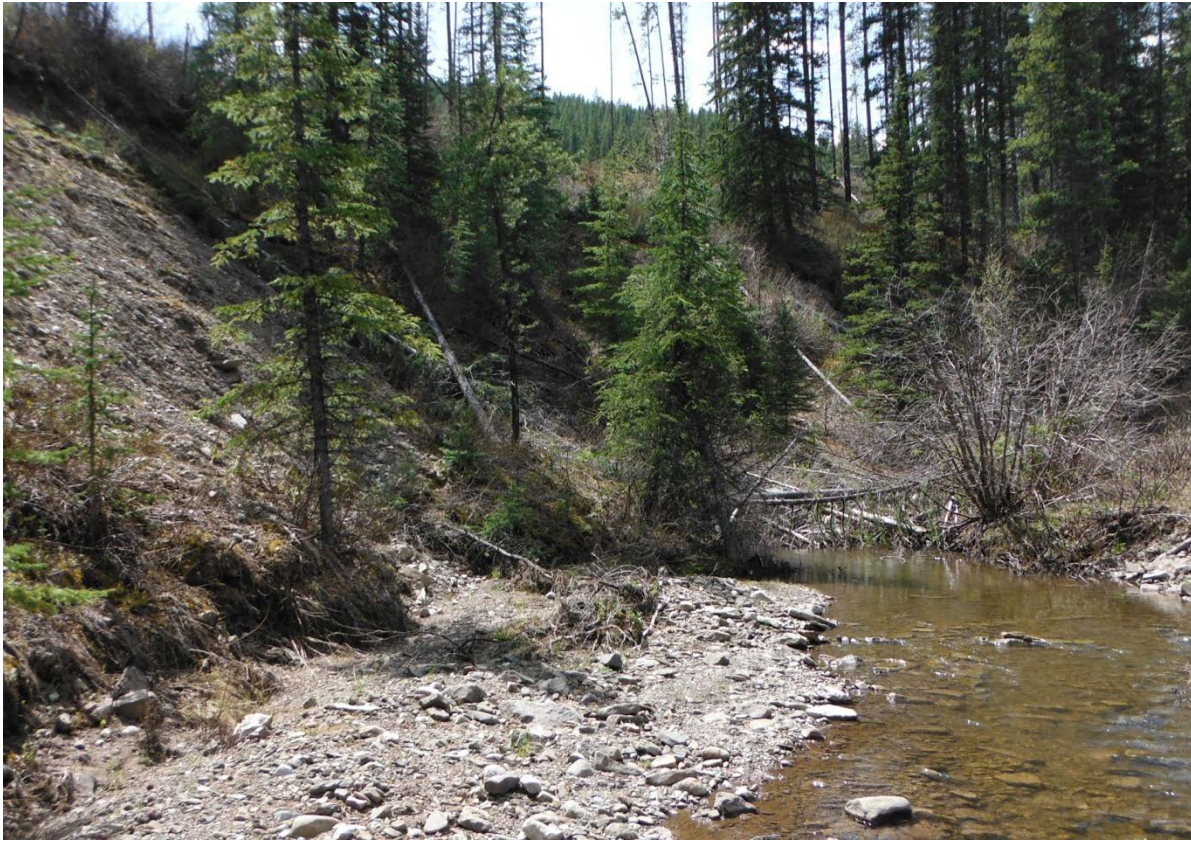
F- 4 Riffle pool morphology at site B1-09 on Blairmore Creek.

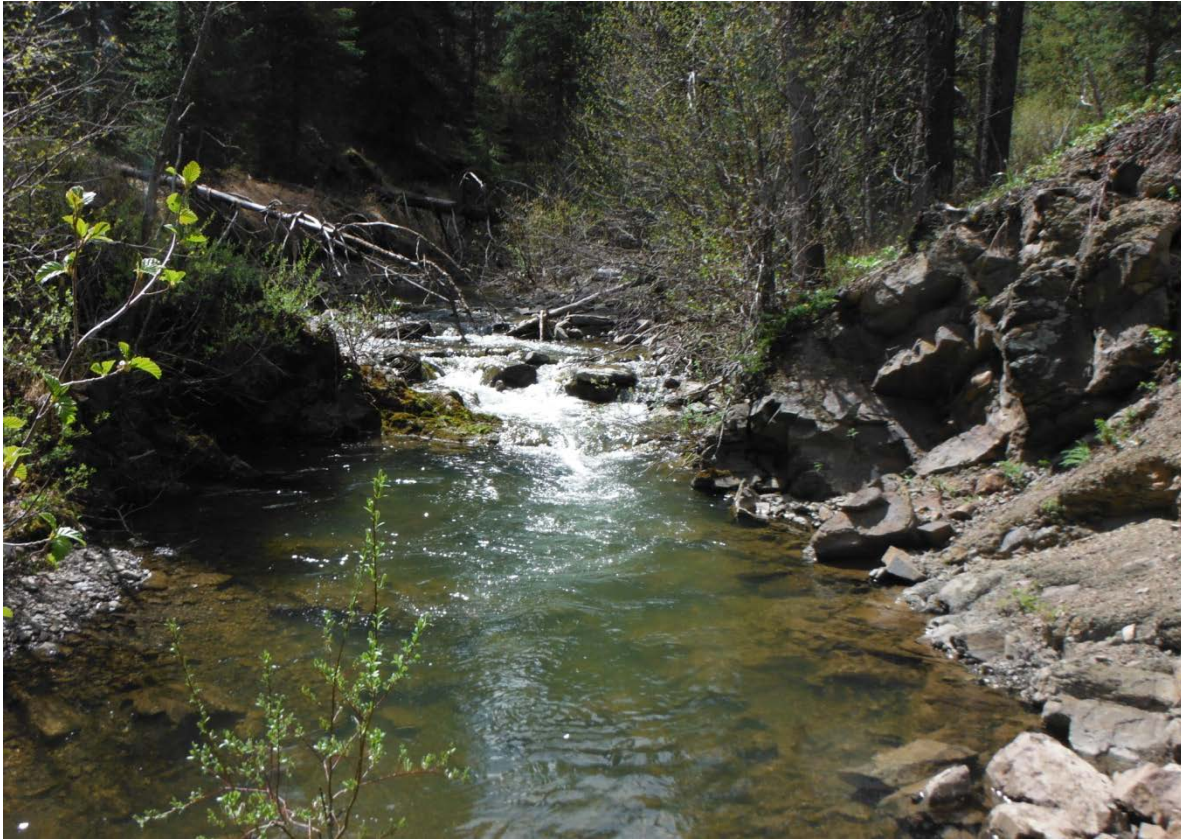
F- 5 Looking downstream toward a bedrock-cascade pool reach on Blairmore Creek near site B1-10.

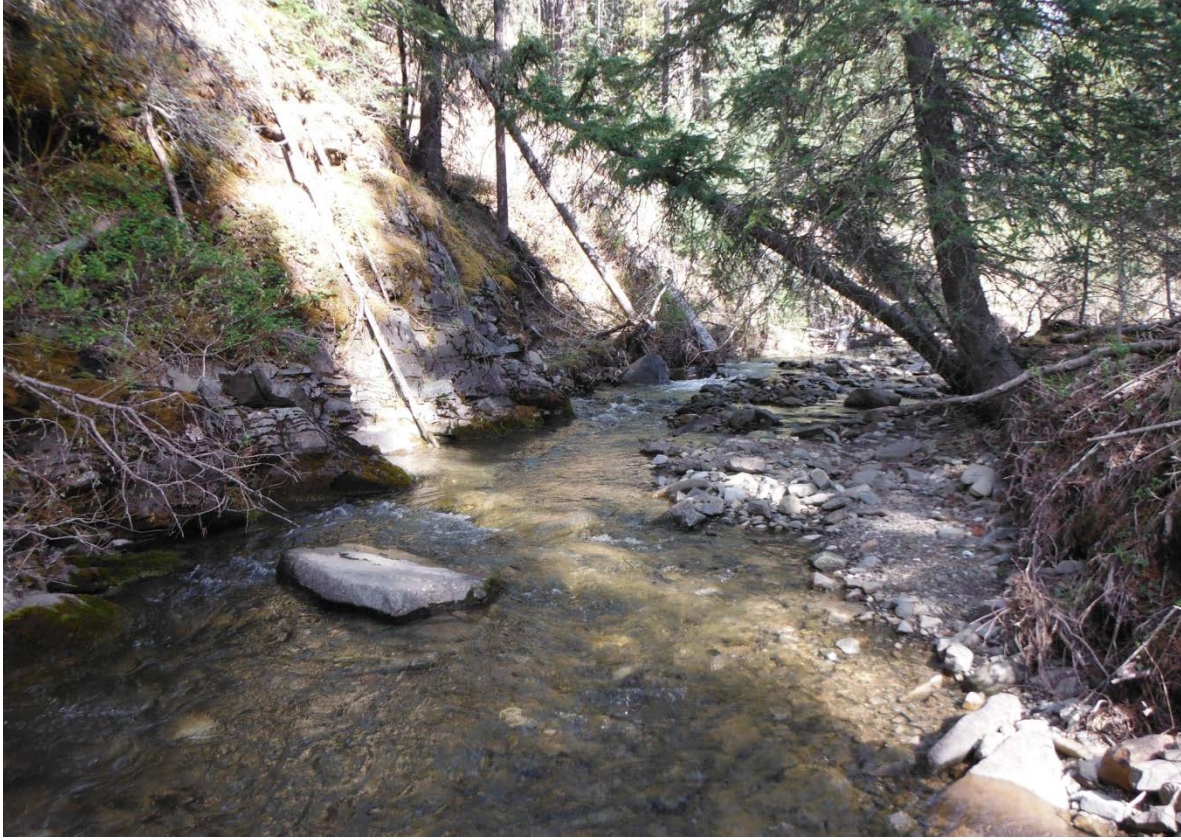
F- 6 Downstream-facing view of a riffle with bedrock confinement on the left bank. Image taken near site B2-02.

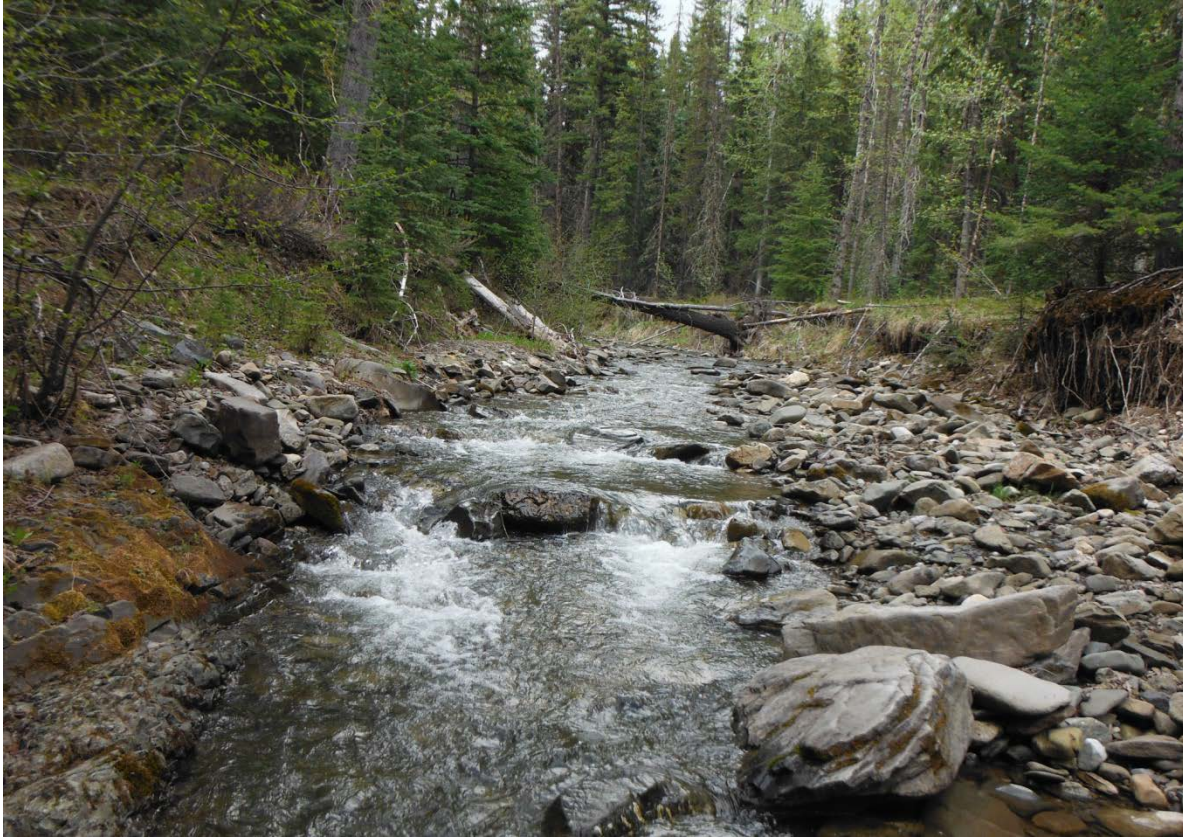
F- 7 Step pool morphology near site B2-07 on Blairmore Creek.

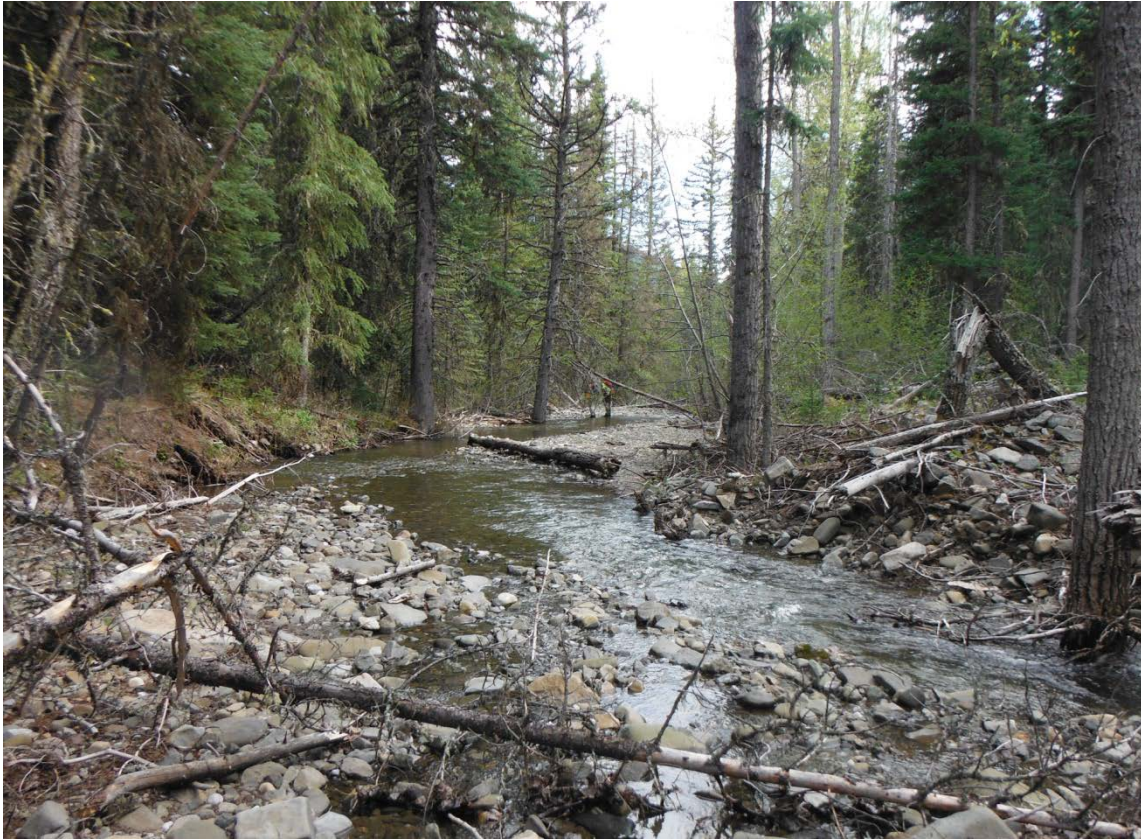
F- 8 Riffle pool sequence with lateral bars at site B2-10 on Blairmore Creek.

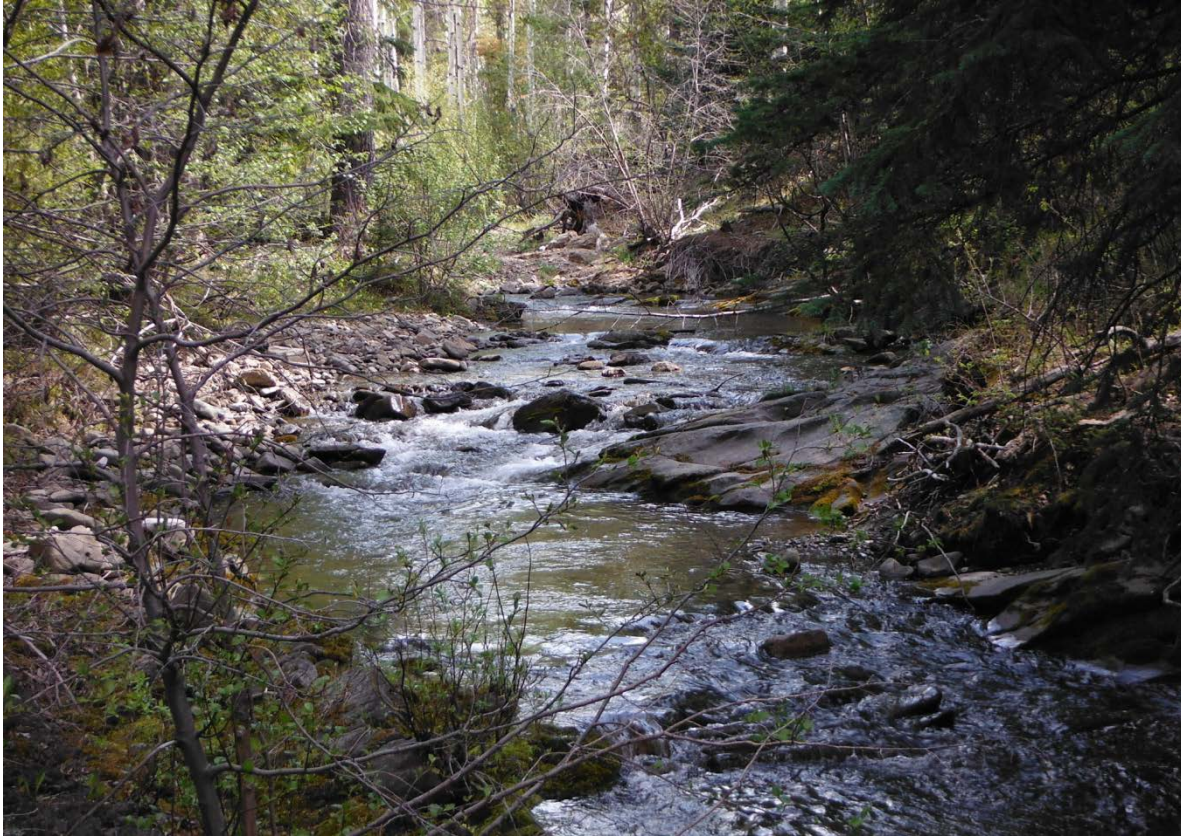
F- 9 Bedrock-riffle pool with a lateral bar near site B2-14.

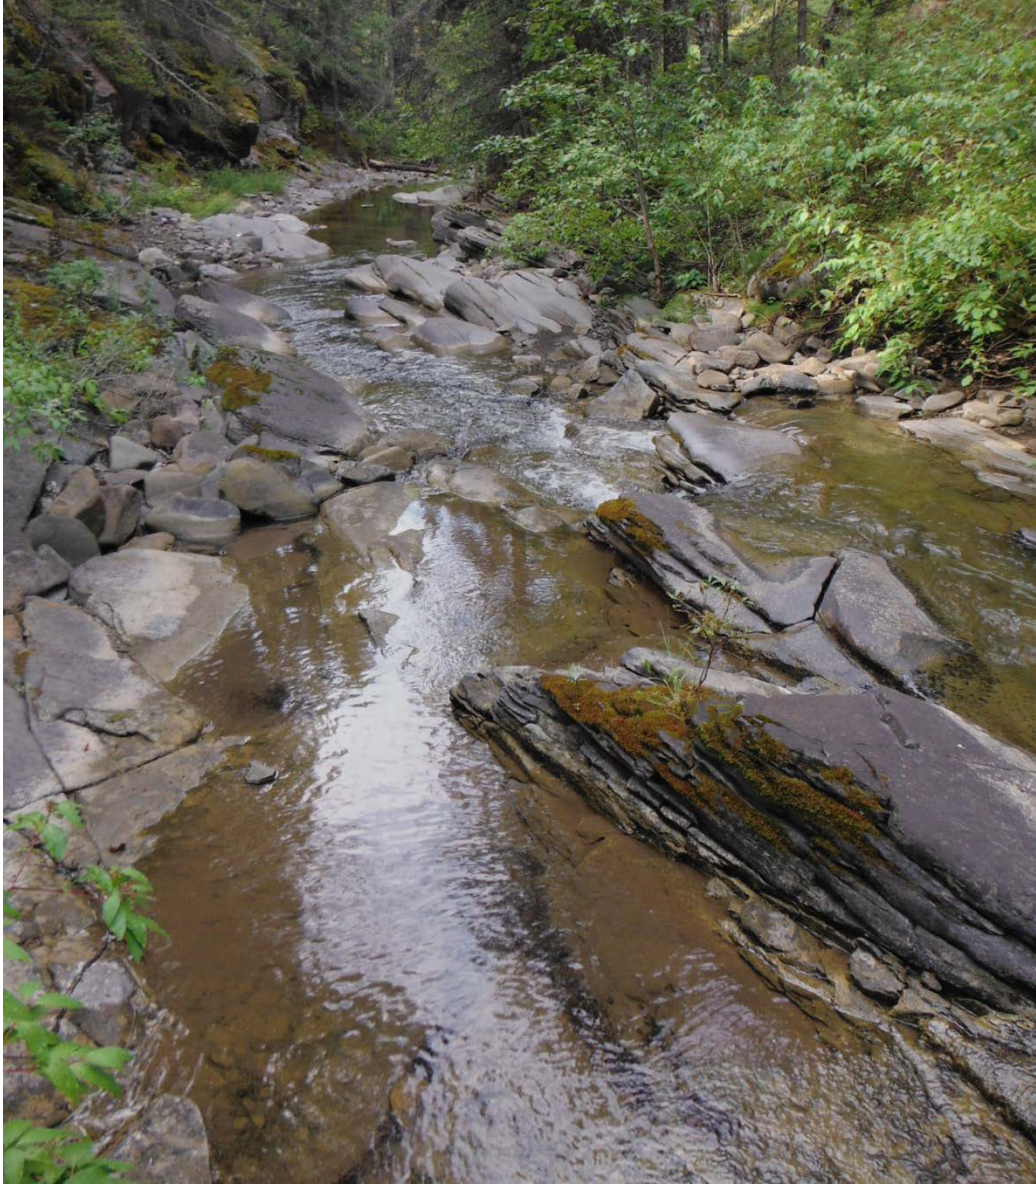
F- 10 Bedrock-step pools near site B3-01 on Blairmore Creek.

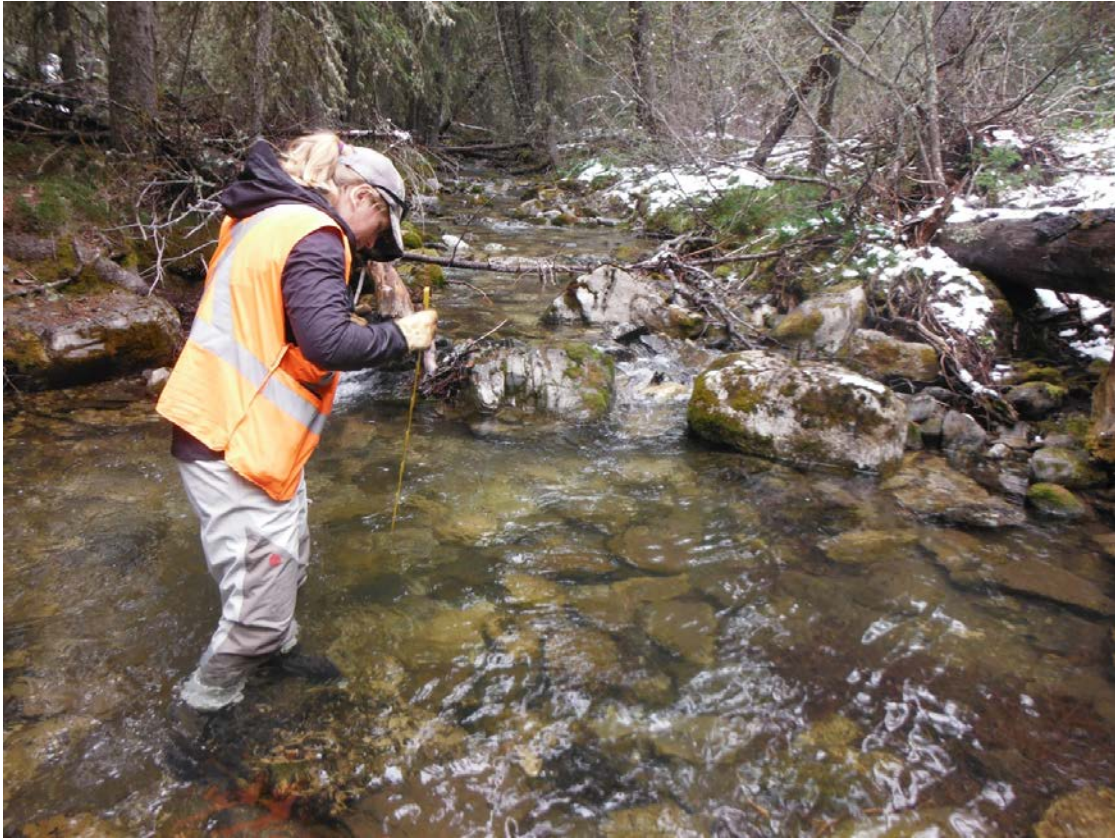
F- 11 Step pool morphology in Upper Gold Creek near site G1-01.

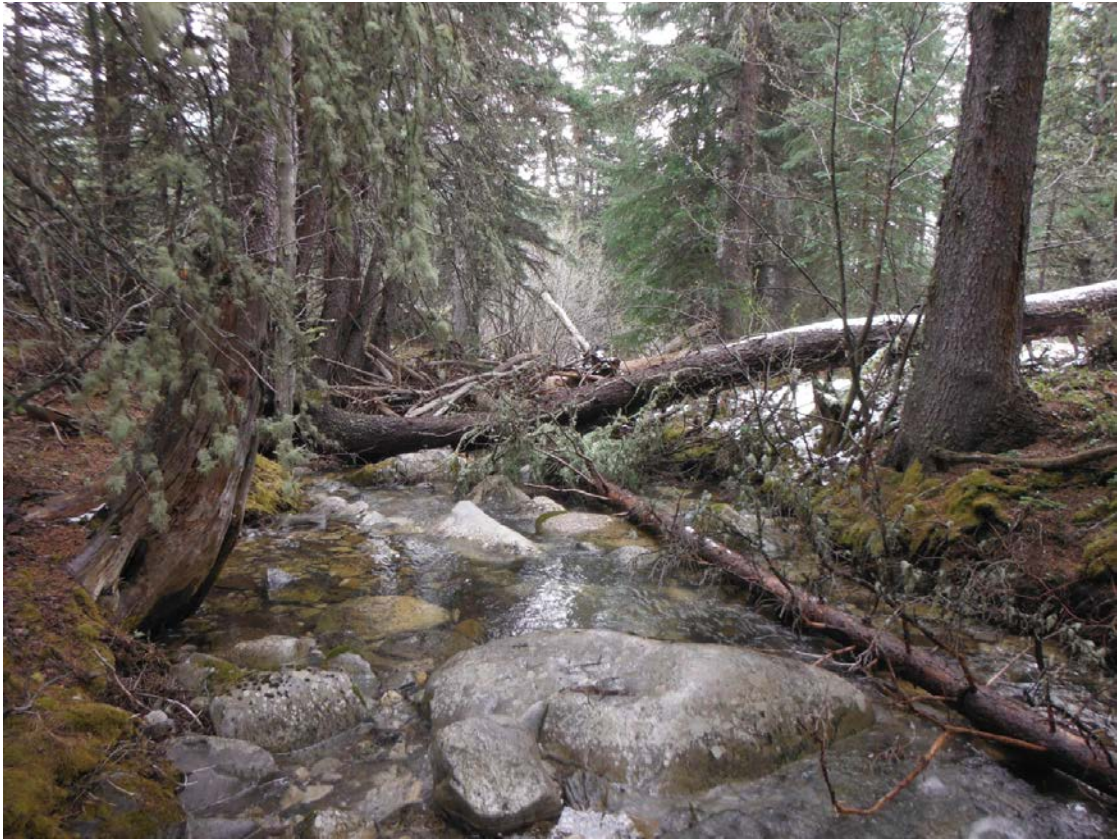
F- 12 Cascade with LWD jam near site G1-04 on Gold Creek.

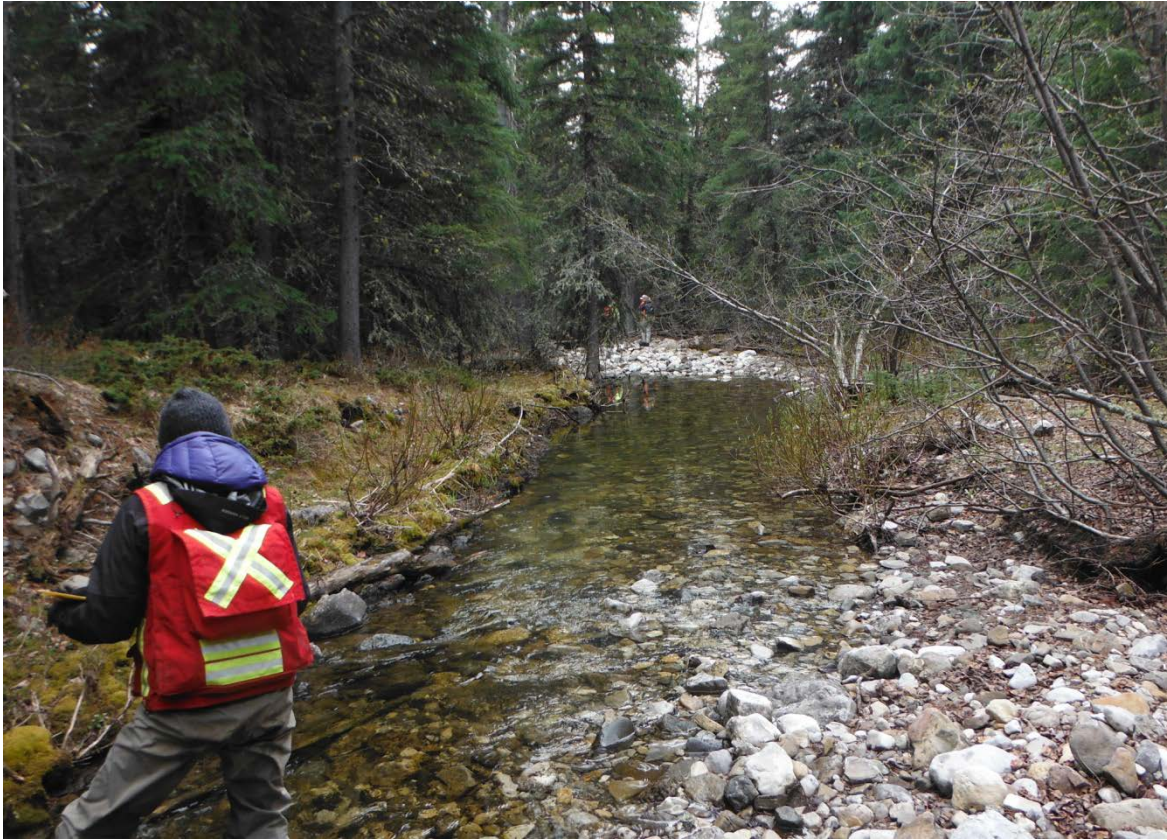
F- 13 Upper Gold Creek riffle pool reach with lateral bars at site G1-12.

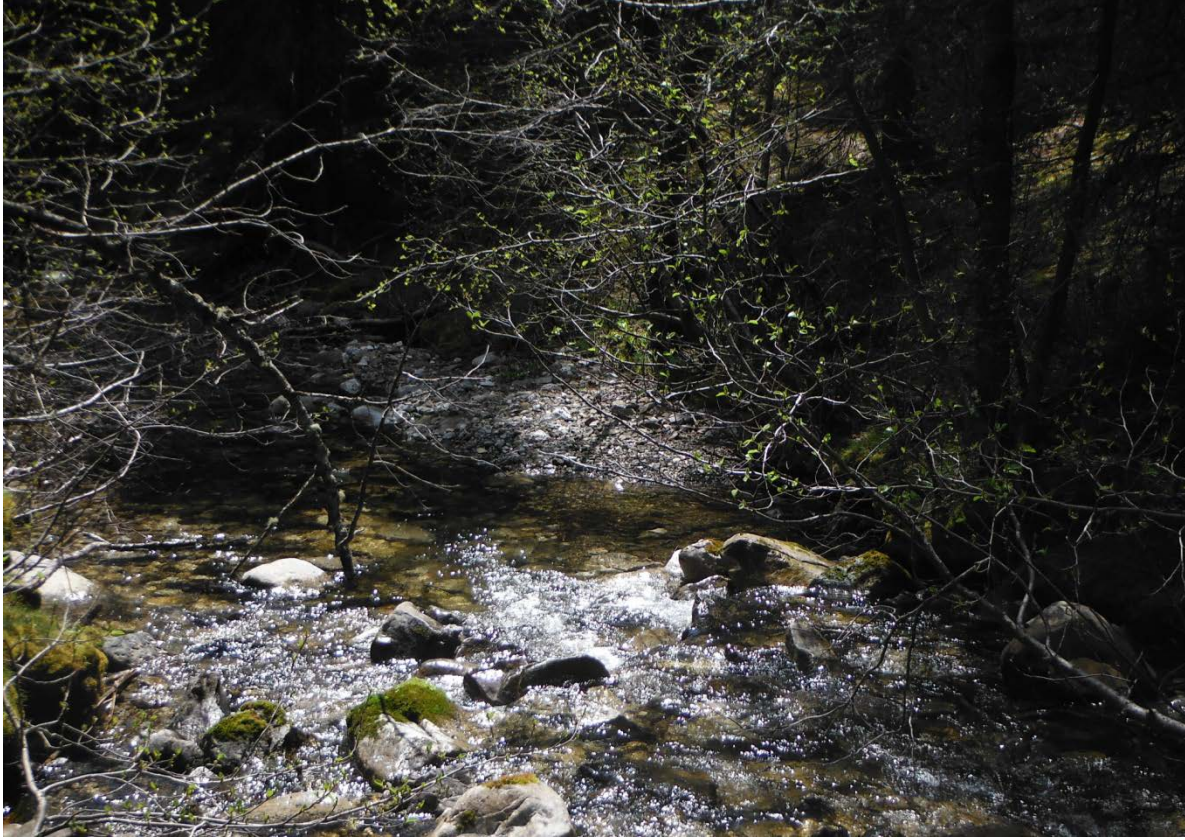
F- 14 Step pool transition into riffle pool at site G1-15.

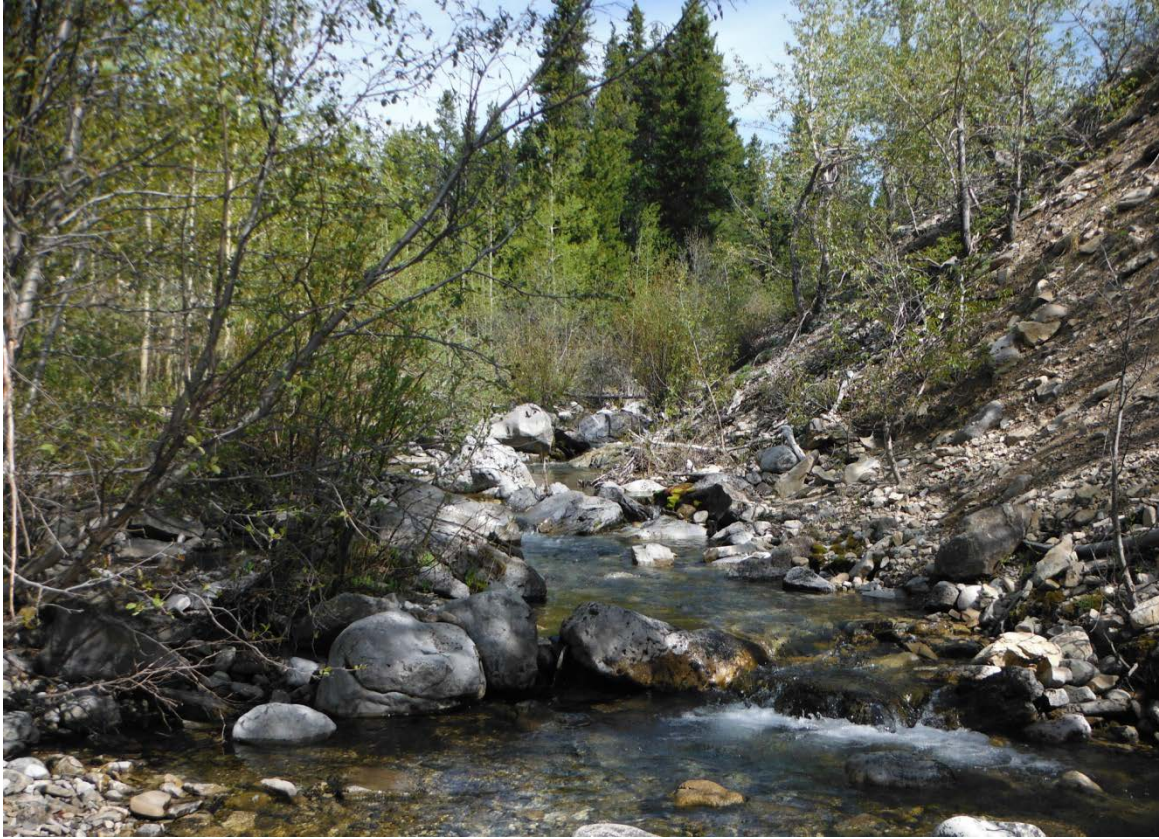
F- 15 Looking downstream toward a step pool sequence at site G2-01 on Gold Creek.

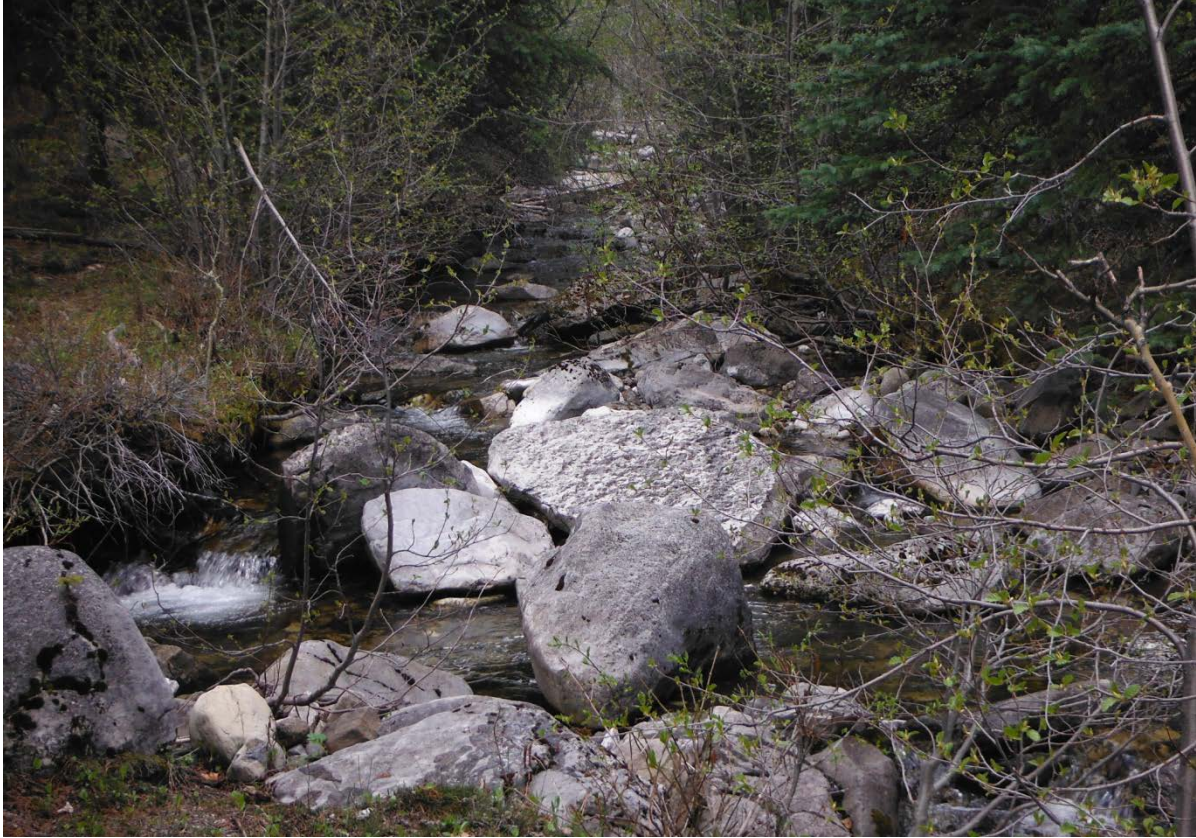
F- 16 Cascade run near site G2-02.

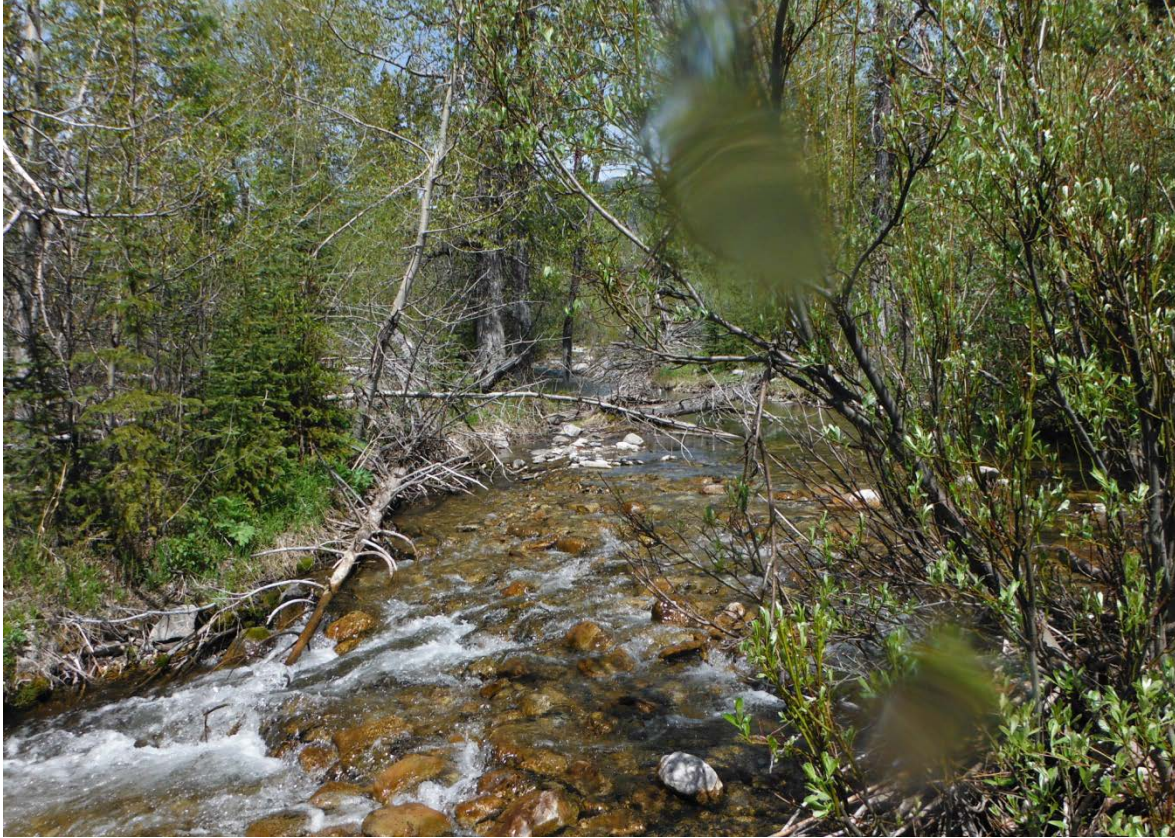
F- 17 Riffle pool transitioning to a cascade at G2-05.

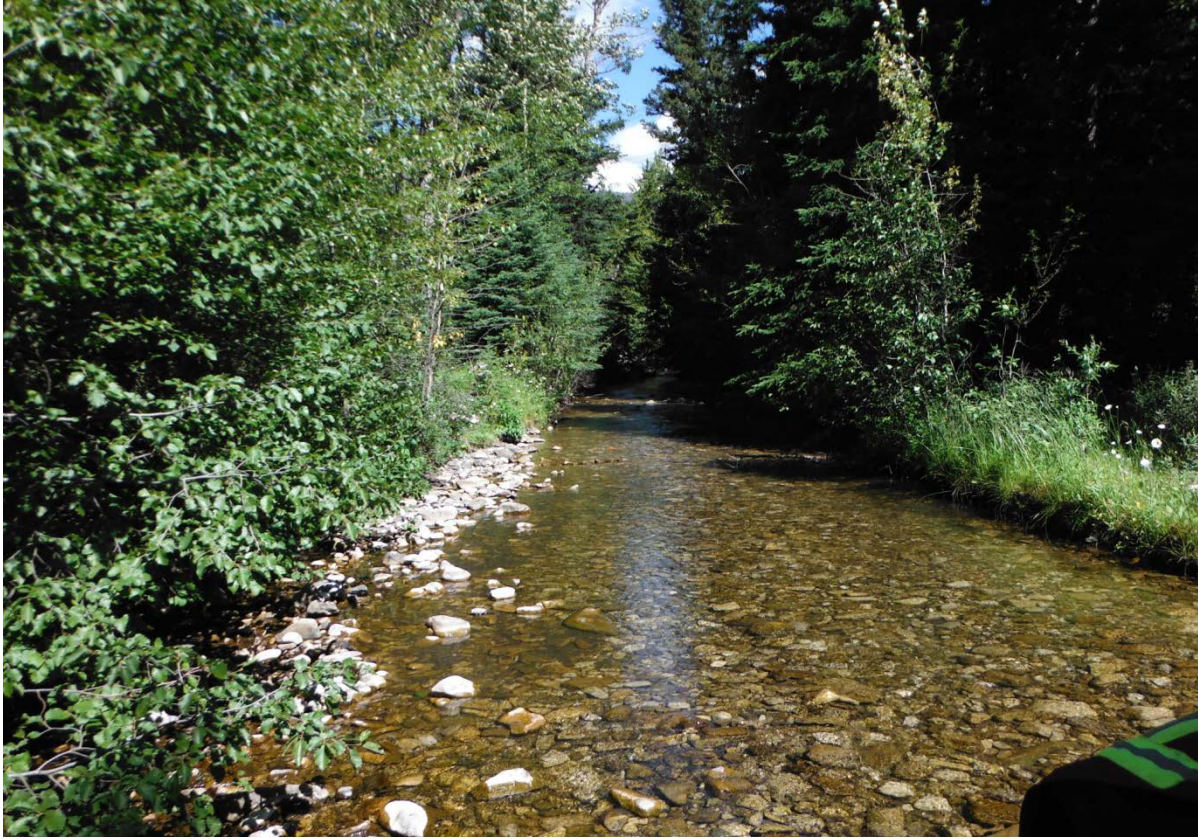
F- 18 Plane bed morphology in Gold Creek upstream of site G3-02.

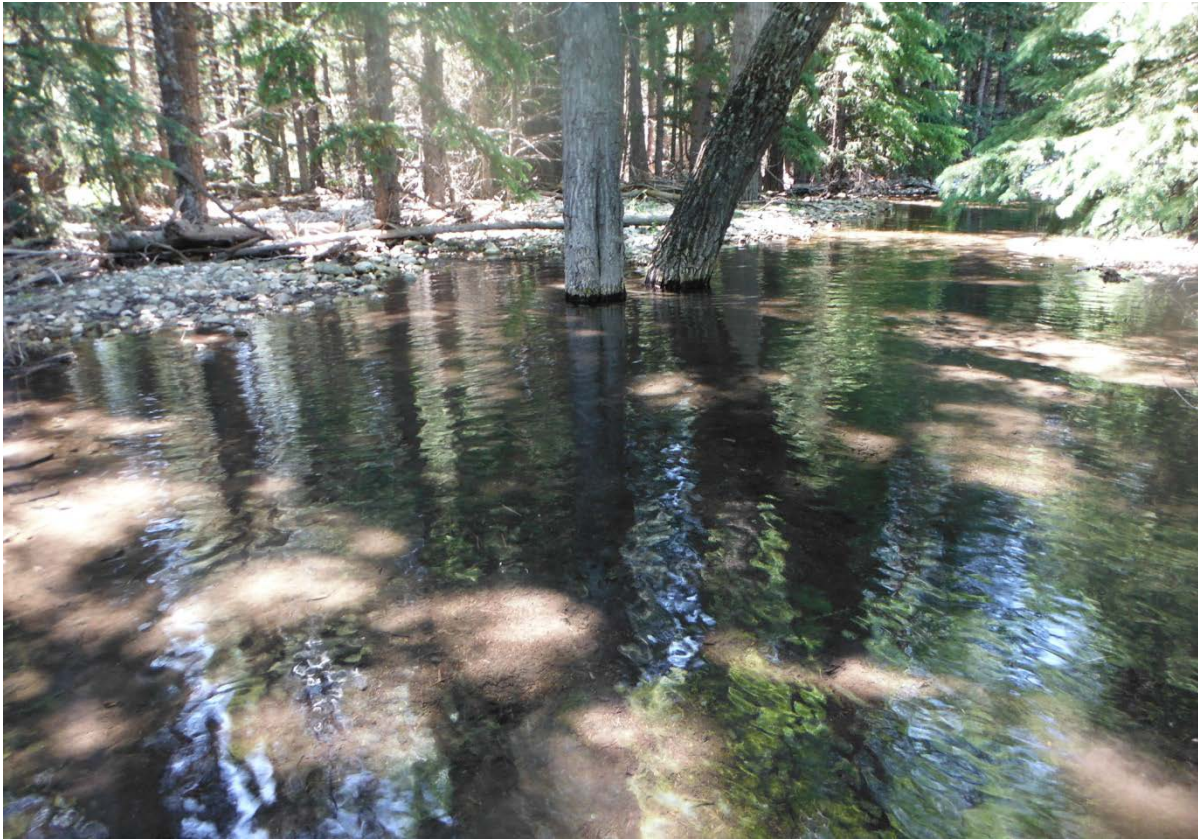
F- 19 Avulsed channel on Gold Creek near Site G3-03. Note the mature conifers submerged in flow.

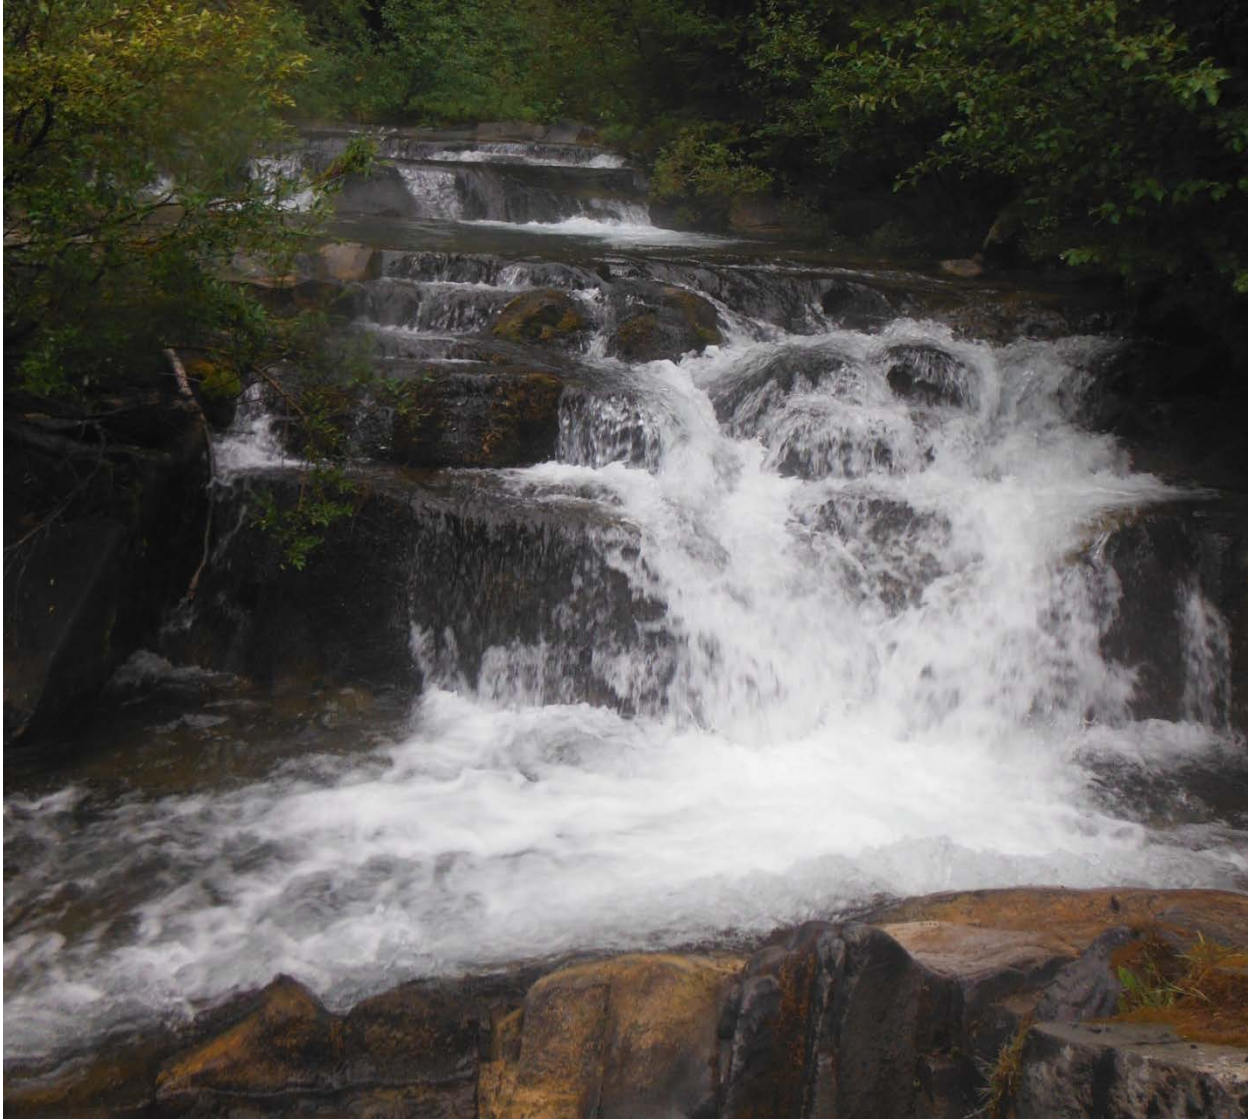
F- 20 Bedrock-cascade near site G4-01 on Gold Creek.

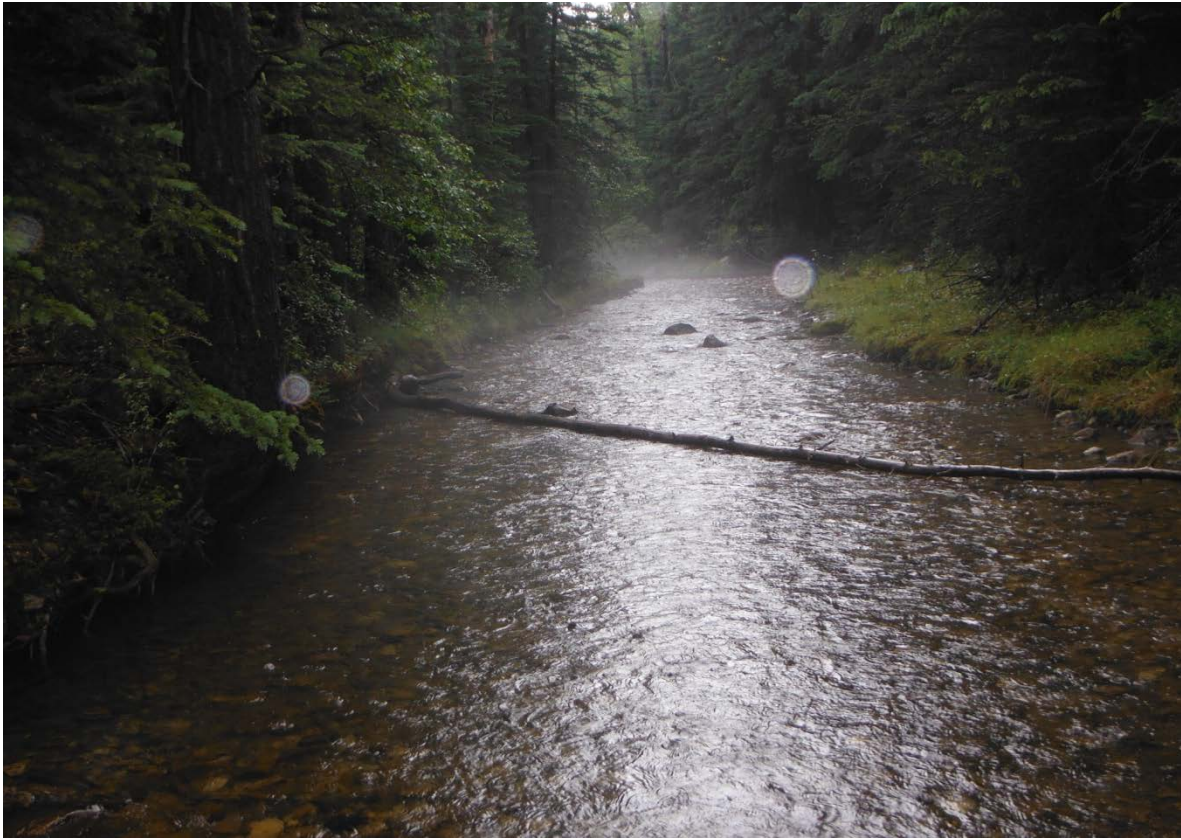
F- 21 Plane bed morphology at site G4-02 on Gold Creek.
