Lake Manitoba and Lake St. Martin Outlet Channel Project Spring Fish Use of Watercourses along the LMBOC Alignment

Prepared for Manitoba Infrastructure $\,\cdot\,$ March 2019 By North/South Consultants Inc. $\,\cdot\,$ 83 Scurfield Blvd. $\,\cdot\,$ Winnipeg, MB $\,\cdot\,$ R3Y 1G4

Spring Fish Use of Watercourses along the LMBOC Alignment

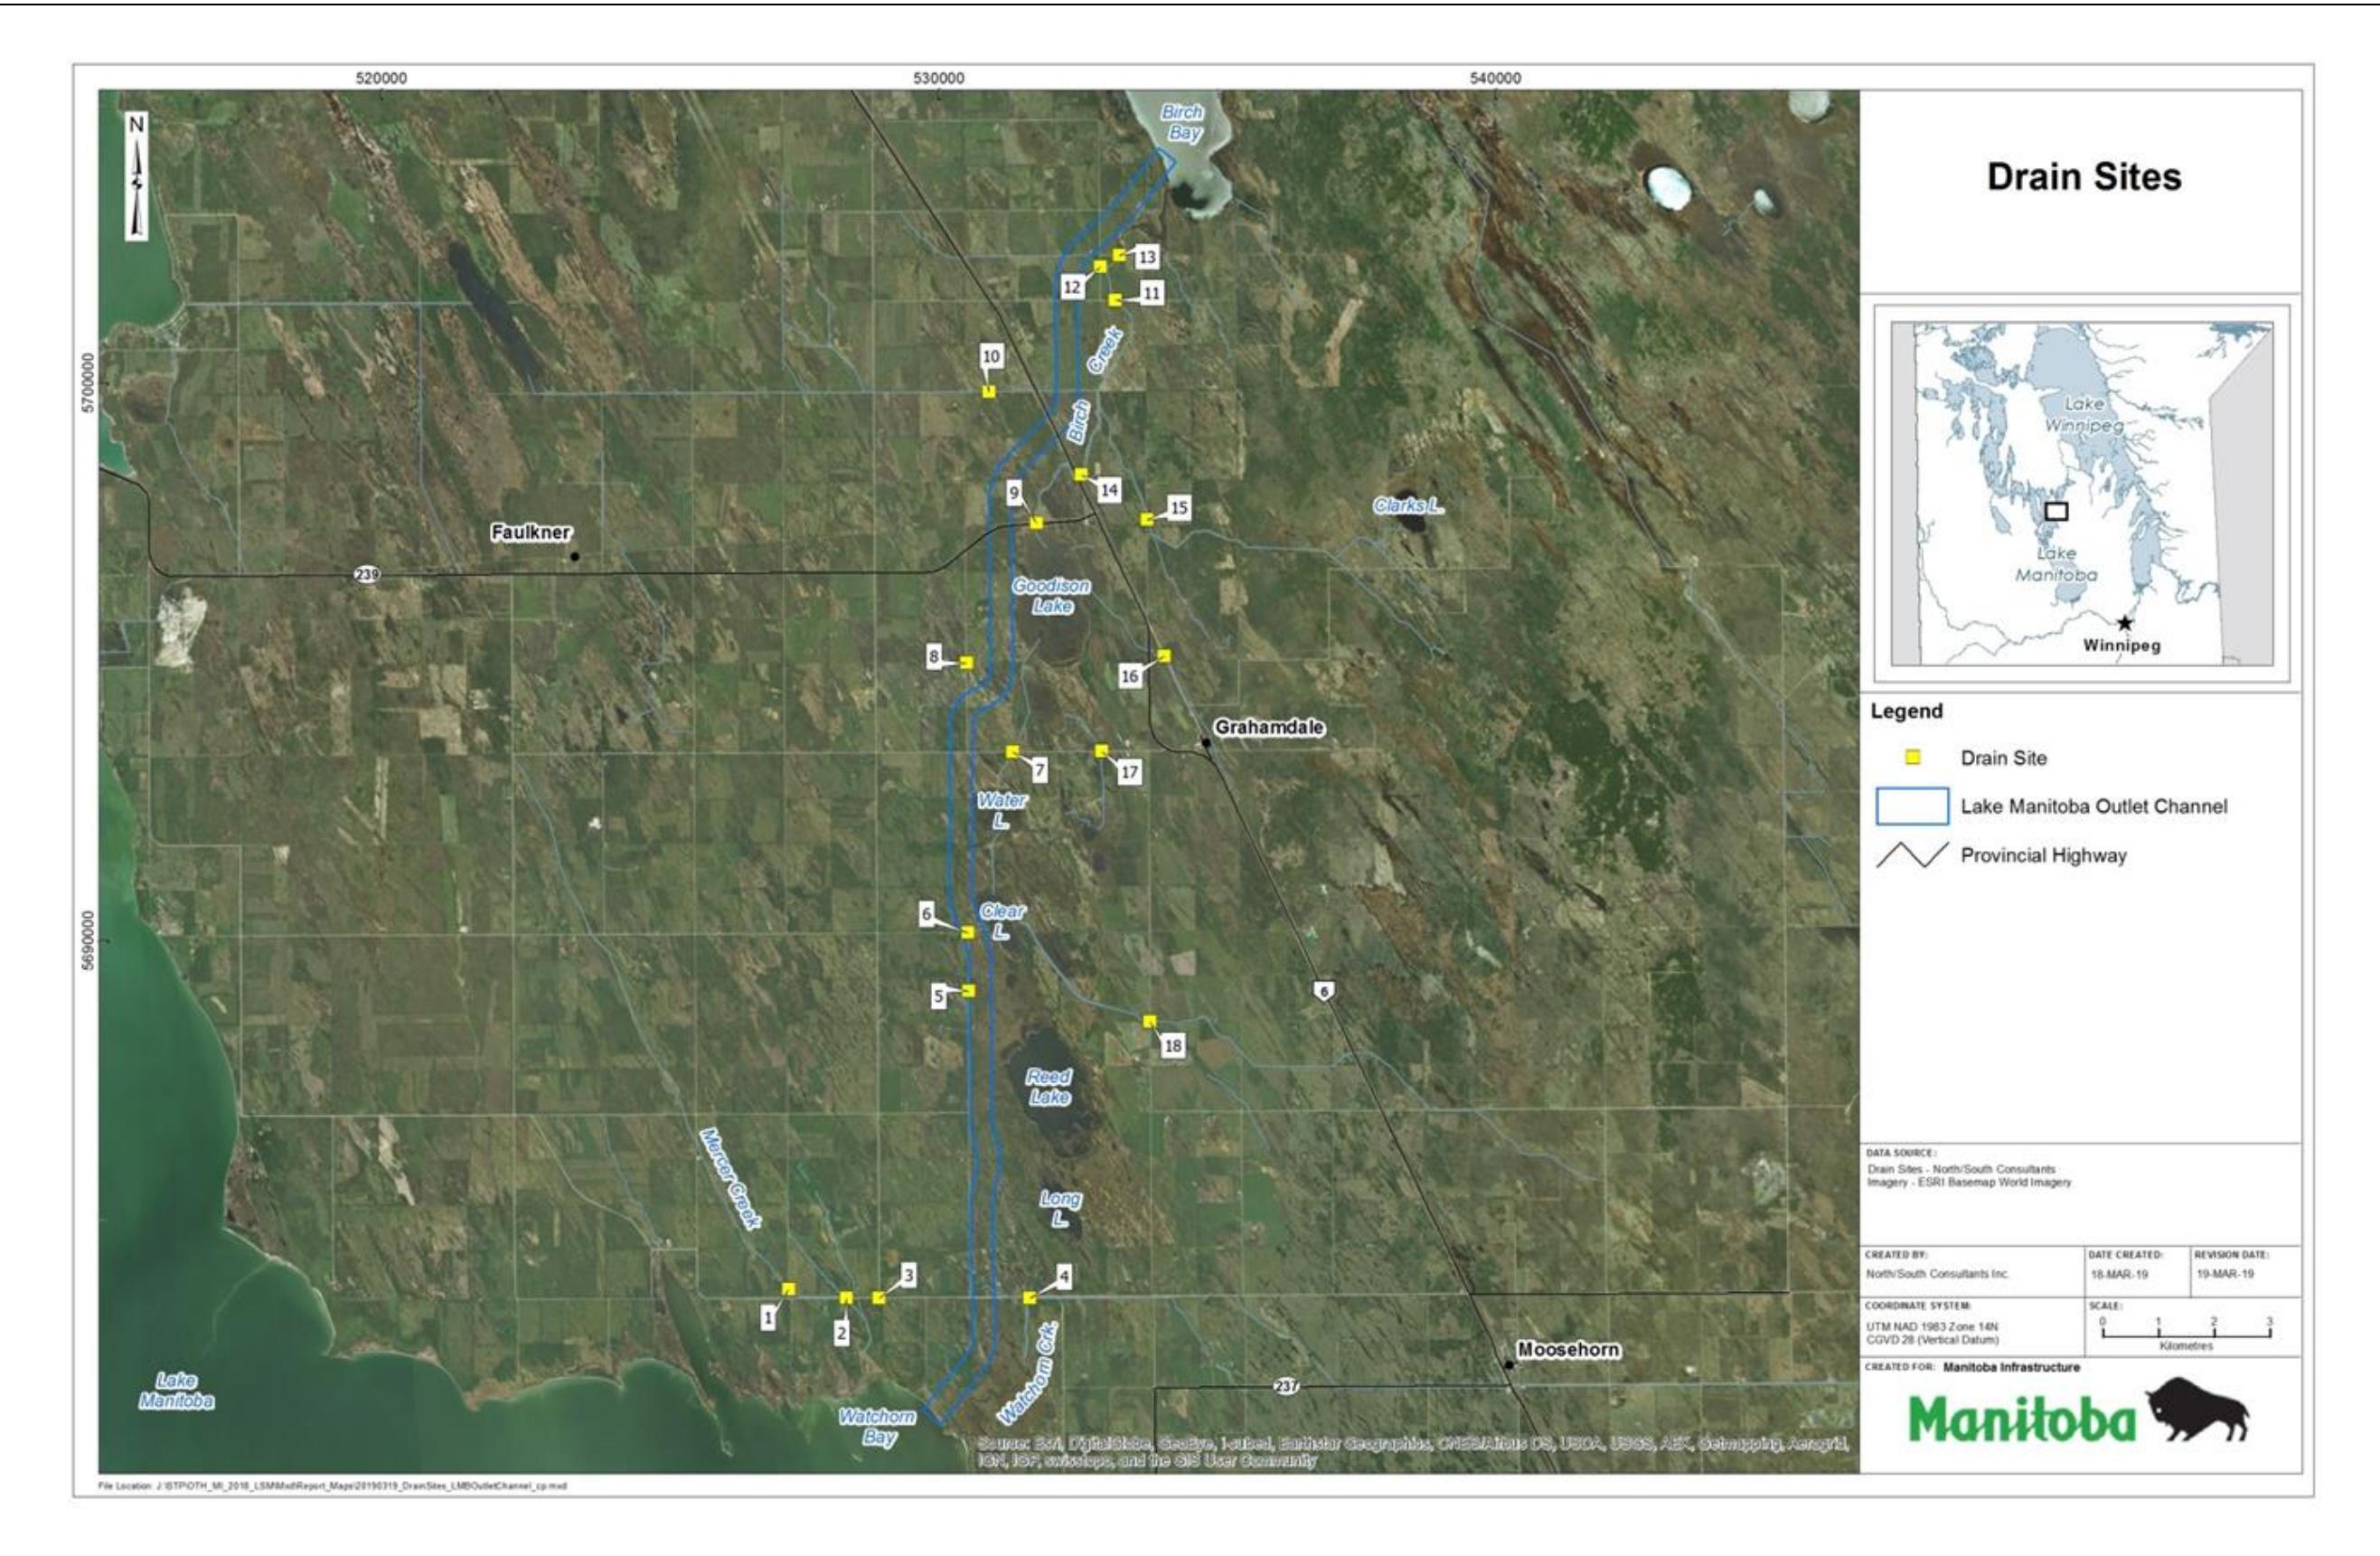
Figure 5. Location of drain sites inspected on May 04, 2018.

To the west of the LMBOC alignment, Sites 5, 6, and 8 were located on 2^{nd} order drains that flowed into small lakes in the upper Birch Creek watershed (Figure 5). The Site 5 drain (Plate 8) entered into Reed Lake, the Site 6 drain (Plate 9) flowed into Clear Lake, and the Site 8 drain (Plate 11) entered into Goodison Lake. Water depth was less than 30 cm and water flow was not apparent at any of those sites. No fish were observed and it is doubtful whether fish occurred at any of those locations during the spring of 2018. Site 10 was located at the Woodale Drain, a 3^{rd} order drain entering into Birch Creek (Figure 5). Water was shallow in the drain, but was flowing (Table 1; Plate 14). Fish were not observed in the drain, but may be able to access the drain from Birch Creek, especially when water levels are higher than observed in 2018. Site 12 occurred on a 2^{nd} order drain that entered Birch Creek near Lake St. Martin (Figure 5). Water depth at the culvert crossing was shallow (< 15 cm) but water flow was evident (Table 1; Plate 16). Although small-bodied fish likely could access the site from Birch Creek, no fish were observed.

Sites along Birch Creek extended from 2.1 (Site 13) to 12.8 km (Site 7) upstream of Lake St. Martin (Figure 5). At the downstream end of the creek (Site 13), water was approximately 45 cm deep and flowing (Table 1; Plate 17). Fish were not observed at this site but a commercial fisher had installed a fish trap upstream of the culvert crossing and was capturing Northern Pike (Plate 17). No fish were observed approximately 1 km farther upstream at Site 11 (Plate 15), where water was shallower (30 cm) but flow was maintained (Table 1; Plate 15). Site 14 occurred where Birch Creek crosses PTH 6, approximately 6.6 km upstream of Lake St. Martin (Figure 5). At this location the creek was about 30 cm

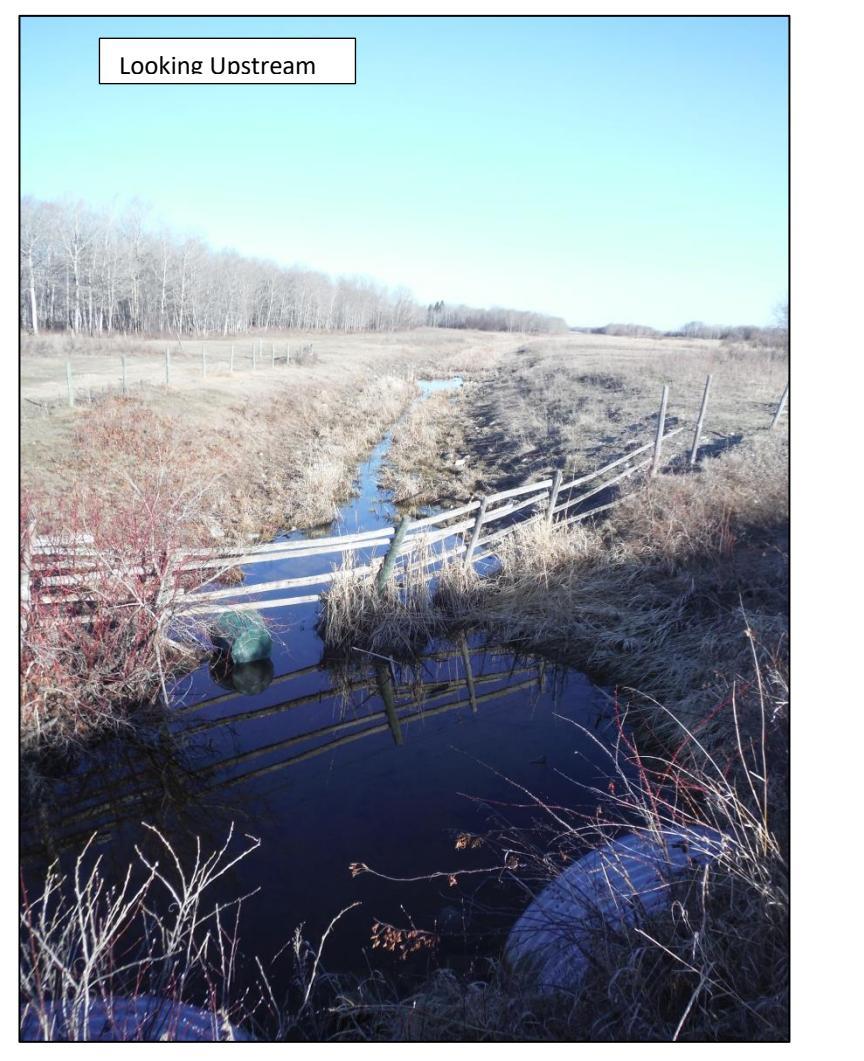
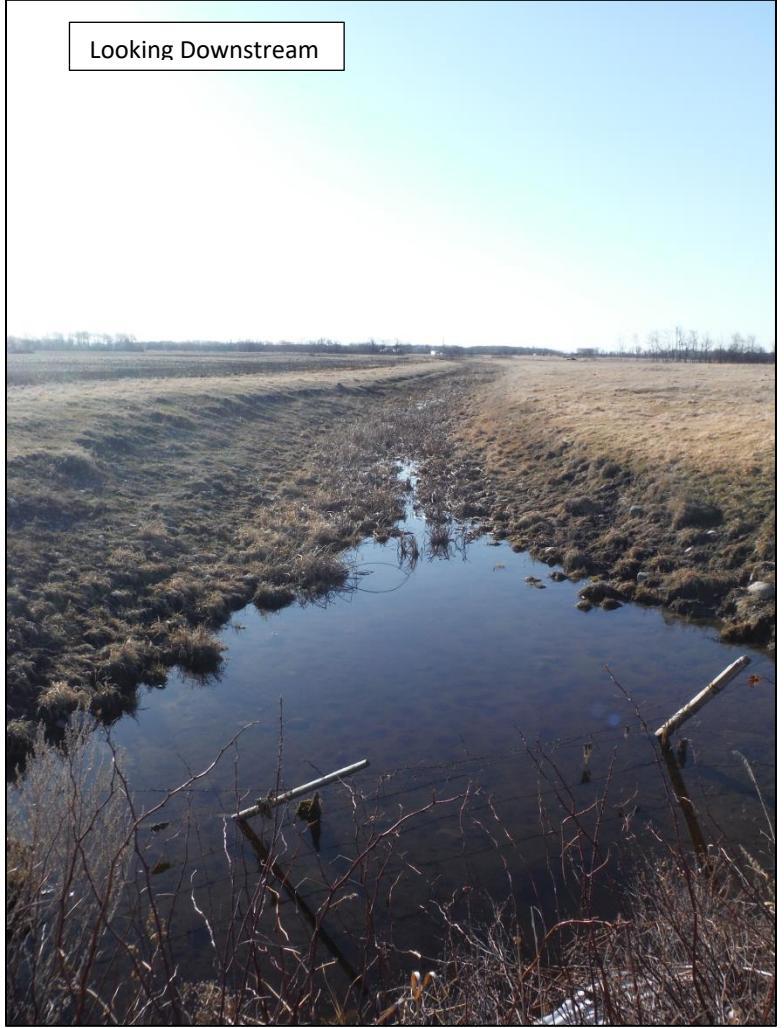
Plate 1. Upstream and downstream views at Site 1 (Mercer Creek), May 04, 2018.

The Mercer Creek watershed lies to the west of the proposed LMBOC and surface water flow patterns will not be interrupted by construction of the LMBOC. Two of the three sites visited within the watershed were situated on the Mercer Creek mainstem (Sites 1 and 2). A shallow pool (30 cm depth; Table 1) occurred in the vicinity of culverts at Site 1, but little water occurred in the creek immediately upstream or downstream of the culvert crossing (Plates 1 and 2). Two live Northern Pike (*Esox lucius*) were observed in the pool. Based on the lack of water elsewhere in the creek, it is likely that those pike ascended the creek earlier in the spring and were stranded in the pool as water level receded. In the absence of increased flow in the creek, fish occurring in the pool at Site 1 would likely have perished as the pool dried up. Site 2 was located about 1 km downstream of Site 1 and 1.6 km from Lake Manitoba (Figure 5). Water depth at that location was 45 cm (Table 1) and the creek was continuously wetted upstream and downstream of the culvert crossing, although no flow was evident (Table 1; Plate 3). Fish were not observed at this site, but it appeared that fish could access the site from Lake Manitoba. The occurrence of fish farther upstream at Site 1 suggests that fish likely occurred in the vicinity of Site 2. Water temperature at both sites was 9°C.

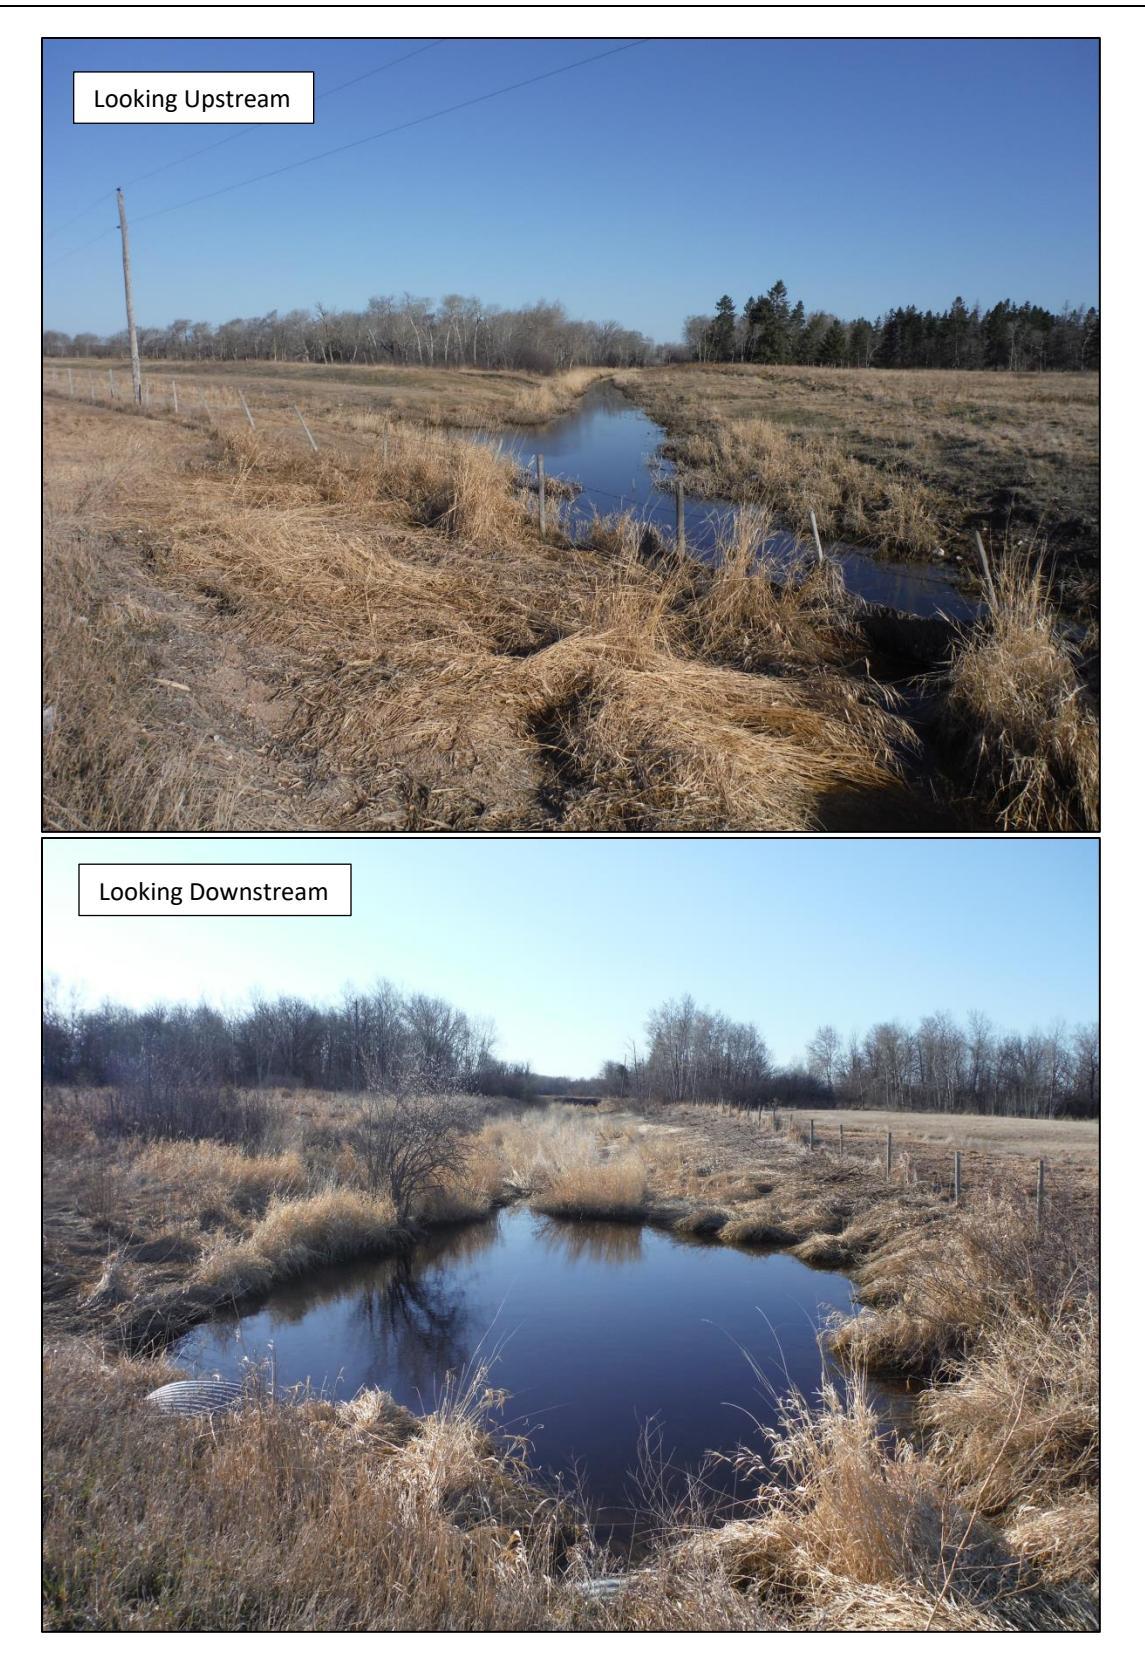
Plate 3. Upstream and downstream views at Site 2 (Mercer Creek), May 04, 2018.

The third site visited (Site 3) occurred on a first order drain approximately 600 m upstream of Mercer Creek. The drain had little water in it (< 5 cm; Table 1) and it is doubtful whether fish occurred there (Plate 3).

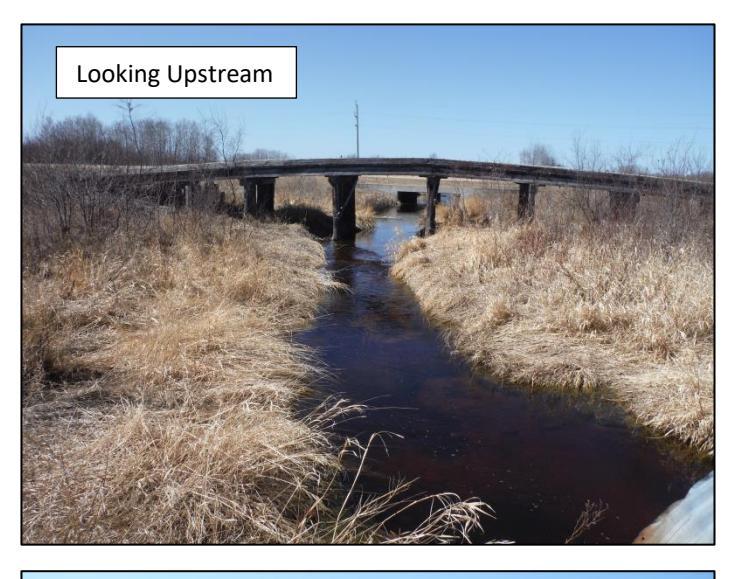
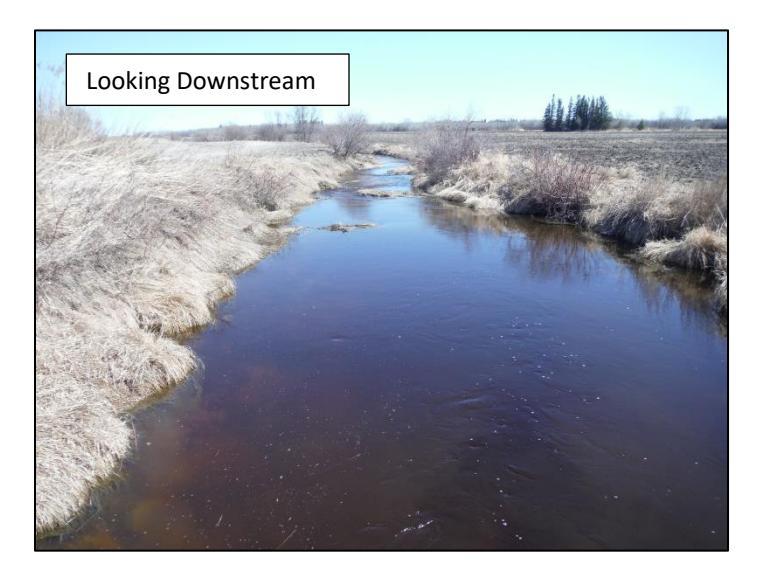
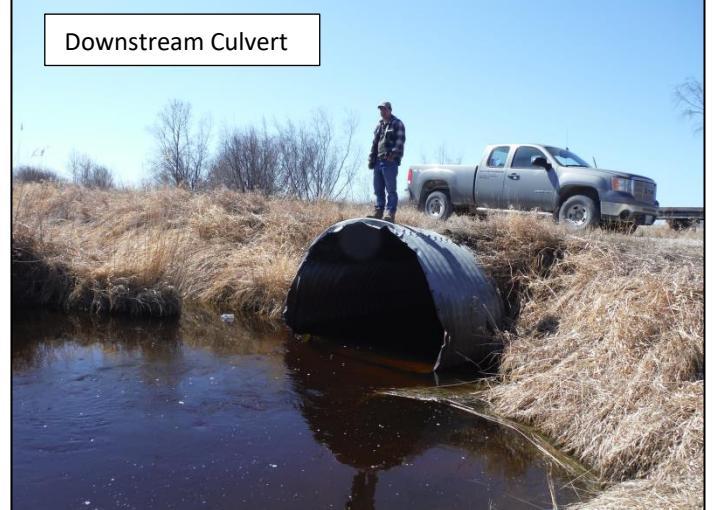
Plate 18. Upstream, downstream , and downstream culvert views at Site 14 (Birch Creek), May 04, 2018.

deep and flowing (Table 1). A large pool was observed downstream of the culvert crossing that was slightly deeper than the upstream or downstream waters (Plate 18). Numerous fish were observed holding in the pool including Northern Pike, White Sucker (*Catostomus commersonii*), and at least two Walleye (*Sander vitreus*). No fish were observed 1.6 km farther upstream at Site 9 (Figure 5), although water depth and flow (30 cm deep, moderate flow; Table 1; Plate 13) were comparable to those observed at Site 14. At Site 7, the upstream-most site, water depth was approximately 30 cm deep but flow at this site was minimal (Table 1; Plate 10). One live White Sucker, one dead White Sucker and one dead Northern Pike were observed at this site. Site 7 was located upstream of Goodison Lake, indicating fish are able to access Birch Creek from Goodison Lake, but whether the fish observed at Site 7 ascended Birch Creek from Lake St. Martin or from Goodison Lake is not known.

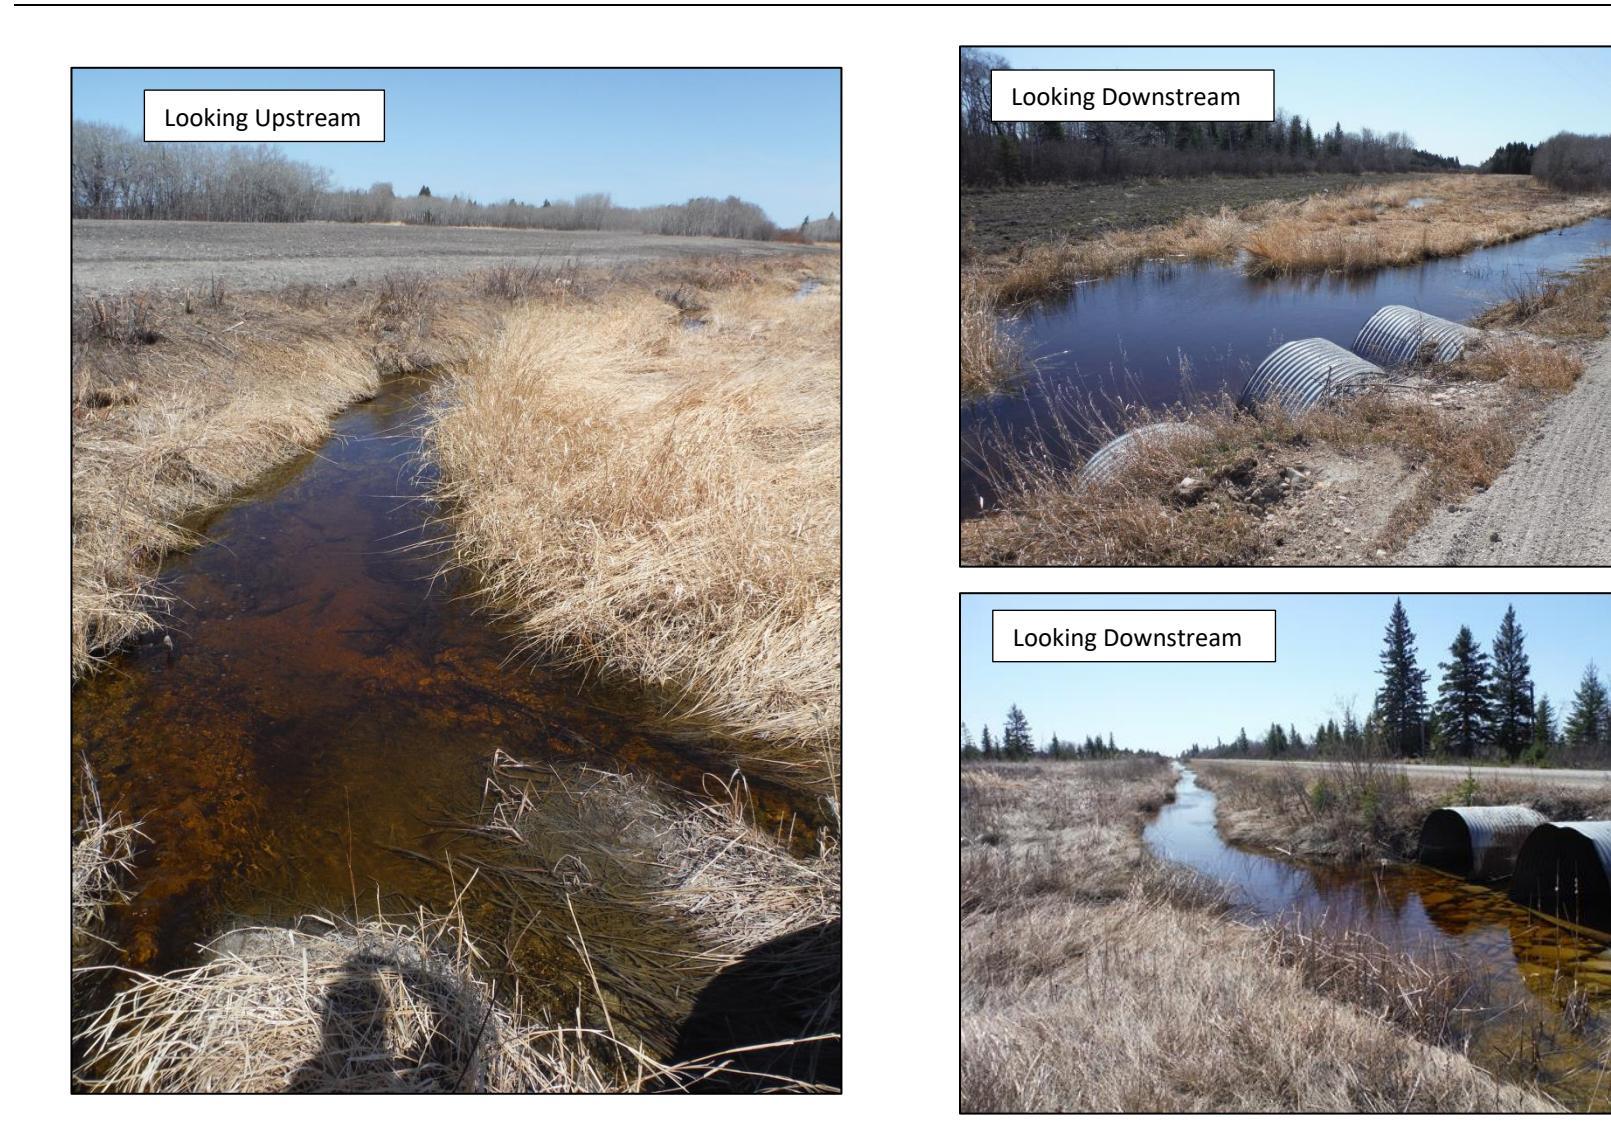
Plate 19. Upstream and downstream views at Site 15 (3rd order drain to Birch Creek), May 04, 2018.

To the east of the LMBOC alignment, Sites 15, 17, and 18 had approximately 30 cm of water flowing in each drain (Table 1; Plates 19, 21 and 22 respectively). The drain at Site 16 was characterized by shallow waters (<30 cm) and had no flow (Table 1; Plate 20). Fish were not observed at any of these sites and it is thought they would be inaccessible to fish occurring in Birch Creek, at least during conditions occurring at the time of the survey.
